## Defect Listing

Pipe Segment Refere... <b>A11-2_A11-1</b>	City <b>Oliver Springs</b>	Street <b>Poplar St</b>	Material <b>Concrete Pipe (non-...</b>	Location C... <b>Light High...</b>	Sewer Use <b>Sanitary</b>
Upstream MH <b>A11-2</b>	Total Length <b>315.4</b>	Year Laid	Shape <b>Circular</b>	Location Details	
DS Manhole <b>A11-1</b>	Length surveyed <b>315.4</b>	Year Renewed	Height <b>8</b>	Width <b>8</b>	Pipe Joint... <b>4</b>

SPR <b>N/A</b>	MPR <b>N/A</b>	PO Number <b>4397-03</b>	Customer <b>GRW</b>
SPRI <b>N/A</b>	MPRI <b>N/A</b>	Work Order <b>4397-02</b>	Purpose <b>Pre-Rehabilitation Survey</b>
QSR <b>N/A</b>	QMR <b>N/A</b>		
OPR <b>N/A</b>	Surveyed By <b>Charlie Gordon</b>	Direction <b>Downstream</b>	Date <b>20150817</b>
OPRI <b>N/A</b>	Certificate Number <b>U-615-07000491</b>	Pre-Cleaning <b>Jetting</b>	Time <b>08:50</b>
	Date Cleaned <b>20150817</b>	End Time <b>09:06</b>	Weather <b>Dry</b>
			Additional Info

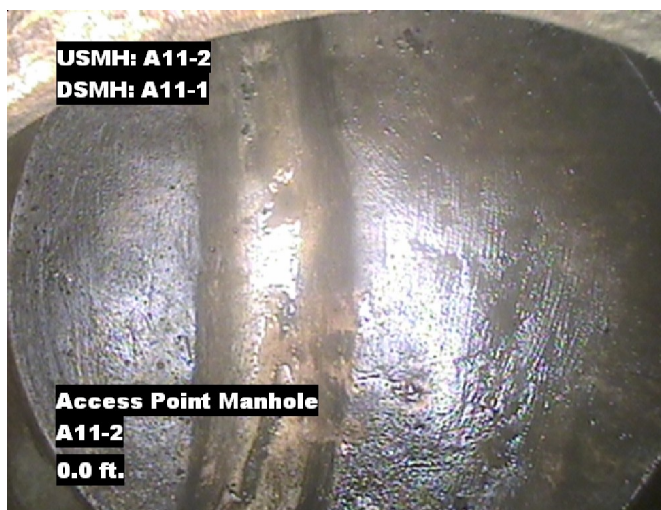
Distance: 0.0 ft. Grade: 0  
Condition: Access Point Manhole  
Remarks: A11-2

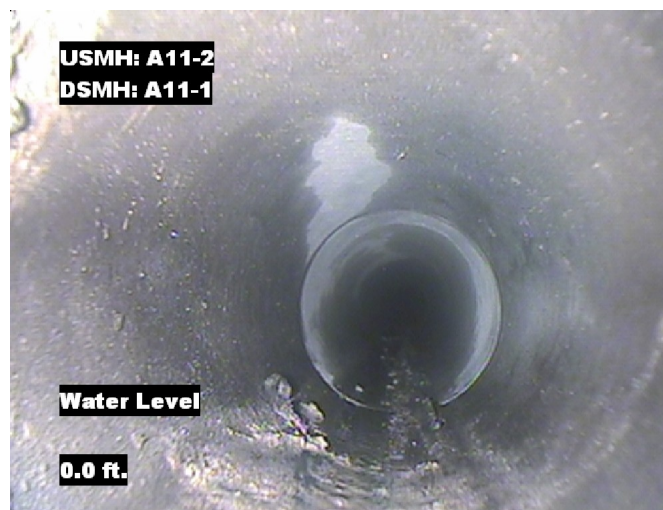
Distance: 0.0 ft. Grade: 0  
Condition: Water Level  
Remarks: N/A

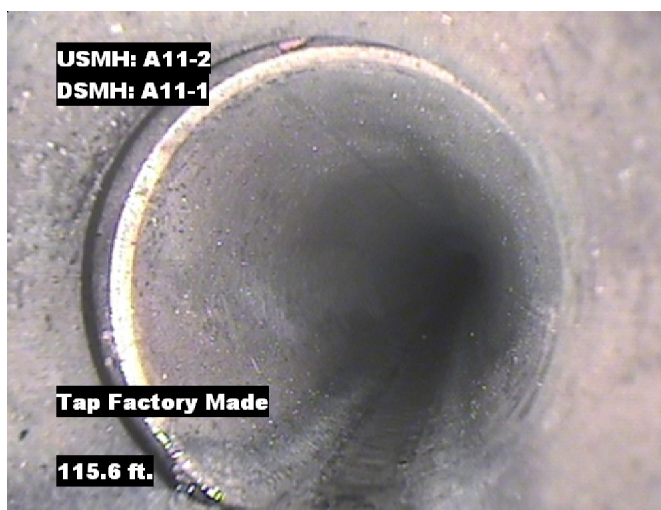
Distance: 115.6 ft. Grade: 0  
Condition: Tap Factory Made  
Remarks: N/A

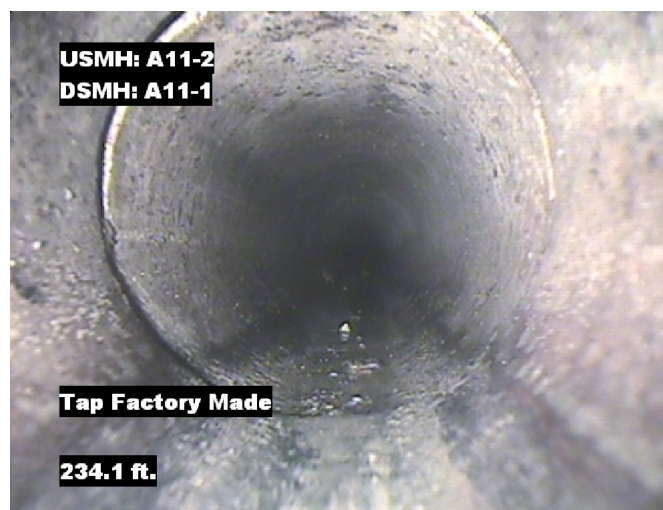
Distance: 234.1 ft. Grade: 0  
Condition: Tap Factory Made  
Remarks: N/A

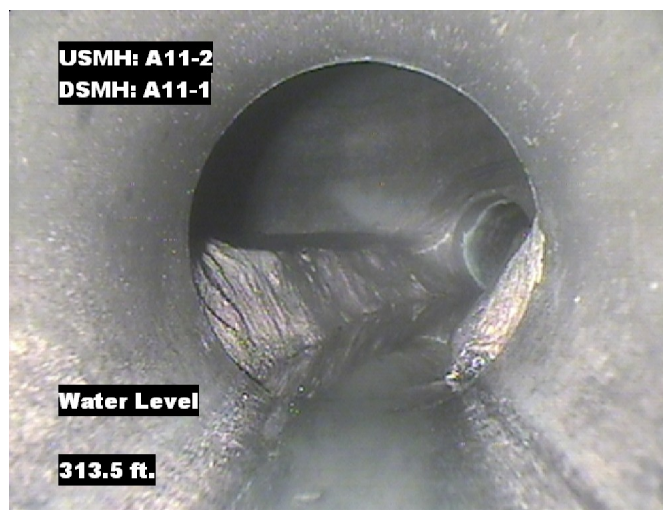
Distance: 313.5 ft.      Grade: 0  
Condition: Water Level  
Remarks: N/A

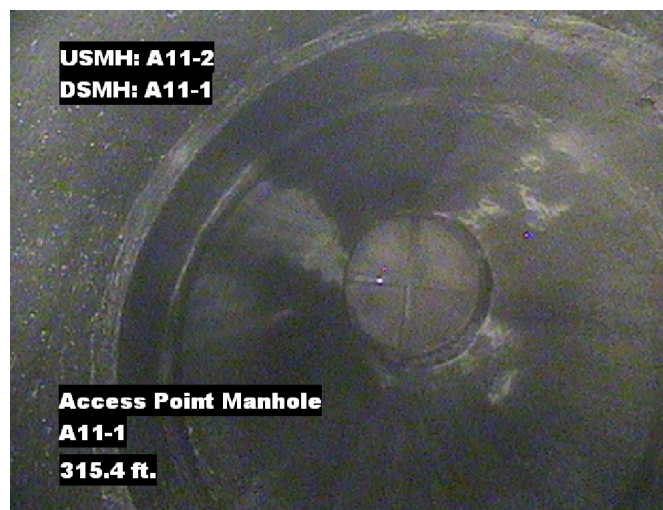
Distance: 315.4 ft.      Grade: 0  
Condition: Access Point Manhole  
Remarks: A11-1
