Defect Listing

Pipe Segment Refere... A11-3_A11-2	City Oliver Springs	Street Place St	Material Concrete Pipe (non-...	Location C... Light High...	Sewer Use Sanitary
Upstream MH A11-3	Total Length 103.3	Year Laid	Shape Circular	Location Details	
DS Manhole A11-2	Length surveyed 103.3	Year Renewed	Height 8	Width 8	Pipe Joint... 4

SPR N/A	MPR N/A	PO Number 4397-03		Customer GRW	
SPRI N/A	MPRI N/A	Work Order 4397-02		Purpose Pre-Rehabilitation Survey	
QSR N/A	QMR N/A				
OPR N/A	Surveyed By Charlie Gordon	Direction Downstream	Date 20150817	Media label	
OPRI N/A	Certificate Number U-615-07000491	Pre-Cleaning Jetting	Time 08:25	Weather Dry	
Date Cleaned 20150817			End Time 08:31	Additional Info

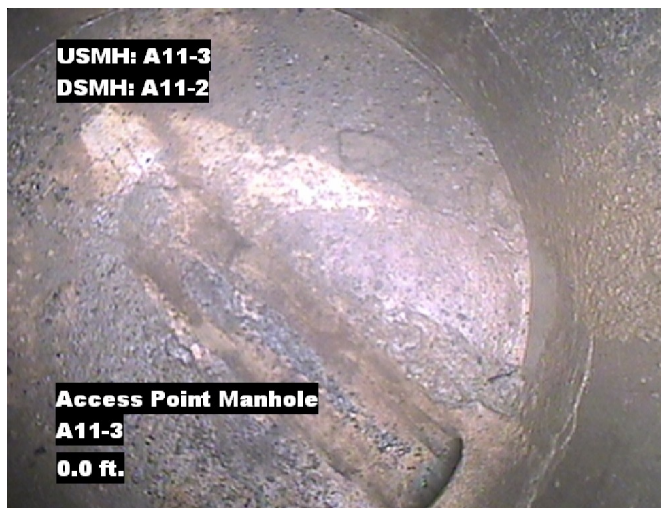
Distance: 0.0 ft. Grade: 0
Condition: Access Point Manhole
Remarks: A11-3

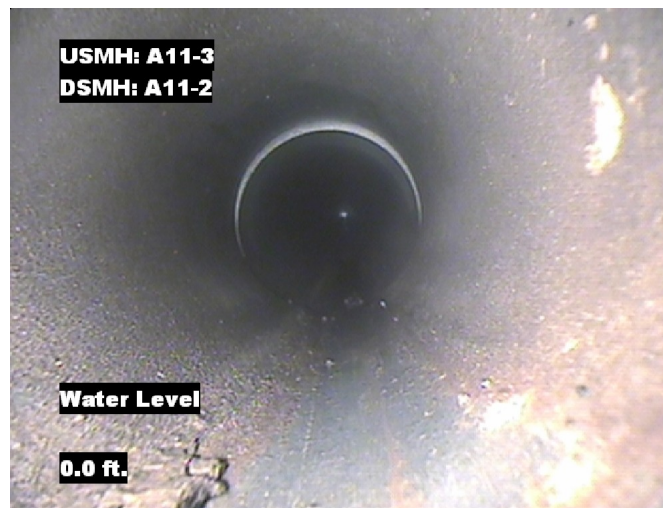
Distance: 0.0 ft. Grade: 0
Condition: Water Level
Remarks: N/A

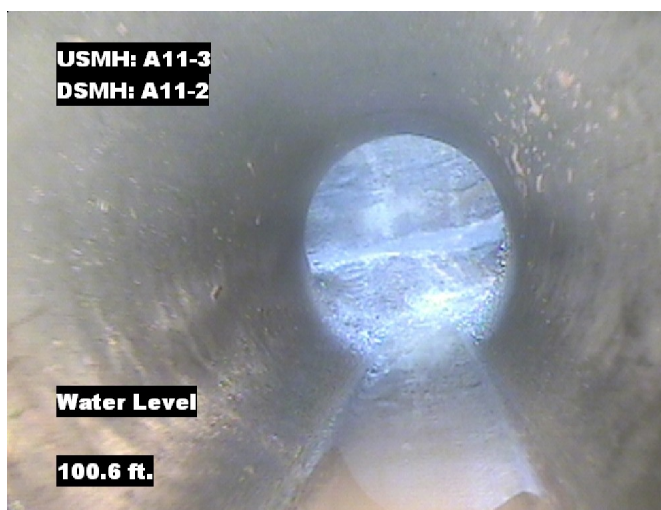
Distance: 100.6 ft. Grade: 0
Condition: Water Level
Remarks: N/A

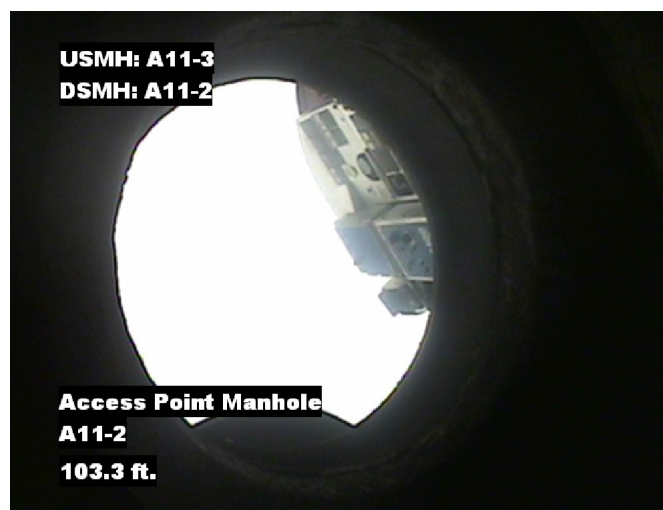
Distance: 103.3 ft. Grade: 0
Condition: Access Point Manhole
Remarks: A11-2
