Defect Listing

Pipe Segment Refere		City		Street	Mat	Material		Sewer Use	
A12-1_A9-4		Oliver Springs		Roane St	Concrete F	Concrete Pipe (non		Sanitary	
Upstream MH A12-1 DS Manhole		Total Length		Year Laid	Sh	Shape		Details	
		26	5.1		Circ	Circular			
		Length surveyed		Year Renewed	Height	Width	Pipe Joint		
AS	A9-4		5.1		8	8	4		
SPR	N/A	MPR	4	PO Number			Customer		
0001	-	MPDI		4397-03		Pre-F			
SPRI	N/A	MPRI	2	Work Order					
QSR	N/A	QMR	2200	4397-02				urvey	
Ol	PR	Surve	yed By	Direction		Date Media lab		alabel	
4	4	Barry_Rogers		Upstream	20150814				
OF	PRI	Certificate Number		Pre-Cleaning	Time		Weather		
:	2		2-16405	Jetting	14	14:38			
	Date Cleaned					End Time		Additional Info	
	20150814					14:56

Image Report 4/Page

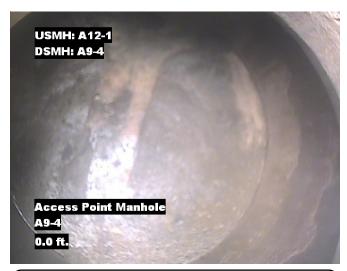
Distance: 0.0 ft. Grade: 0

Condition: Access Point Manhole

Remarks: A9-4

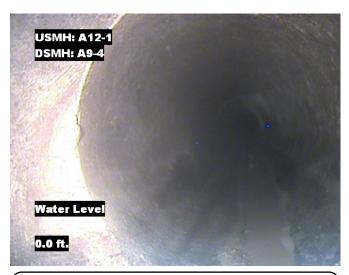
Distance: 0.0 ft. Grade: 0

Condition: Water Level

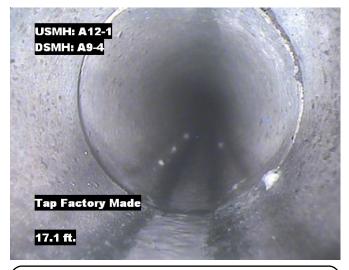
Distance: 17.1 ft. Grade: 0

Condition: Tap Factory Made

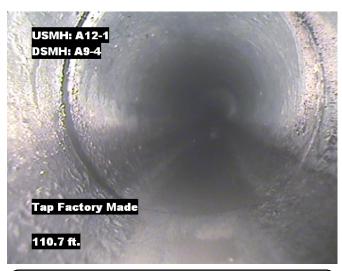
Distance: 110.7 ft. Grade: 0

Condition: Tap Factory Made

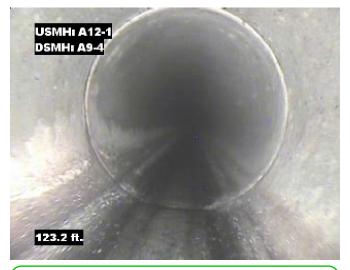
Distance: 123.2 ft. Grade: 2
Condition: Deposits Attached Grease

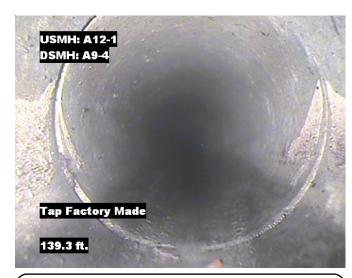
Distance: 139.3 ft. Grade: 0

Condition: Tap Factory Made

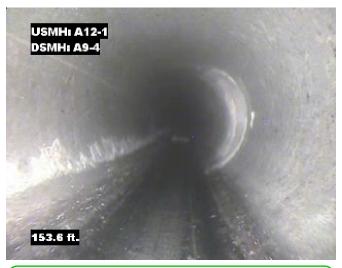
Distance: 153.6 ft. Grade: Condition: Deposits Attached Grease Remarks: this is a continious defect

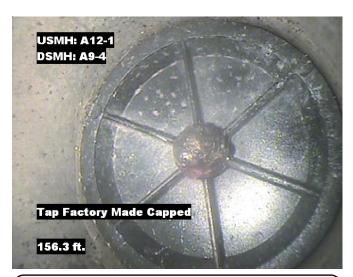
Distance: 156.3 ft. Grade: Condition: Tap Factory Made Capped

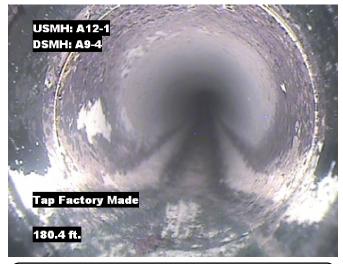
Distance: 180.4 ft. Grade: 0 Tap Factory Made

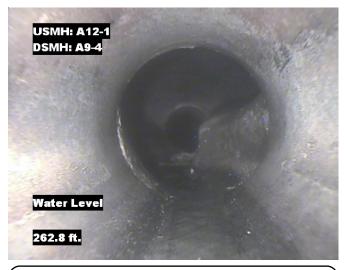
Distance: 262.6 ft. Grade: 0

Condition: Water Level

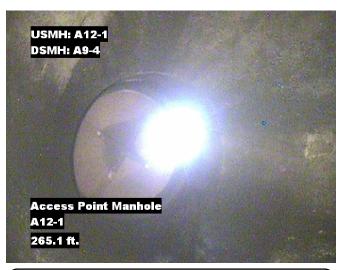
Distance: 265.1 ft. Grade: 0

Condition: Access Point Manhole

Remarks: A12-1
