Defect Listing

Pipe Segment Refere... A13-1_A9-4	City Oliver Springs	Street Roane St	Material Concrete Pipe (non-...	Location C... Light High...	Sewer Use Sanitary
Upstream MH A13-1	Total Length 299.4	Year Laid	Shape Circular	Location Details	
DS Manhole A9-4	Length surveyed 299.4	Year Renewed	Height 8	Width 8	Pipe Joint... 4

SPR N/A	MPR N/A	PO Number 4397-03	Customer GRW
SPRI N/A	MPRI N/A	Work Order 4397-02	Purpose Pre-Rehabilitation Survey
QSR N/A	QMR N/A		
OPR N/A	Surveyed By Barry Rogers	Direction Downstream	Date 20150814
OPRI N/A	Certificate Number U-1012-16405	Pre-Cleaning Jetting	Time 13:39
	Date Cleaned 20150814	End Time 14:00	Weather Damp
			Additional Info

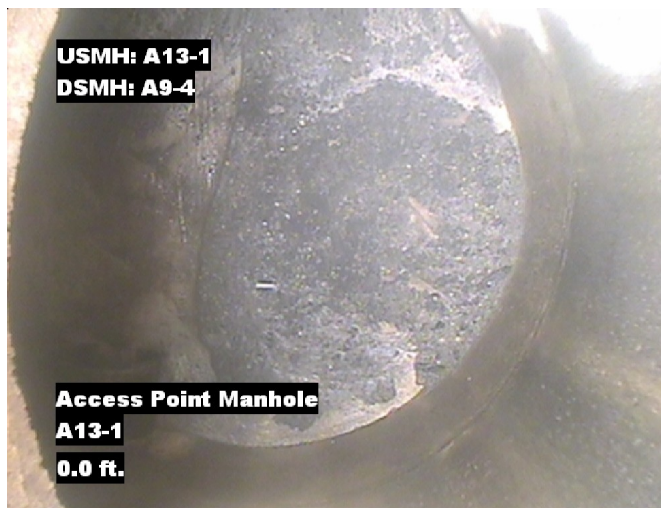
Distance: 0.0 ft. Grade: 0
Condition: Access Point Manhole
Remarks: A13-1

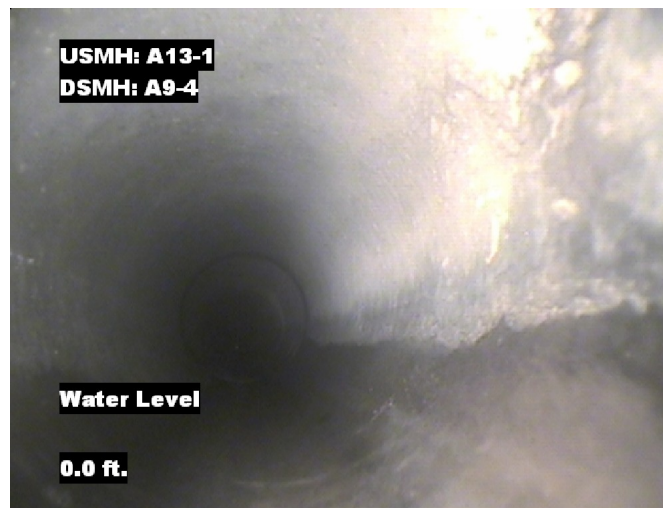
Distance: 0.0 ft. Grade: 0
Condition: Water Level
Remarks: N/A

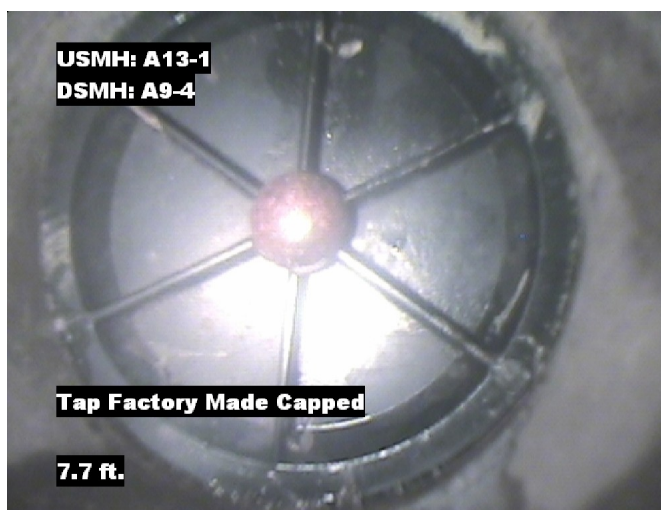
Distance: 7.7 ft. Grade: 0
Condition: Tap Factory Made Capped
Remarks: N/A

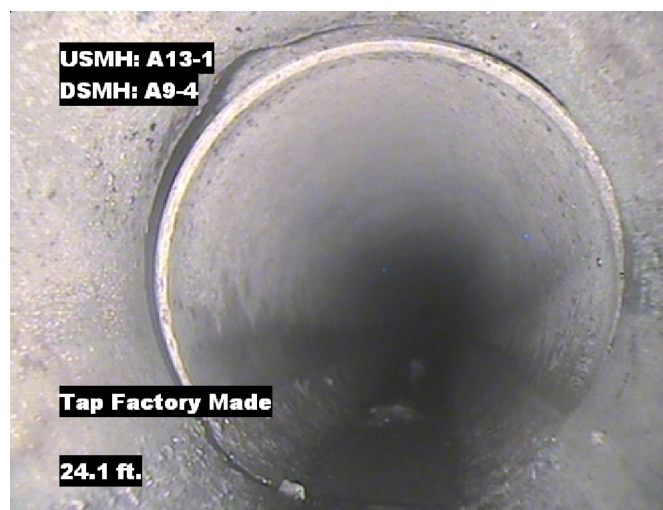
Distance: 24.1 ft. Grade: 0
Condition: Tap Factory Made
Remarks: N/A

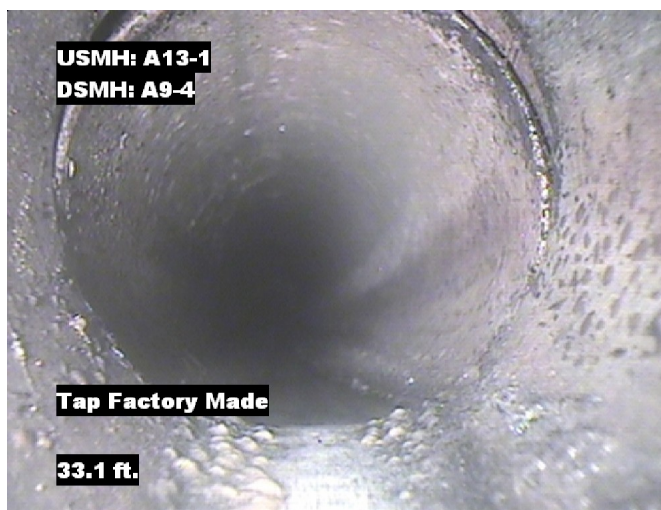
Distance: 33.1 ft. Grade: 0
Condition: Tap Factory Made
Remarks: N/A

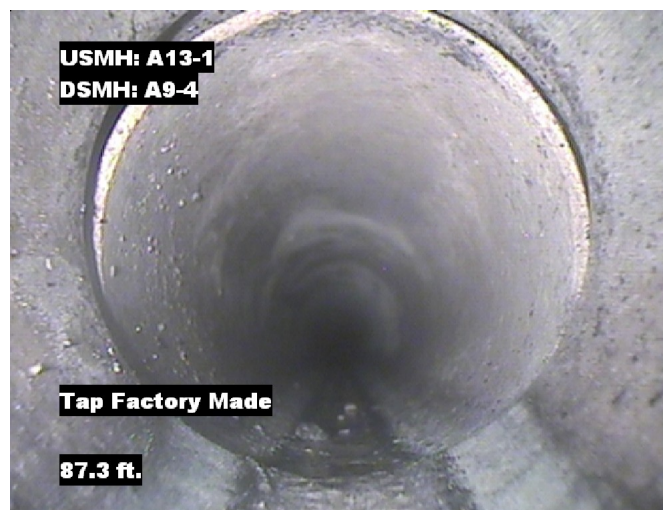
Distance: 87.3 ft. Grade: 0
Condition: Tap Factory Made
Remarks: N/A

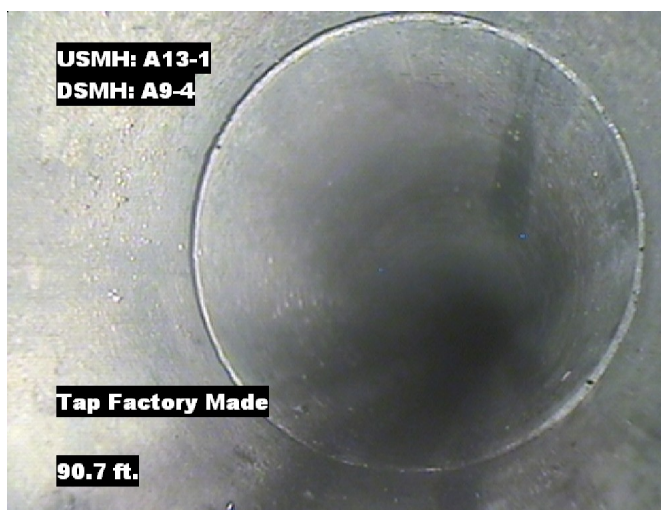
Distance: 90.7 ft. Grade: 0
Condition: Tap Factory Made
Remarks: N/A

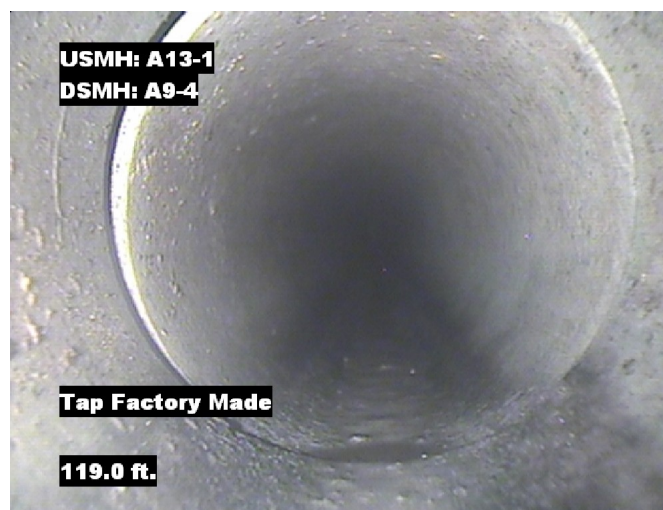
Distance: 119.0 ft. Grade: 0
Condition: Tap Factory Made
Remarks: N/A

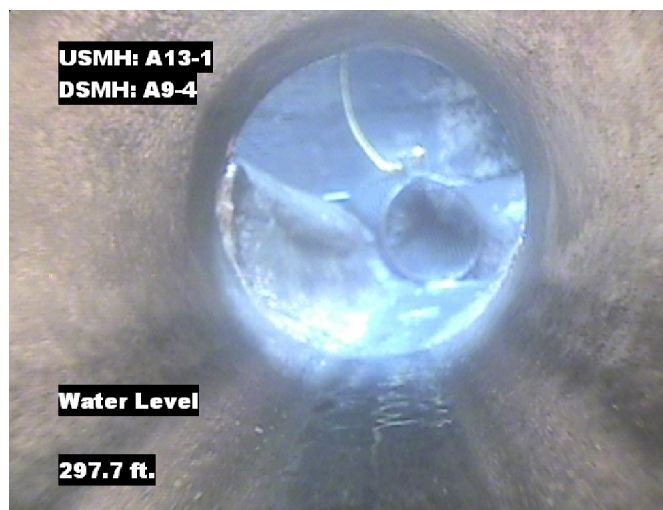
Distance: 297.4 ft. Grade: 0
Condition: Water Level
Remarks: N/A

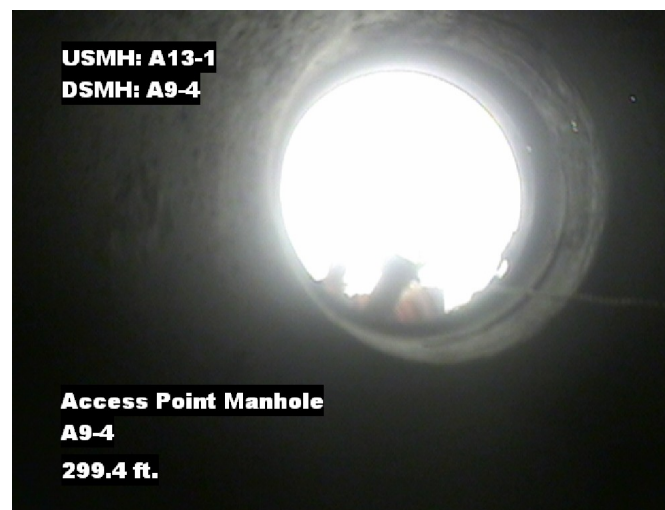
Distance: 299.4 ft. Grade: 0
Condition: Access Point Manhole
Remarks: A9-4
