## Defect Listing

Pipe Segment Refere... <b>A14-1_A9-1</b>	City <b>Oliver Springs</b>	Street <b>Central Ave</b>	Material <b>Fibreglass Reinforc...</b>	Location C... <b>Parking Lo...</b>	Sewer Use <b>Sanitary</b>
Upstream MH <b>A14-1</b>	Total Length <b>330.8</b>	Year Laid	Shape <b>Circular</b>	Location Details	
DS Manhole <b>A9-1</b>	Length surveyed <b>330.8</b>	Year Renewed	Height <b>8</b>	Width <b>8</b>	Pipe Joint... <b>N/A</b>

SPR <b>N/A</b>	MPR <b>8</b>	PO Number <b>4397-03</b>	Customer <b>GRW</b>
SPRI <b>N/A</b>	MPRI <b>2.7</b>	Work Order <b>4397-02</b>	Purpose <b>Pre-Rehabilitation Survey</b>
QSR <b>N/A</b>	QMR <b>4122</b>		
OPR <b>8</b>	Surveyed By <b>Charlie Gordon</b>	Direction <b>Downstream</b>	Date <b>20150817</b>
OPRI <b>2.7</b>	Certificate Number <b>U-615-07000491</b>	Pre-Cleaning <b>Jetting</b>	Time <b>14:53</b>
	Date Cleaned <b>20150817</b>	End Time <b>15:13</b>	Weather <b>Light Rain</b>
			Media label
			Additional Info

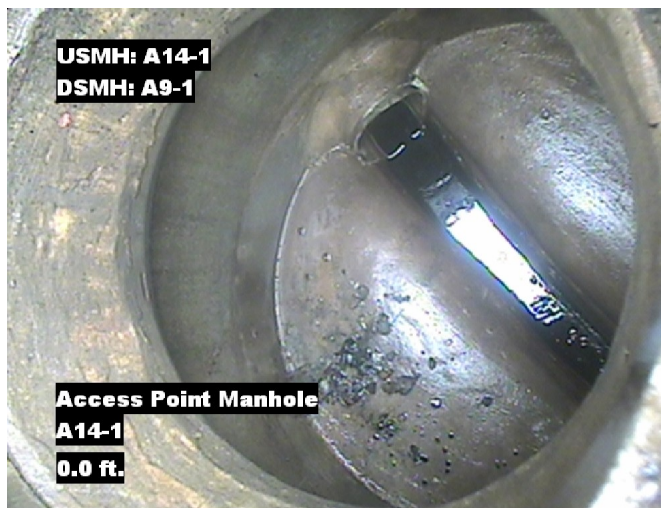
Distance: 0.0 ft. Grade: 0  
Condition: Access Point Manhole  
Remarks: A14-1

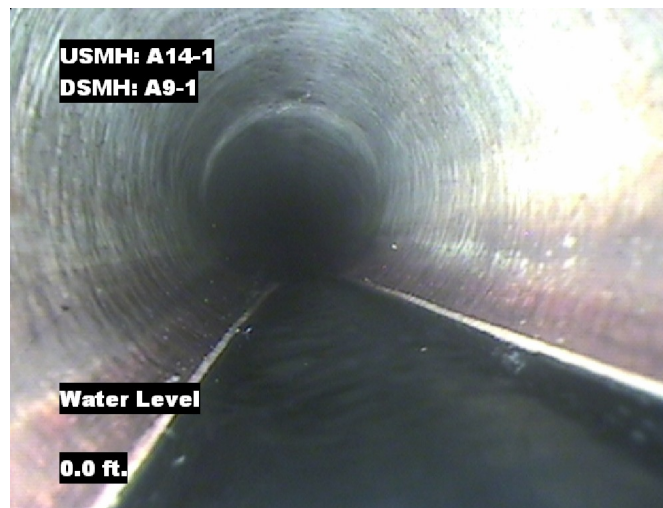
Distance: 0.0 ft. Grade: 0  
Condition: Water Level  
Remarks: N/A

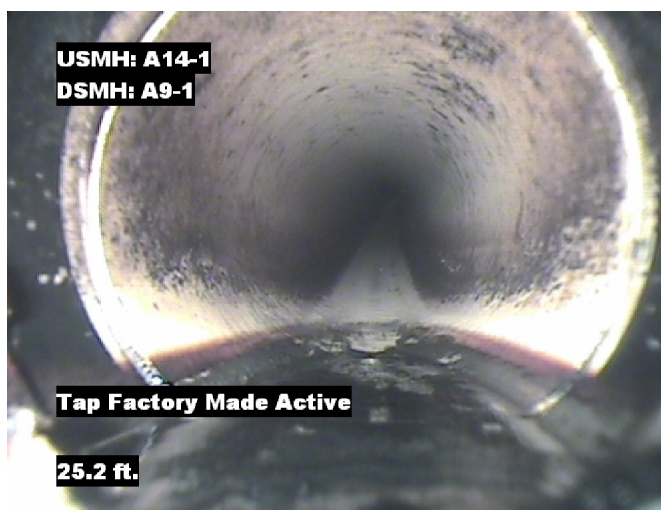
Distance: 25.2 ft. Grade: 0  
Condition: Tap Factory Made Active  
Remarks: N/A

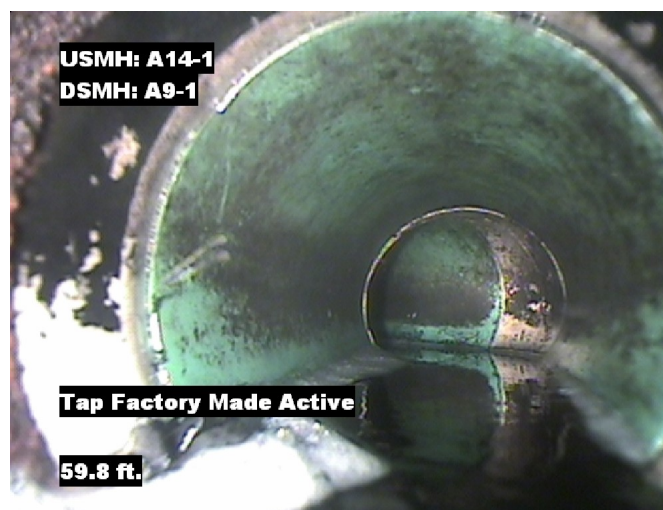
Distance: 59.8 ft. Grade: 0  
Condition: Tap Factory Made Active  
Remarks: N/A

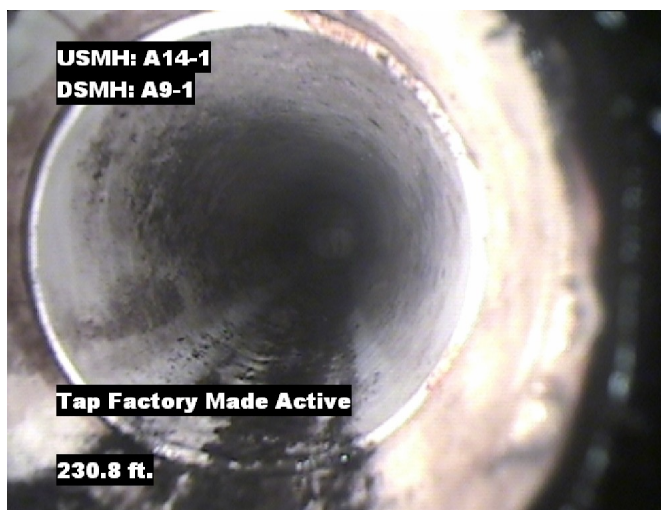
Distance: 230.8 ft. Grade: 0  
Condition: Tap Factory Made Active  
Remarks: N/A

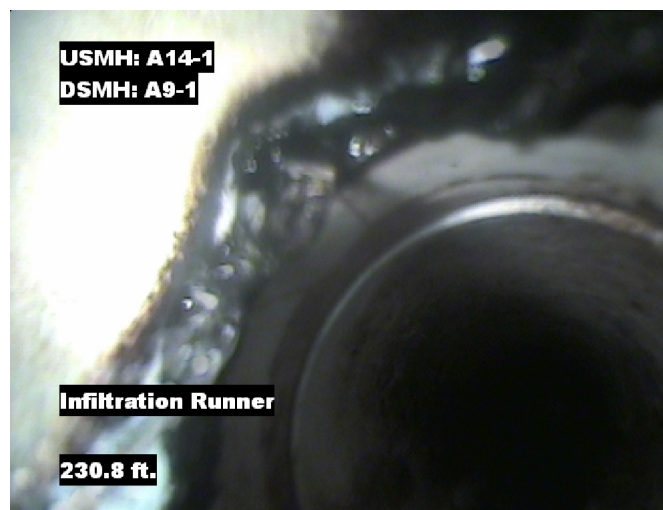
Distance: 230.8 ft. Grade: 4  
Condition: Infiltration Runner  
Remarks: N/A

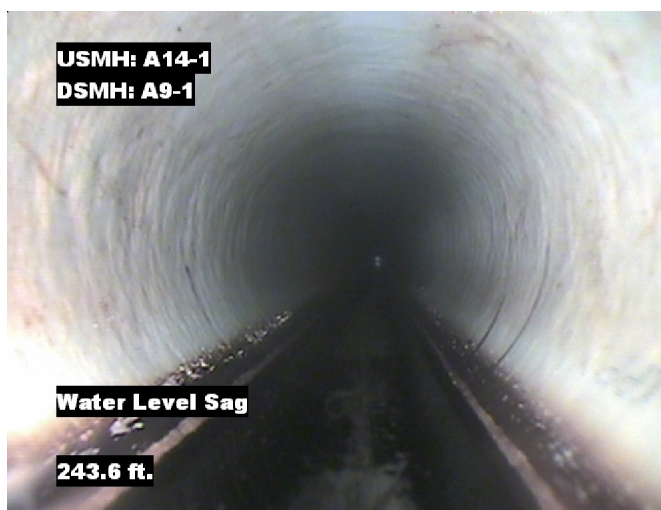
Distance: 243.6 ft. Grade: 2  
Condition: Water Level Sag  
Remarks: N/A

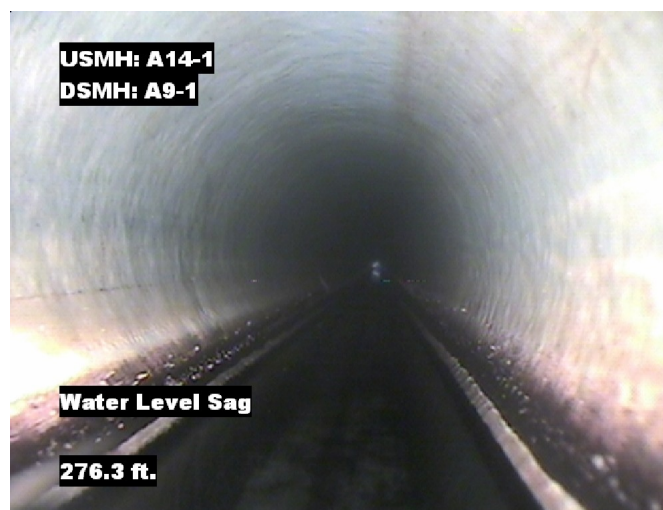
Distance: 276.3 ft. Grade: 2  
Condition: Water Level Sag  
Remarks: N/A

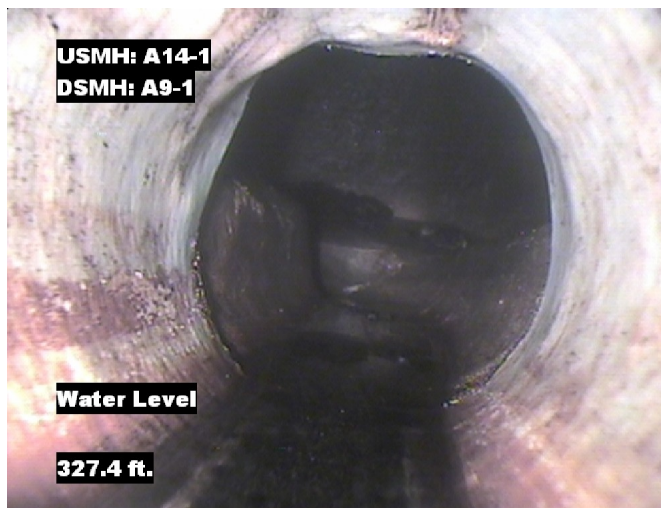
Distance: 327.3 ft.      Grade: 0  
Condition: Water Level  
Remarks: N/A

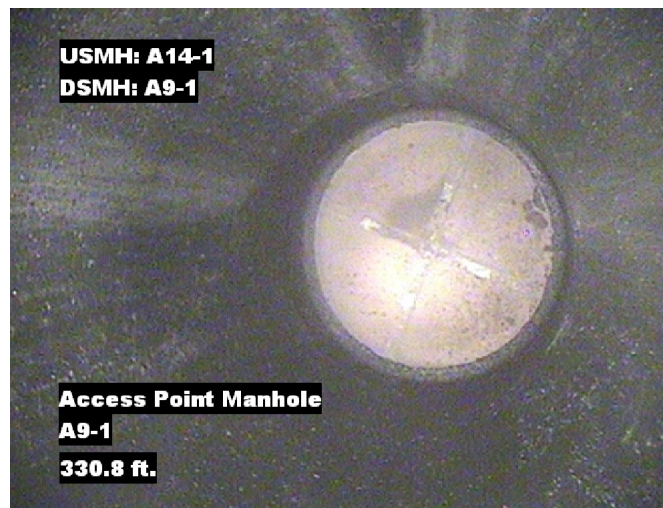
Distance: 330.8 ft.      Grade: 0  
Condition: Access Point Manhole  
Remarks: A9-1
