Defect Listing

Pipe Segment Refere... A14-2_A14-1	City Oliver Springs	Street City hall Building	Material Concrete Pipe (non-...	Location C... Yard	Sewer Use Sanitary
Upstream MH A14-2	Total Length 267.2	Year Laid	Shape Circular	Location Details	
DS Manhole A14-1	Length surveyed 267.2	Year Renewed	Height 8	Width 8	Pipe Joint... 4

SPR N/A	MPR 9	PO Number 4397-03	Customer GRW
SPRI N/A	MPRI 1.8	Work Order 4397-02	Purpose Pre-Rehabilitation Survey
QSR N/A	QMR 2411		
OPR 9	Surveyed By Charlie Gordon	Direction Upstream	Date 20150817
OPRI 1.8	Certificate Number U-615-07000491	Pre-Cleaning Jetting	Time 14:19
	Date Cleaned 20150817	End Time 14:41	Weather Light Rain
			Media label
			Additional Info

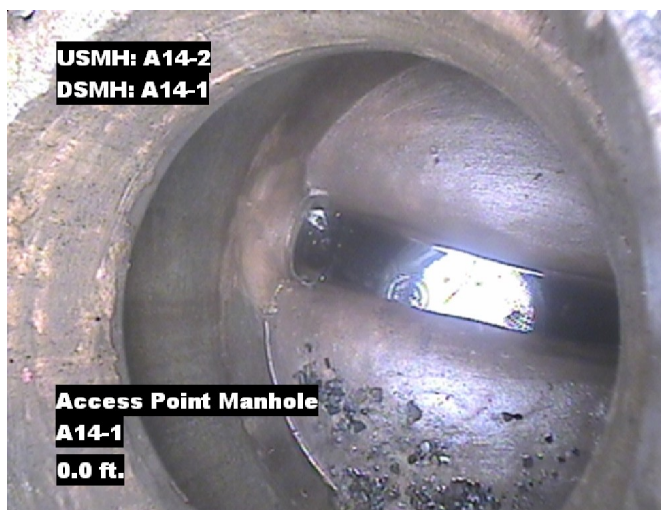
Distance: 0.0 ft. Grade: 0
Condition: Access Point Manhole
Remarks: A14-1

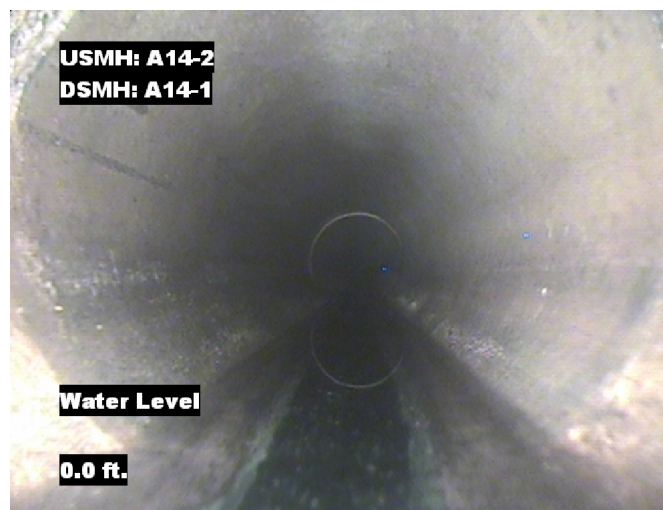
Distance: 0.0 ft. Grade: 0
Condition: Water Level
Remarks: N/A

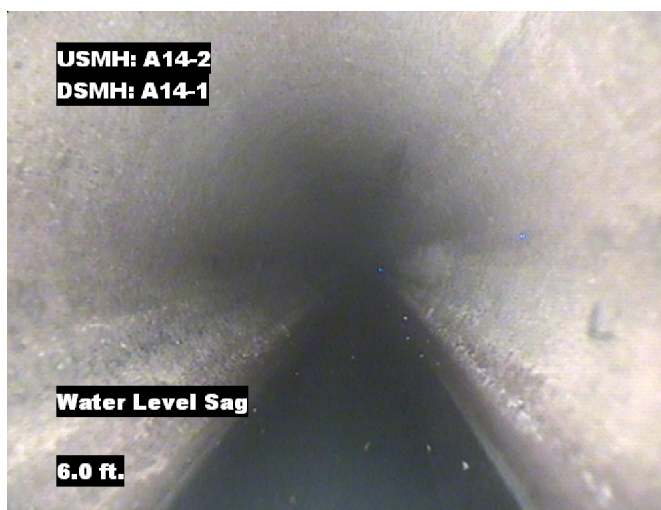
Distance: 6.0 ft. Grade: 2
Condition: Water Level Sag
Remarks: N/A

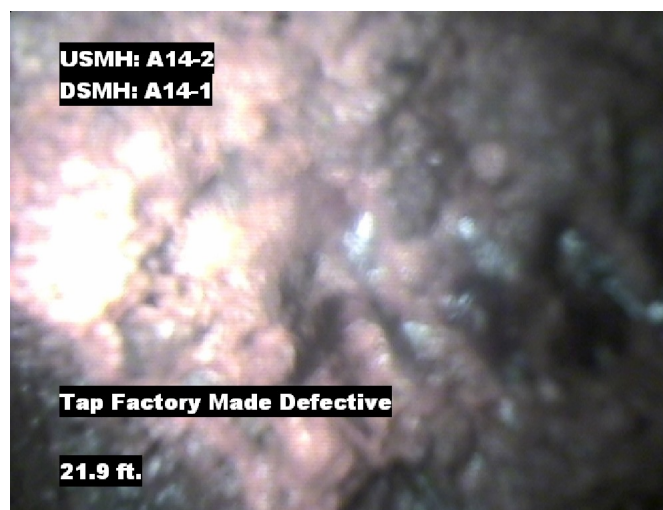
Distance: 21.9 ft. Grade: 2
Condition: Tap Factory Made Defective
Remarks: N/A

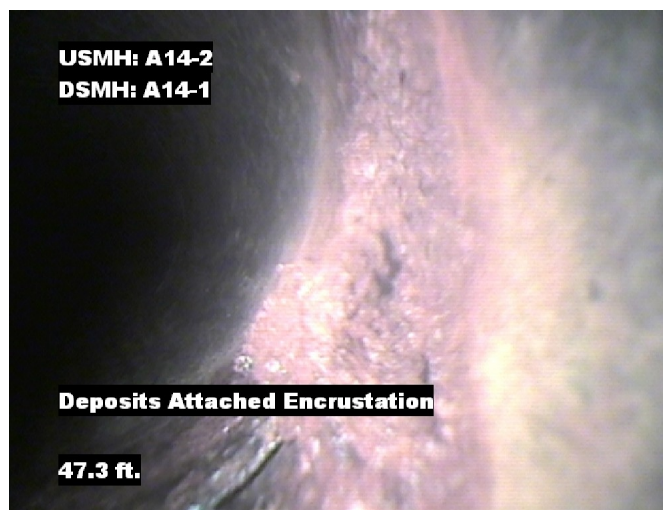
Distance: 47.3 ft. Grade: 2
Condition: Deposits Attached Encrustation
Remarks: N/A

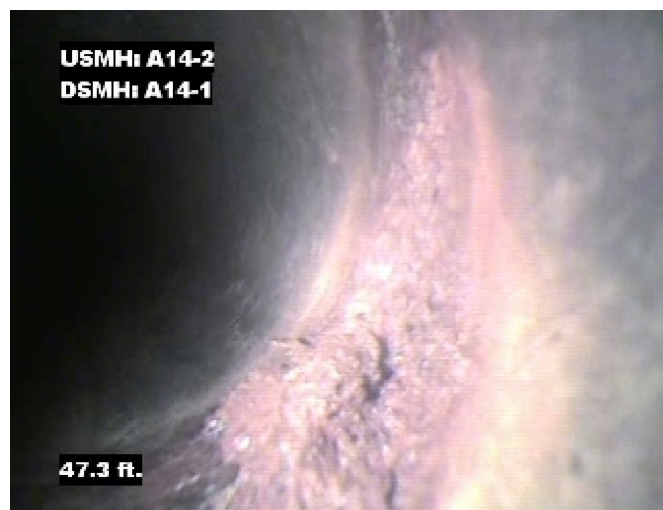
Distance: 47.3 ft. Grade: 0
Condition: Infiltration Stain
Remarks: N/A

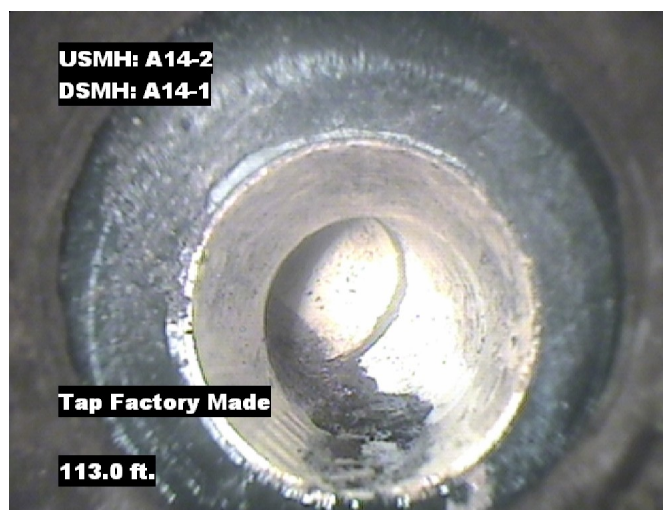
Distance: 113.0 ft. Grade: 0
Condition: Tap Factory Made
Remarks: N/A

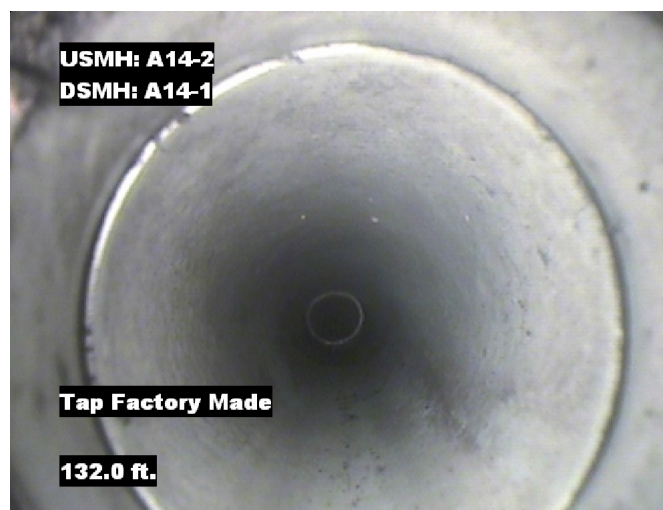
Distance: 132.0 ft. Grade: 0
Condition: Tap Factory Made
Remarks: N/A

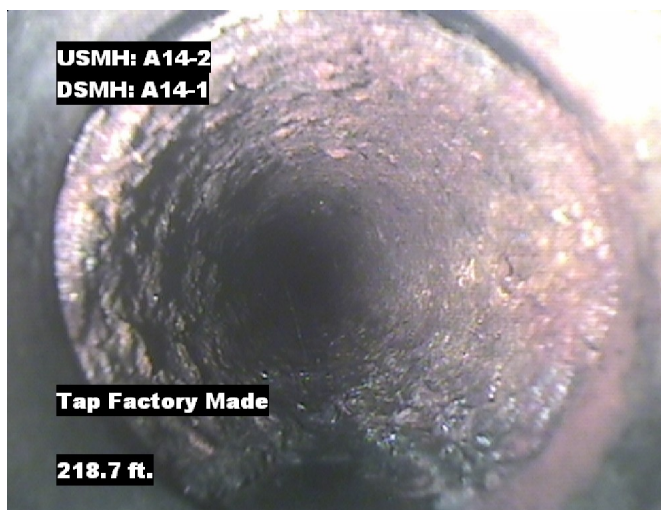
Distance: 218.7 ft. Grade: 0
Condition: Tap Factory Made
Remarks: N/A

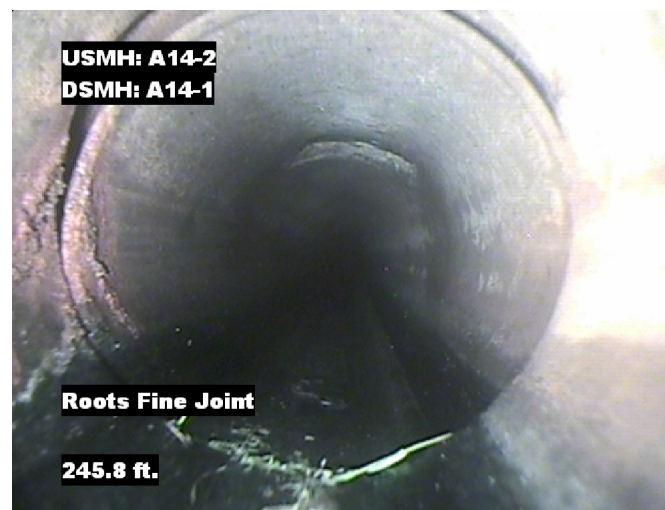
Distance: 245.8 ft. Grade: 1
Condition: Roots Fine Joint
Remarks: N/A

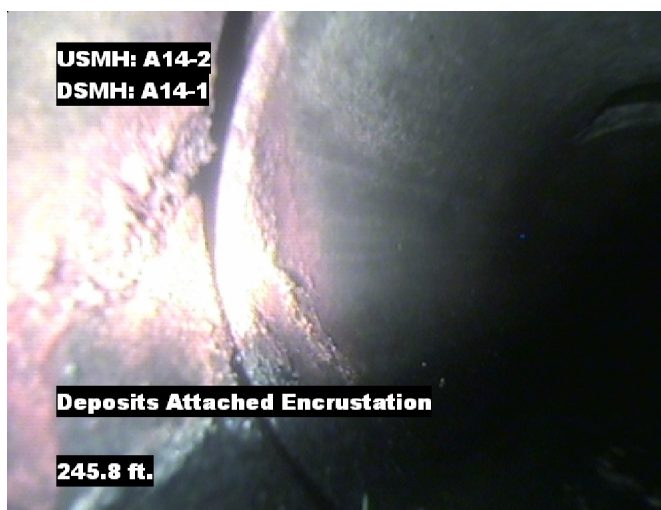
Distance: 245.8 ft. Grade: 2
Condition: Deposits Attached Encrustation
Remarks: N/A

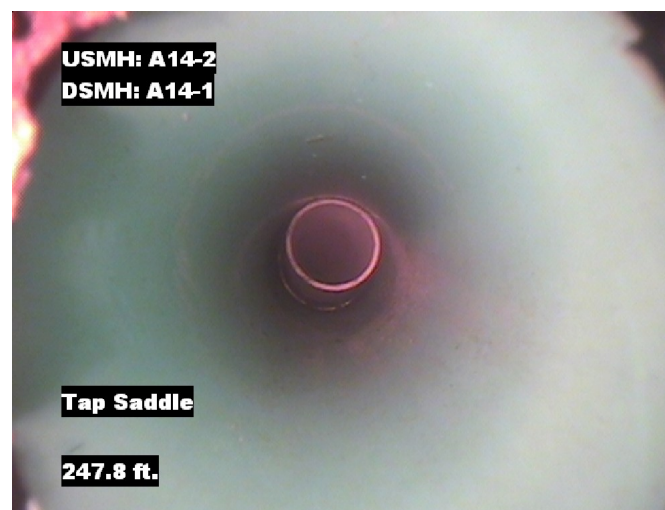
Distance: 247.8 ft. Grade: 0
Condition: Tap Saddle
Remarks: N/A

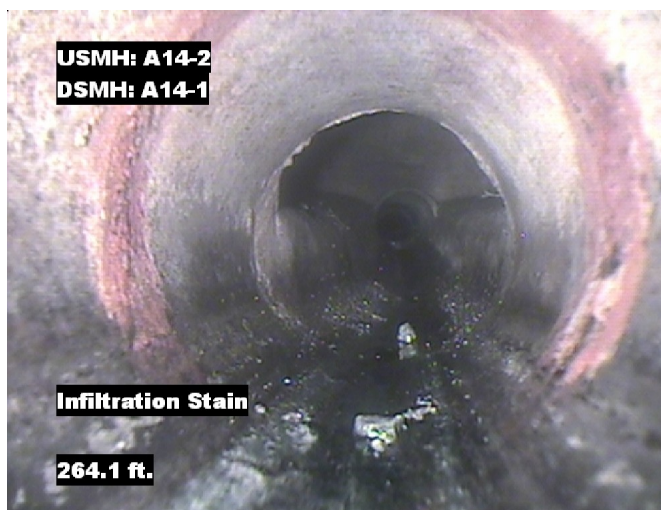
Distance: 264.1 ft. Grade: 0
Condition: Infiltration Stain
Remarks: N/A

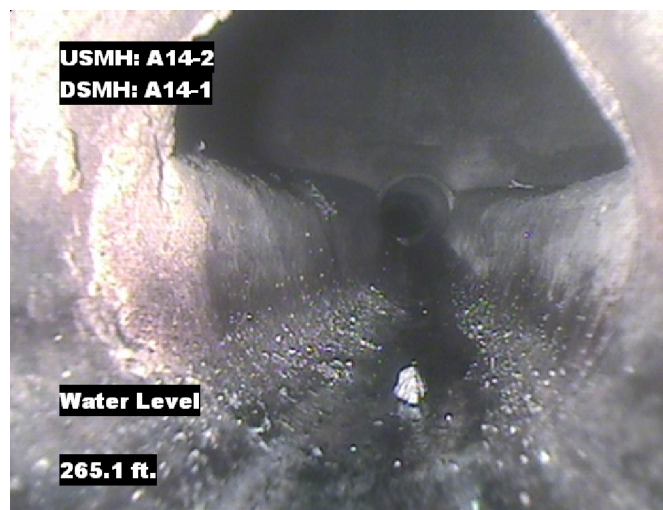
Distance: 265.1 ft. Grade: 0
Condition: Water Level
Remarks: N/A

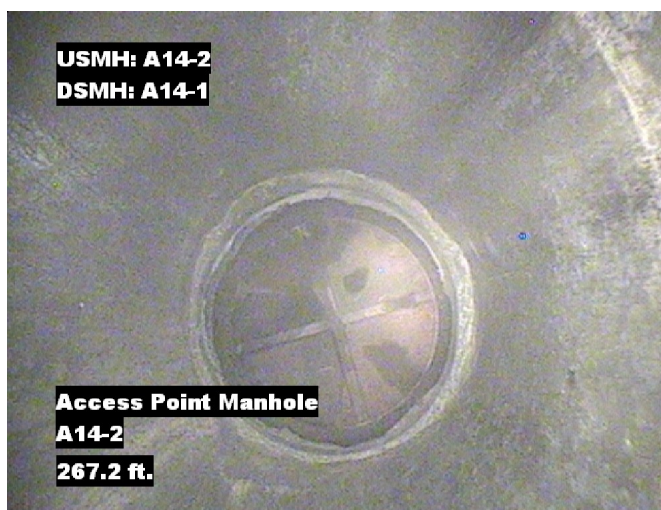
Distance: 267.2 ft. Grade: 0
Condition: Access Point Manhole
Remarks: A14-2
