Defect Listing

Pipe Segment Refere... A15-1_A8-4	City Oliver Springs	Street Easterbrook Ave	Material Concrete Pipe (non-...	Location C... Sidewalk	Sewer Use Sanitary
Upstream MH A15-1	Total Length 28	Year Laid	Shape Circular	Location Details	
DS Manhole A8-4	Length surveyed 28	Year Renewed	Height 8	Width 8	Pipe Joint... 4

Image Report 4/Page

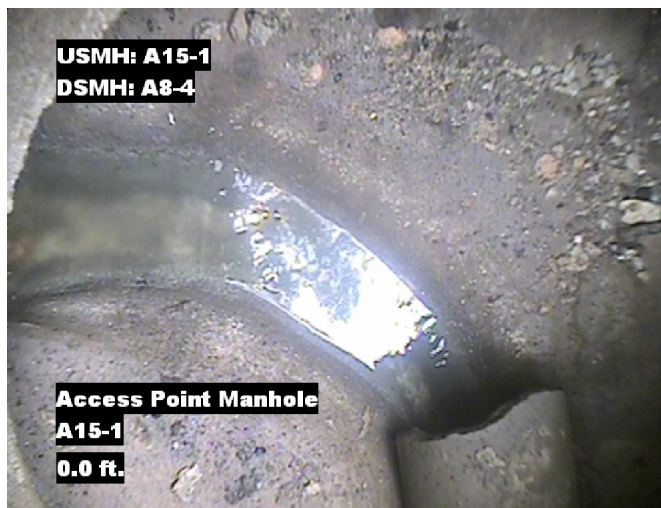
Distance: 0.0 ft. Grade: 0
Condition: Access Point Manhole
Remarks: A15-1

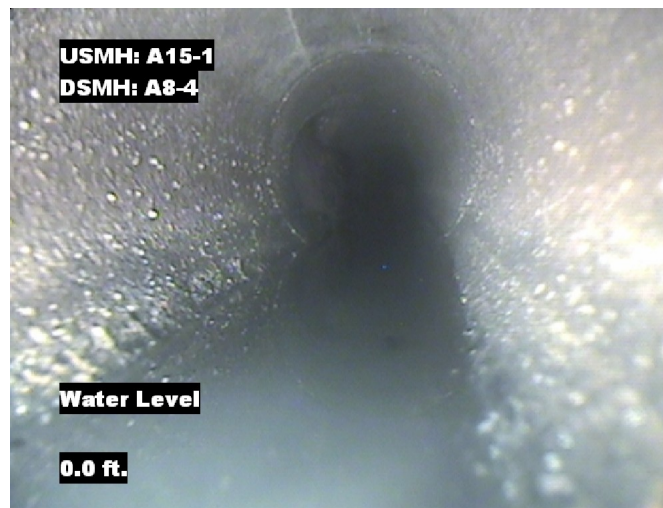
Distance: 0.0 ft. Grade: 0
Condition: Water Level
Remarks: N/A

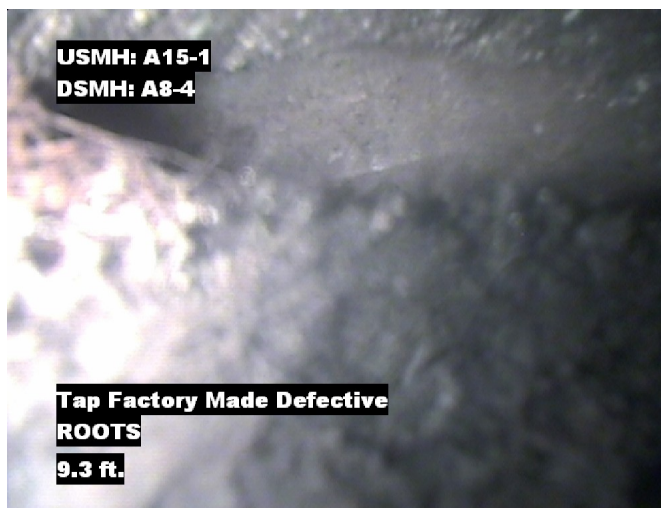
Distance: 9.3 ft. Grade: 2
Condition: Tap Factory Made Defective
Remarks: ROOTS

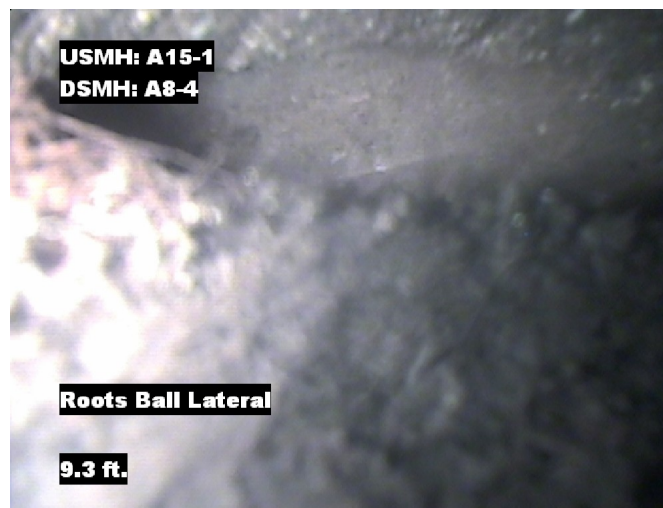
Distance: 9.3 ft. Grade: 4
Condition: Roots Ball Lateral
Remarks: N/A

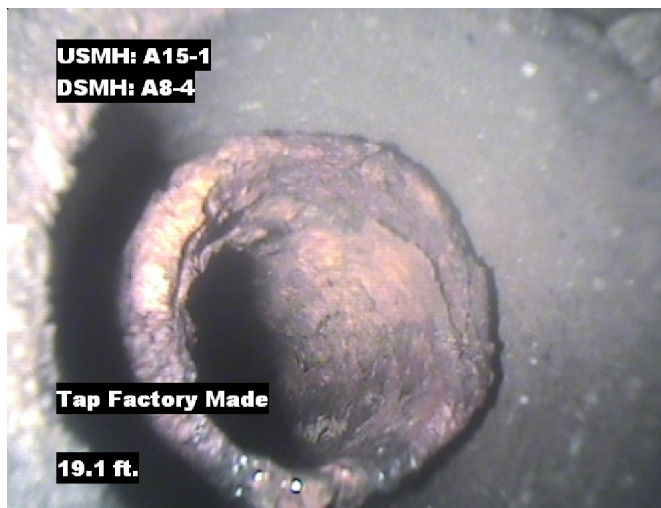
Distance: 19.1 ft. Grade: 0
Condition: Tap Factory Made
Remarks: N/A

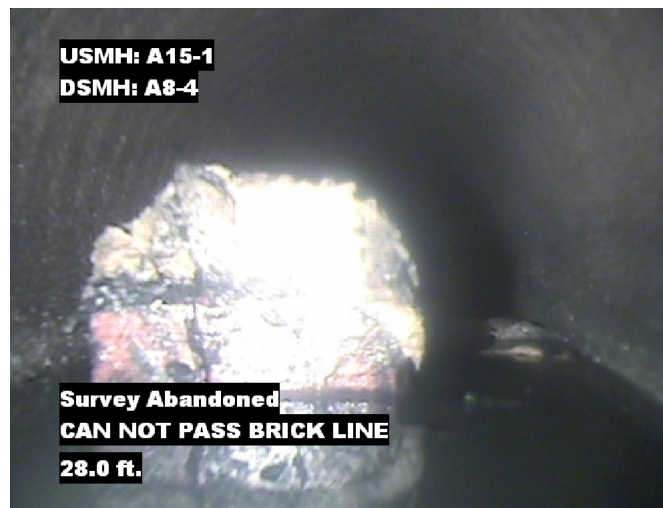
Distance: 28.0 ft. Grade: 0
Condition: Survey Abandoned
Remarks: CAN NOT PASS BRICK LINE
