## Defect Listing

Pipe Segment Refere... <b>A16-1_A8-4</b>	City <b>Oliver Springs</b>	Street <b>Main St</b>	Material <b>Fibreglass Reinforc...</b>	Location C... <b>Light High...</b>	Sewer Use <b>Sanitary</b>
Upstream MH <b>A16-1</b>	Total Length <b>184.3</b>	Year Laid	Shape <b>Circular</b>	Location Details	
DS Manhole <b>A8-4</b>	Length surveyed <b>184.3</b>	Year Renewed	Height <b>8</b>	Width <b>8</b>	Pipe Joint... <b>N/A</b>

SPR <b>N/A</b>	MPR <b>4</b>	PO Number <b>4397-03</b>	Customer <b>GRW</b>
SPRI <b>N/A</b>	MPRI <b>2</b>	Work Order <b>4397-02</b>	Purpose <b>Pre-Rehabilitation Survey</b>
QSR <b>N/A</b>	QMR <b>2200</b>		
OPR <b>4</b>	Surveyed By <b>Barry Rogers</b>	Direction <b>Upstream</b>	Date <b>20150814</b>
OPRI <b>2</b>	Certificate Number <b>U-1012-16405</b>	Pre-Cleaning <b>Jetting</b>	Time <b>08:01</b>
	Date Cleaned <b>20150814</b>	End Time <b>08:12</b>	Weather <b>Dry</b>
		Additional Info

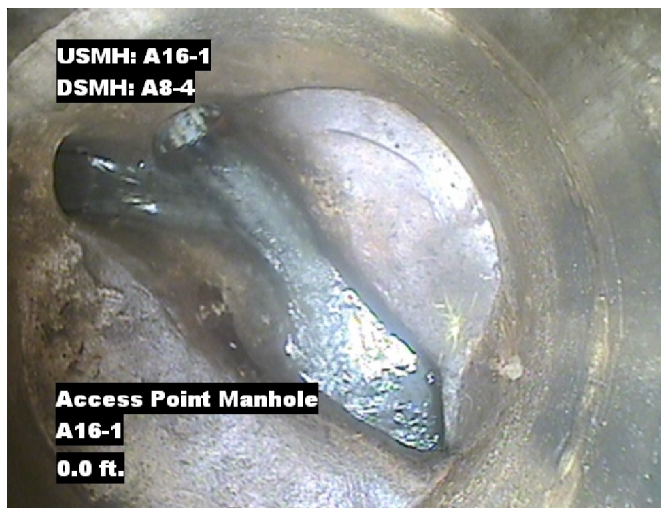
Distance: 0.0 ft. Grade: 0  
Condition: Access Point Manhole  
Remarks: A16-1

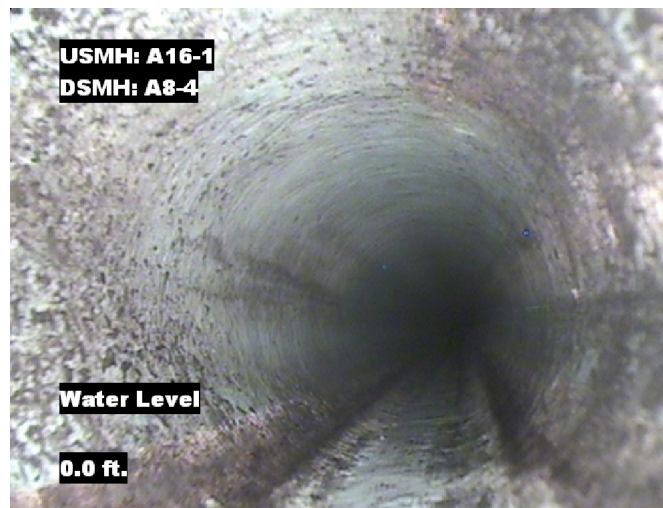
Distance: 0.0 ft. Grade: 0  
Condition: Water Level  
Remarks: N/A

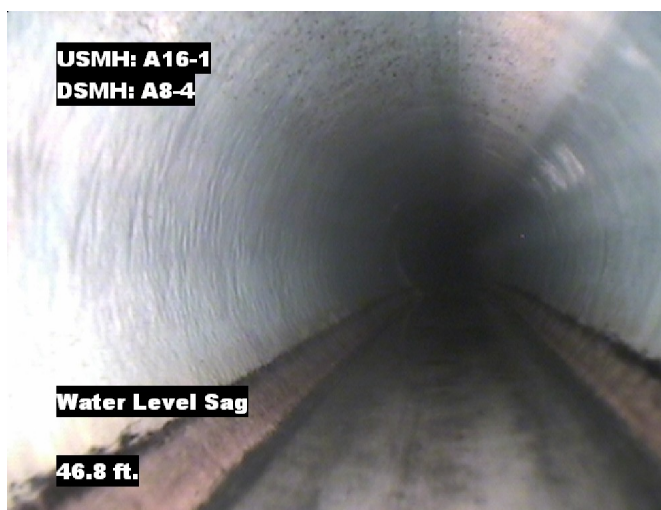
Distance: 46.8 ft. Grade: 2  
Condition: Water Level Sag  
Remarks: N/A

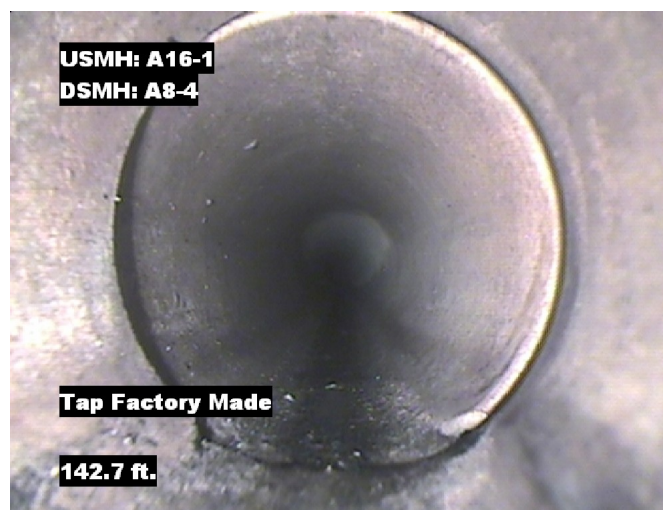
Distance: 142.7 ft. Grade: 0  
Condition: Tap Factory Made  
Remarks: N/A

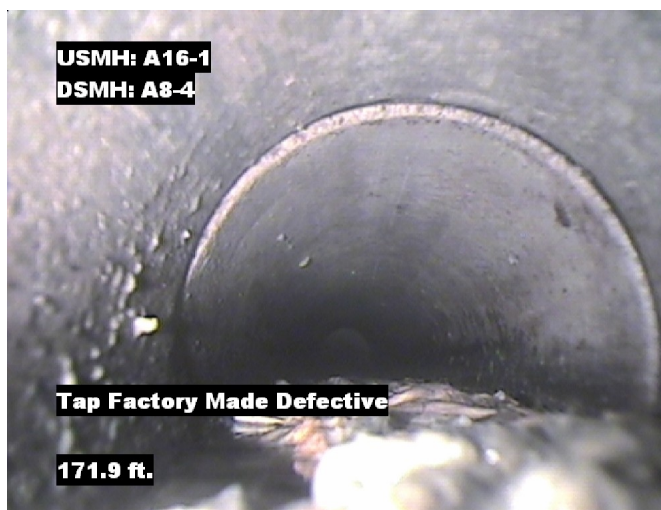
Distance: 171.9 ft. Grade: 2  
Condition: Tap Factory Made Defective  
Remarks: N/A

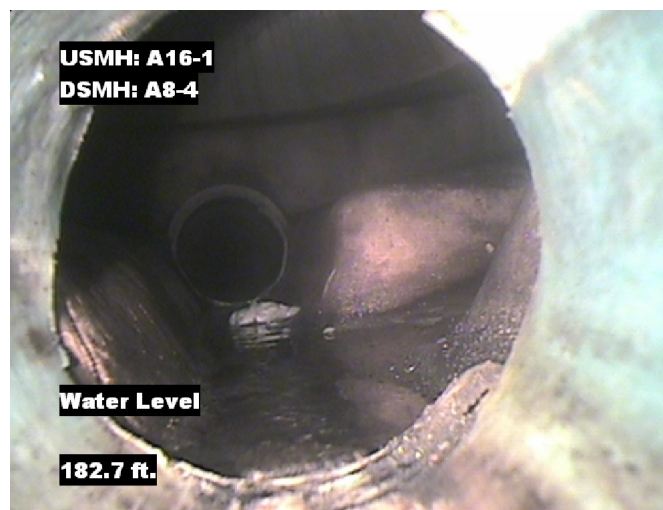
Distance: 182.7 ft. Grade: 0  
Condition: Water Level  
Remarks: N/A

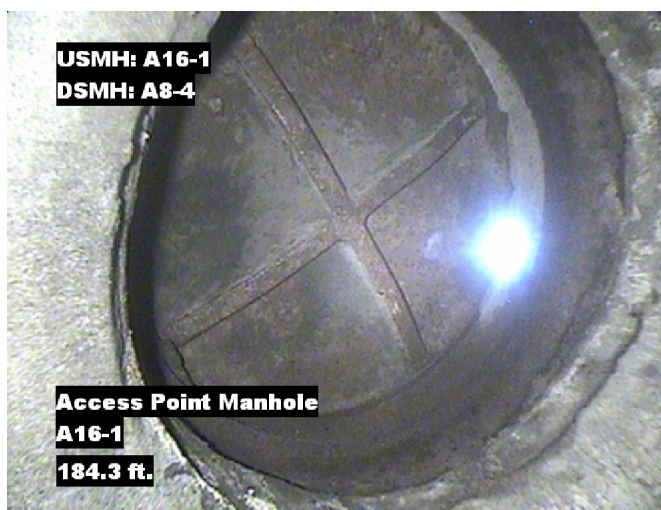
Distance: 184.3 ft. Grade: 0  
Condition: Access Point Manhole  
Remarks: A16-1
