## Defect Listing

Pipe Segment Refere... <b>A16-2_A16-1</b>	City <b>Oliver Springs</b>	Street <b>Kington St</b>	Material <b>Fibreglass Reinforc...</b>	Location C... <b>Light High...</b>	Sewer Use <b>Sanitary</b>
Upstream MH <b>A16-2</b>	Total Length <b>361.5</b>	Year Laid	Shape <b>Circular</b>	Location Details	
DS Manhole <b>A16-1</b>	Length surveyed <b>361.5</b>	Year Renewed	Height <b>8</b>	Width <b>8</b>	Pipe Joint... <b>N/A</b>

SPR <b>N/A</b>	MPR <b>N/A</b>	PO Number <b>4397-03</b>	Customer <b>GRW</b>
SPRI <b>N/A</b>	MPRI <b>N/A</b>	Work Order <b>4397-02</b>	Purpose <b>Pre-Rehabilitation Survey</b>
QSR <b>N/A</b>	QMR <b>N/A</b>		
OPR <b>N/A</b>	Surveyed By <b>Barry Rogers</b>	Direction <b>Downstream</b>	Date <b>20150813</b>
OPRI <b>N/A</b>	Certificate Number <b>U-1012-16405</b>	Pre-Cleaning <b>Jetting</b>	Time <b>15:08</b>
	Date Cleaned <b>20150813</b>	End Time <b>15:29</b>	Weather <b>Very Dry</b>
			Media label
			Additional Info

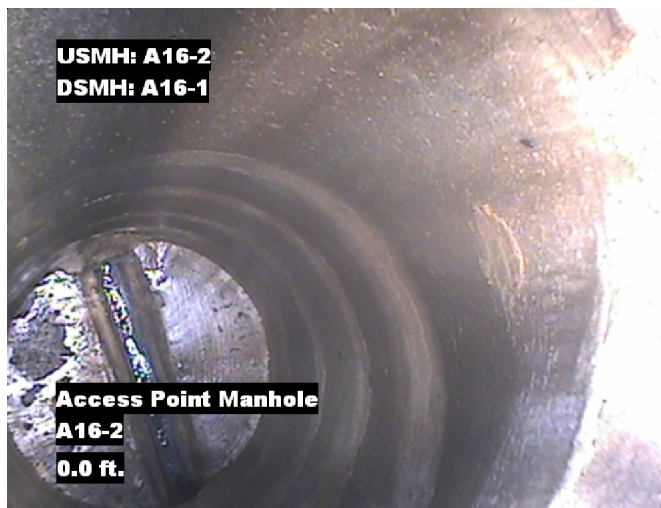
Distance: 0.0 ft. Grade: 0  
Condition: Access Point Manhole  
Remarks: A16-2

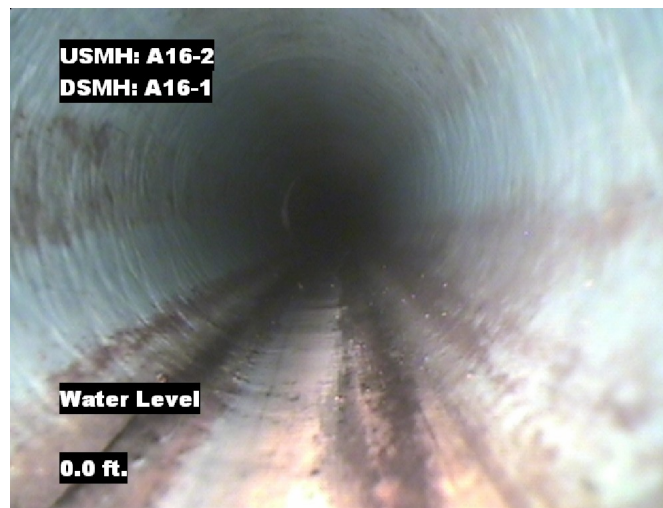
Distance: 0.0 ft. Grade: 0  
Condition: Water Level  
Remarks: N/A

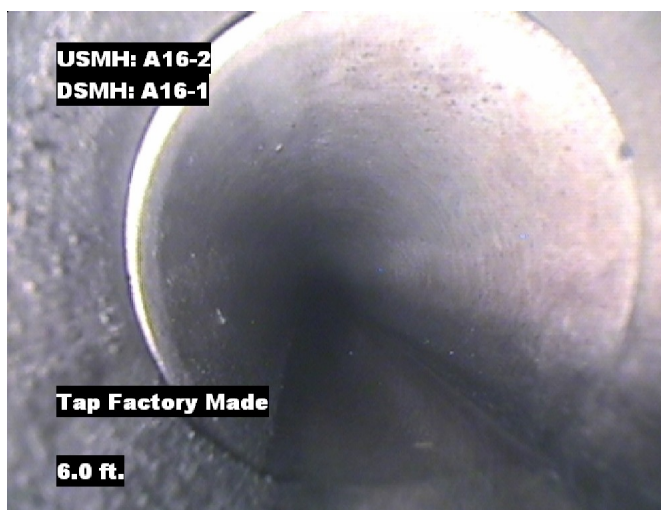
Distance: 6.0 ft. Grade: 0  
Condition: Tap Factory Made  
Remarks: N/A

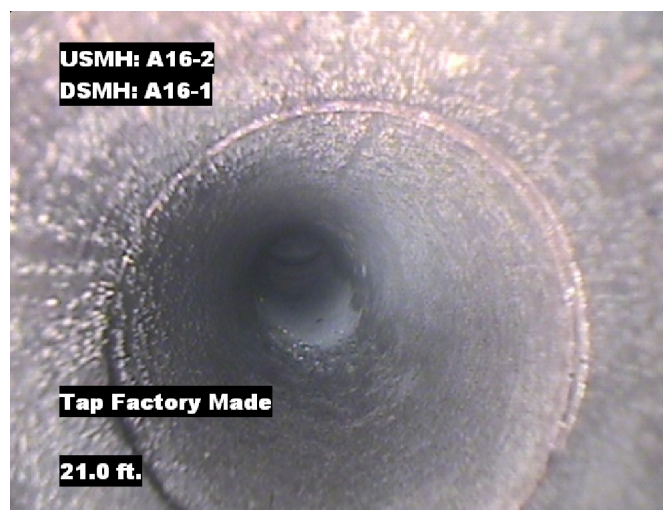
Distance: 21.0 ft. Grade: 0  
Condition: Tap Factory Made  
Remarks: N/A

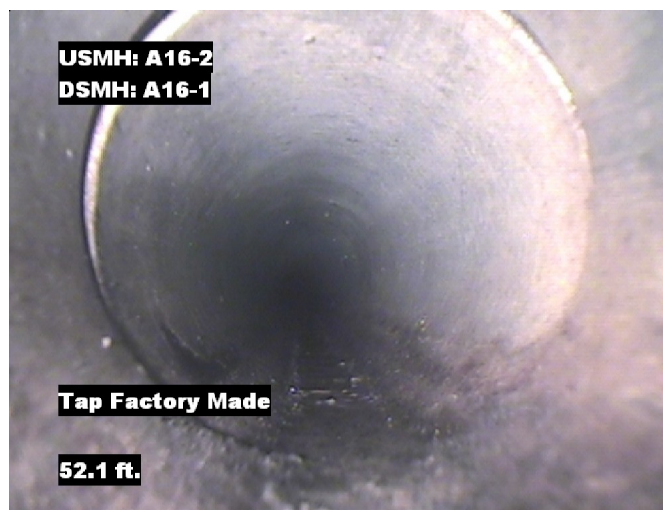
Distance: 52.1 ft. Grade: 0  
Condition: Tap Factory Made  
Remarks: N/A

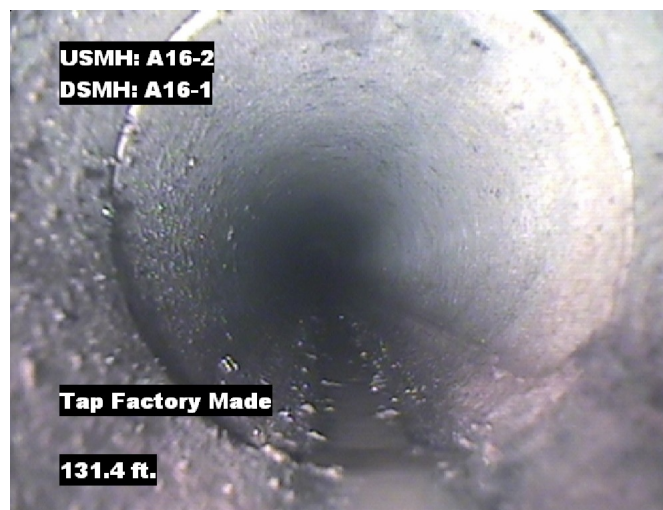
Distance: 131.4 ft. Grade: 0  
Condition: Tap Factory Made  
Remarks: N/A

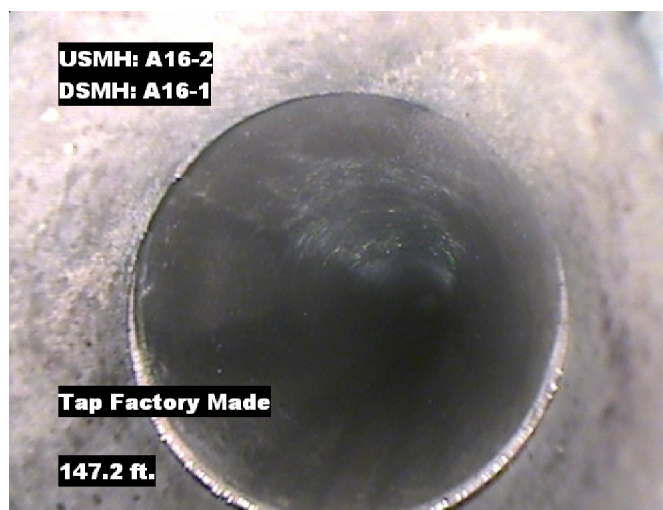
Distance: 147.2 ft. Grade: 0  
Condition: Tap Factory Made  
Remarks: N/A

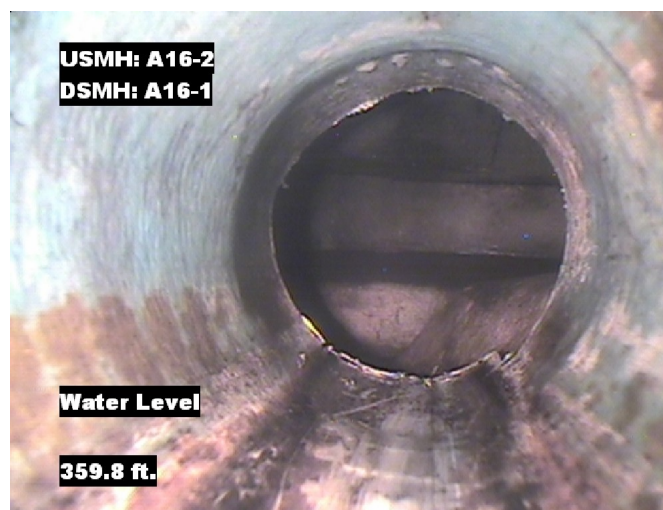
Distance: 359.8 ft. Grade: 0  
Condition: Water Level  
Remarks: N/A

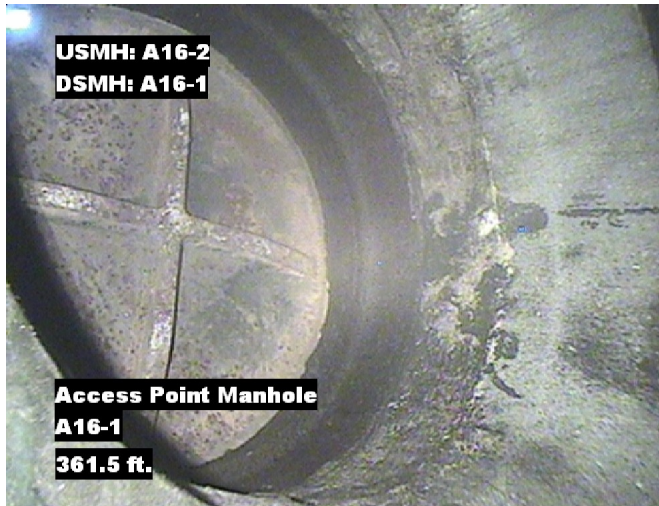
Distance: 361.5 ft.      Grade: 0  
Condition: Access Point Manhole  
Remarks: A16-1
