Defect Listing

Pipe Segment Refere		City		Street	Material		Location C	Sewer Use	
A16-3	A16-3_A16-2		Springs	kington St	Concrete Pipe (non		Light High	Sanitary	
Upstre	am MH	Total I	_ength	Year Laid	Sh	ape	Location Detai		
A1	6-3	21	3.7		Circular				
DS M	anhole	Length s	surveyed	Year Renewed	Height	leight Width Pipe Joint			
A 1	6-2	21	3.7		8 8 4		4		
SPR	N/A	MPR	4	PO Number	PO Number		Customer		
0001	-	MDDI		4397-03 Work Order			GRW		
SPRI	N/A	MPRI	2				Purpose		
QSR	N/A	QMR	2200	4397-02		Pre-	e-Rehabilitation Survey		
Ol	PR	Surve	yed By	Direction	Date		Media label		
	4	Barry_	Rogers	Downstream	20150813				
OF	PRI	Certificate Number		Pre-Cleaning	Time		Weather		
2	2		2-16405	No Pre-Cleaning	14	14:34 Very Dry End Time Additi			
		Date C	leaned	End				nal Info	
					14	:54

Image Report 4/Page

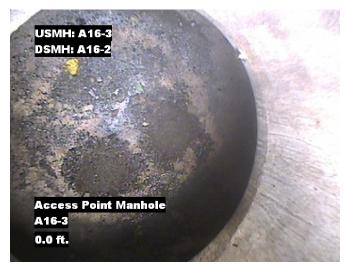
Distance: 0.0 ft. Grade: 0

Condition: Access Point Manhole

Remarks: A16-3

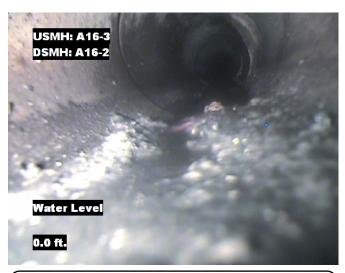
Distance: 0.0 ft. Grade: 0

Condition: Water Level

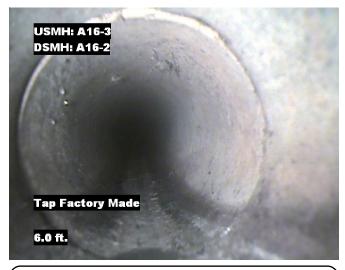
Distance: 6.0 ft. Grade: 0

Condition: Tap Factory Made

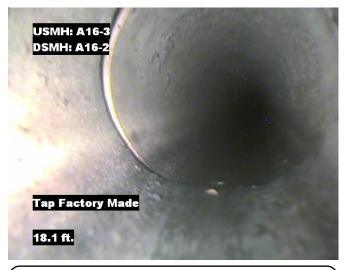
Distance: 18.1 ft. Grade: 0

Condition: Tap Factory Made

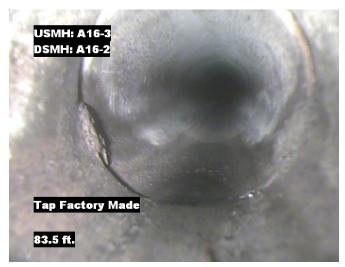
Distance: 83.5 ft. Grade: 0

Condition: Tap Factory Made

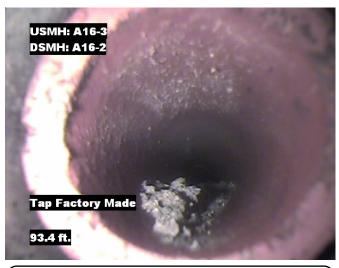
Distance: 93.4 ft. Grade: 0

Condition: Tap Factory Made

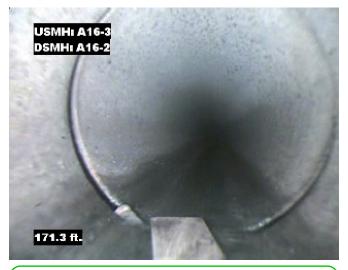
Distance: 171.0 ft. Grade: 2

Condition: Obstacle Other

Remarks: piece of wood or metal

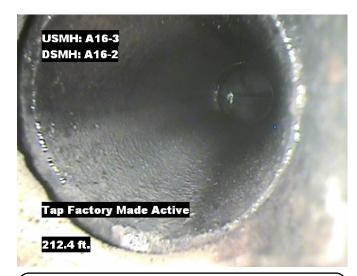
Distance: 212.4 ft. Grade: 0

Condition: Tap Factory Made Active

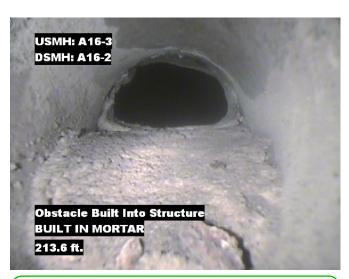
Distance: 213.6 ft. Grade: 2 Condition: Obstacle Built Into Structure

Remarks: **BUILT IN MORTAR**
