Defect Listing

Pipe Segment Refere... A17-1_A16-1	City Oliver Springs	Street Eastbrook St	Material Fibreglass Reinforc...	Location C... Light High...	Sewer Use Sanitary
Upstream MH A17-1	Total Length 190.4	Year Laid	Shape Circular	Location Details	
DS Manhole A16-1	Length surveyed 190.4	Year Renewed	Height 8	Width 8	Pipe Joint... N/A

SPR N/A	MPR N/A	PO Number 4397-03	Customer GRW
SPRI N/A	MPRI N/A	Work Order 4397-02	Purpose Pre-Rehabilitation Survey
QSR N/A	QMR N/A		
OPR N/A	Surveyed By Barry Rogers	Direction Downstream	Date 20150813
OPRI N/A	Certificate Number U-1012-16405	Pre-Cleaning Jetting	Time 13:35
	Date Cleaned 20150813	End Time 13:52	Weather Very Dry
			Media label
			Additional Info

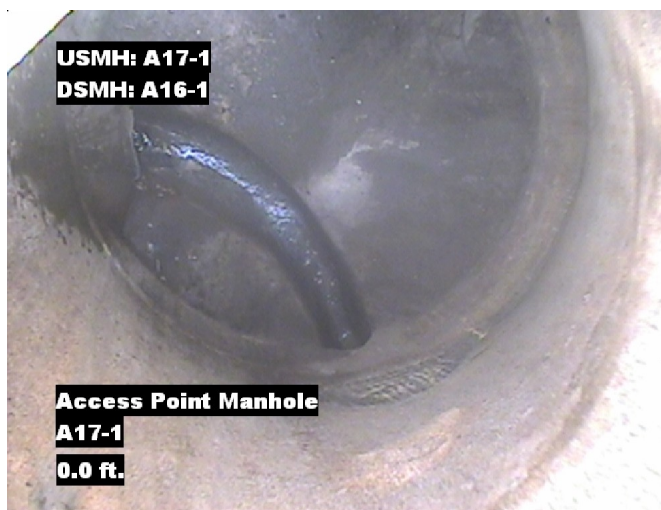
Distance: 0.0 ft. Grade: 0
Condition: Access Point Manhole
Remarks: A17-1

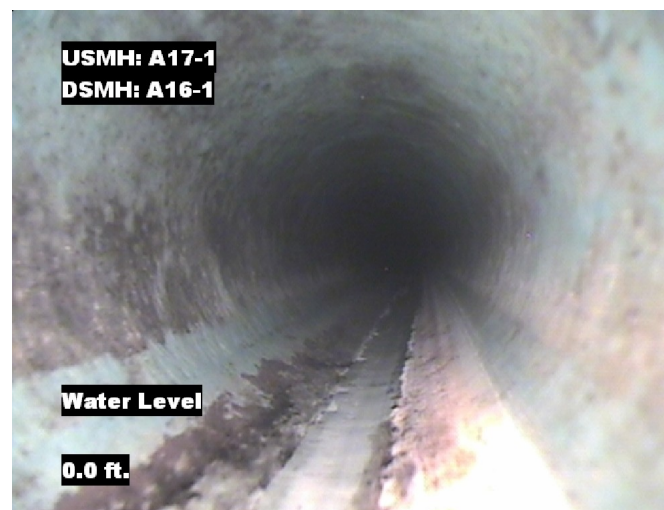
Distance: 0.0 ft. Grade: 0
Condition: Water Level
Remarks: N/A

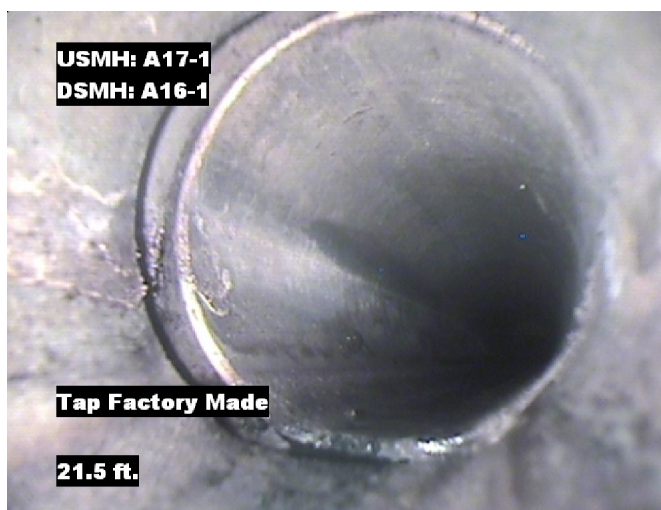
Distance: 21.5 ft. Grade: 0
Condition: Tap Factory Made
Remarks: N/A

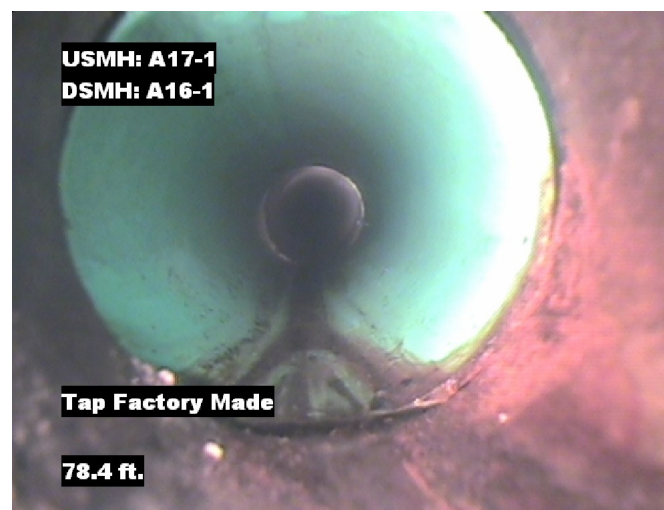
Distance: 78.4 ft. Grade: 0
Condition: Tap Factory Made
Remarks: N/A

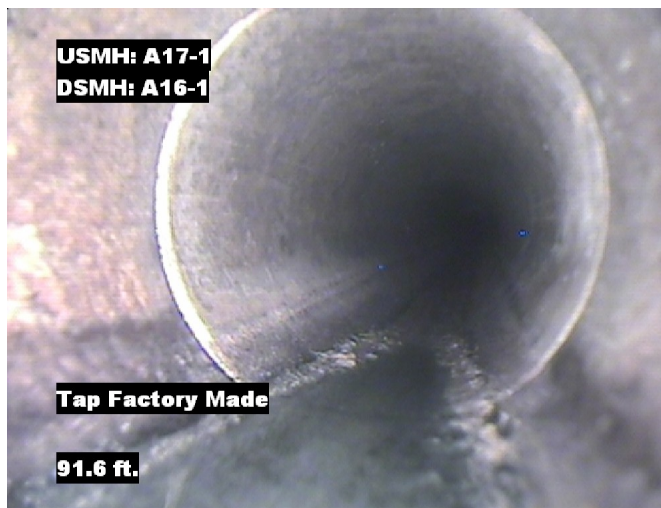
Distance: 91.6 ft. Grade: 0
Condition: Tap Factory Made
Remarks: N/A

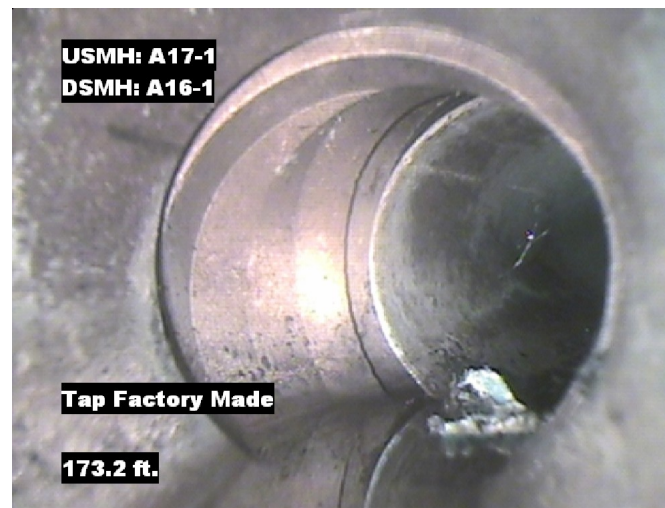
Distance: 173.2 ft. Grade: 0
Condition: Tap Factory Made
Remarks: N/A

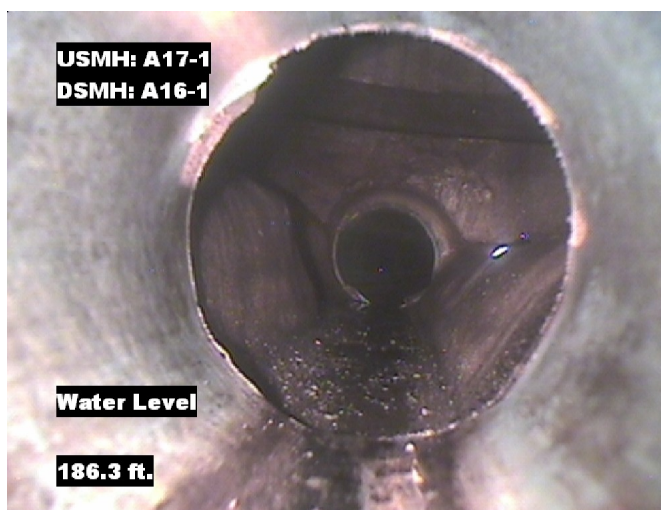
Distance: 186.3 ft. Grade: 0
Condition: Water Level
Remarks: N/A

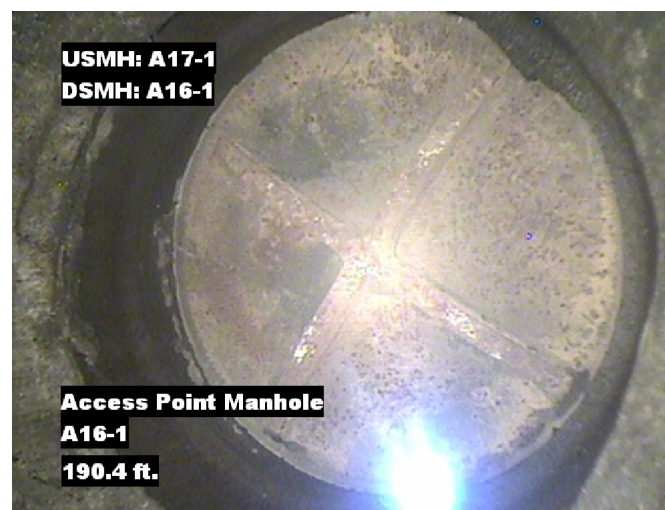
Distance: 190.4 ft. Grade: 0
Condition: Access Point Manhole
Remarks: A16-1
