Defect Listing

Pipe Segment Refere		City		Street	Mat	Material		Sewer Use
A19-1_A8-6 Upstream MH A19-1 DS Manhole A8-6		Oliver Springs Total Length 160.9 Length surveyed 160.9		Roane St	Fibreglass	Fibreglass Reinforc		Sanitary
				Year Laid	Sh	ape	Location	Details
					Circ	Circular		
				Year Renewed	Height	Width	Pipe Joint	
					8	8	N/A	
SPR	3	MPR	10	PO Number		PO Number Custom		
				4397-03				
SPRI	3	MPRI	2	Work Order				
QSR	3100	QMR	2500	4397-02		Pre-Rehabilitation Survey		
OI	PR	Surve	yed By	Direction	D	Date		alabel
1	3	Barry_Rogers		Downstream	2015	20150813		
OF	PRI	Certificate Number		Pre-Cleaning	Ti	Time		
2.2		U-1012-16405		Jetting	10	10:20		
		Cleaned		End Time		Additio	Additional Info	
		2015	0813		10	:31

Image Report 4/Page

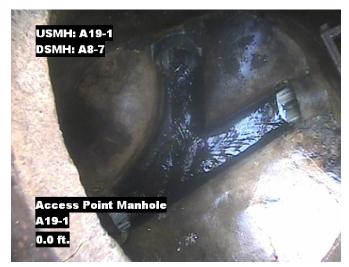
Distance: 0.0 ft. Grade: 0

Condition: Access Point Manhole

Remarks: A19-1

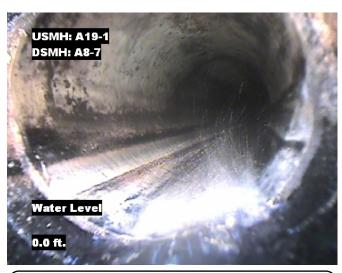
Distance: 0.0 ft. Grade: 0

Condition: Water Level

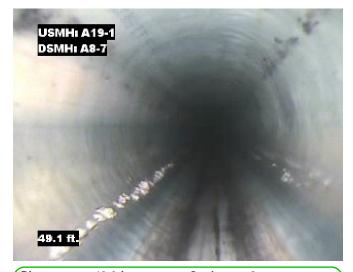
Distance:49.0 ft.Grade:Condition:Deposits Attached Grease

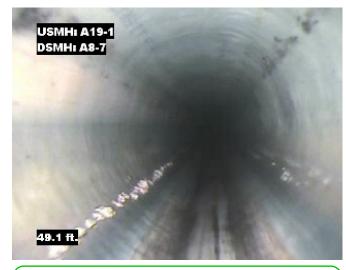
Distance: 49.0 ft. Grade: 2

Condition: Deposits Attached Grease

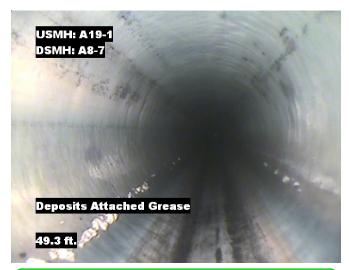
Distance: 49.3 ft. **Grade**: 2 **Condition**: Deposits Attached Grease

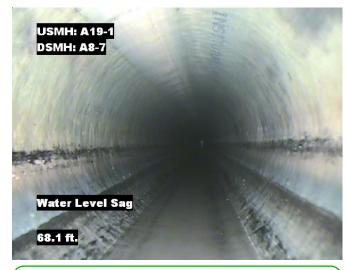
Distance: 68.1 ft. Grade: 2

Condition: Water Level Sag

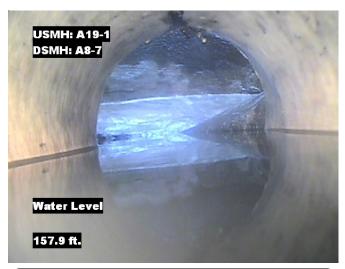
157.8 ft. Distance: Grade: 0

Condition: Water Level
