Defect Listing

Pipe Segment Refere... A19-2_A19-1	City Oliver Springs	Street roane st	Material Fibreglass Reinforc...	Location C... Light High...	Sewer Use Sanitary
Upstream MH A19-2	Total Length 192.5	Year Laid	Shape Circular	Location Details	
DS Manhole A19-1	Length surveyed 192.5	Year Renewed	Height 8	Width 8	Pipe Joint... N/A

SPR N/A	MPR 13	PO Number 4397-03	Customer GRW
SPRI N/A	MPRI 2.6	Work Order 4397-02	Purpose Pre-Rehabilitation Survey
QSR N/A	QMR 4131		
OPR 13	Surveyed By Barry Rogers	Direction Downstream	Date 20150812
OPRI 2.6	Certificate Number U-1012-16405	Pre-Cleaning Jetting	Time 09:26
	Date Cleaned 20150812	End Time 09:56	Weather Dry
			Media label
			Additional Info

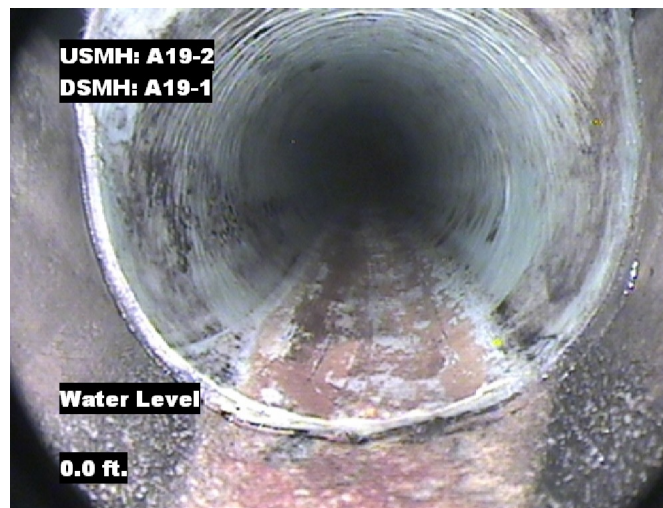
Distance: 0.0 ft. Grade: 0
Condition: Water Level
Remarks: N/A

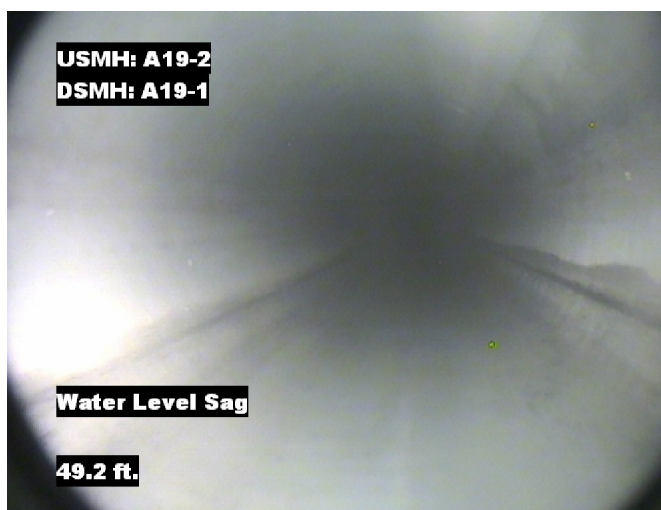
Distance: 49.1 ft. Grade: 2
Condition: Water Level Sag
Remarks: N/A

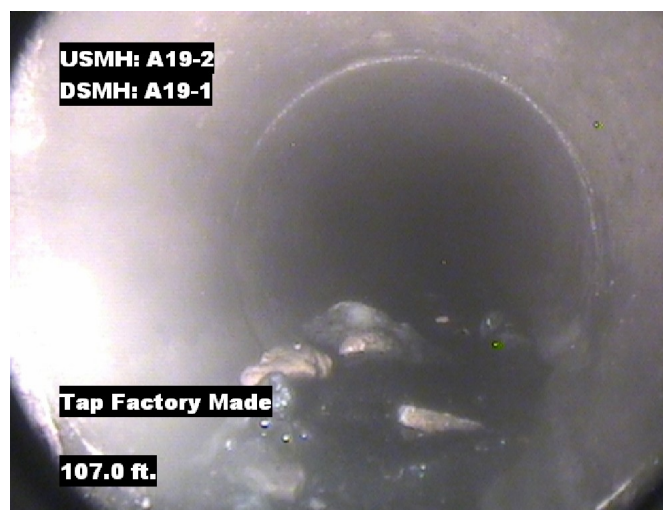
Distance: 107.0 ft. Grade: 0
Condition: Tap Factory Made
Remarks: N/A

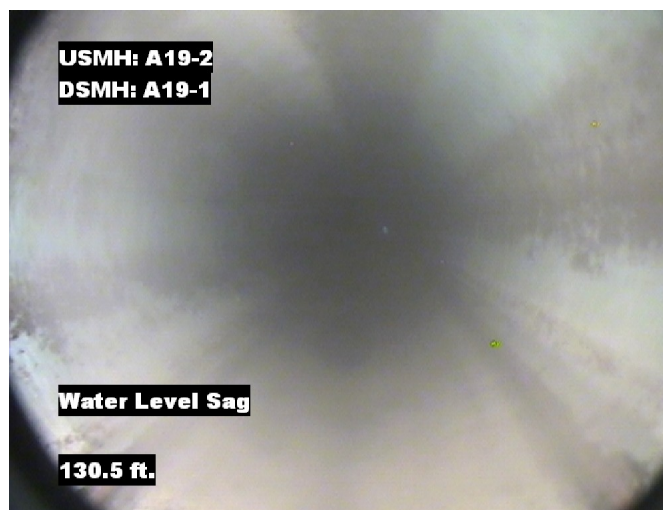
Distance: 130.4 ft. Grade: 2
Condition: Water Level Sag
Remarks: N/A

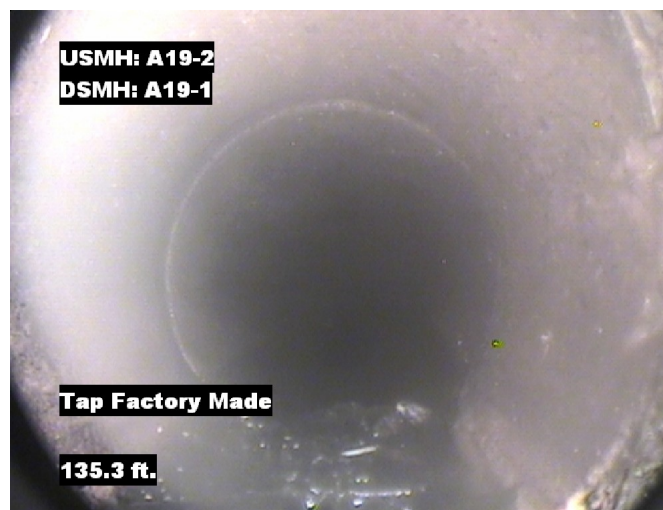
Distance: 135.3 ft. Grade: 0
Condition: Tap Factory Made
Remarks: N/A

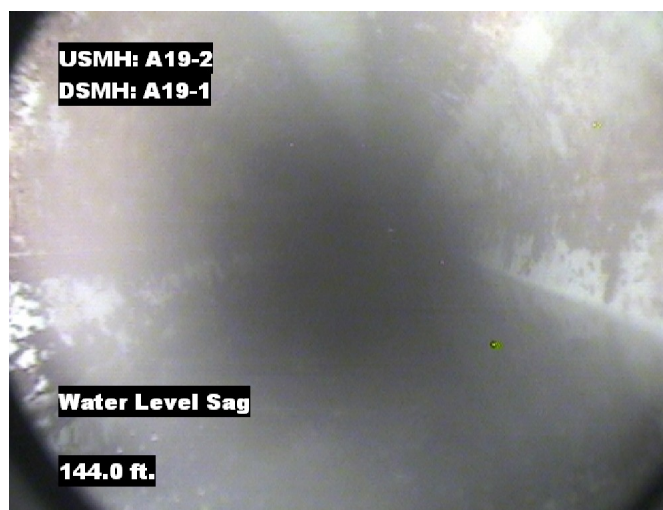
Distance: 143.9 ft. Grade: 2
Condition: Water Level Sag
Remarks: N/A

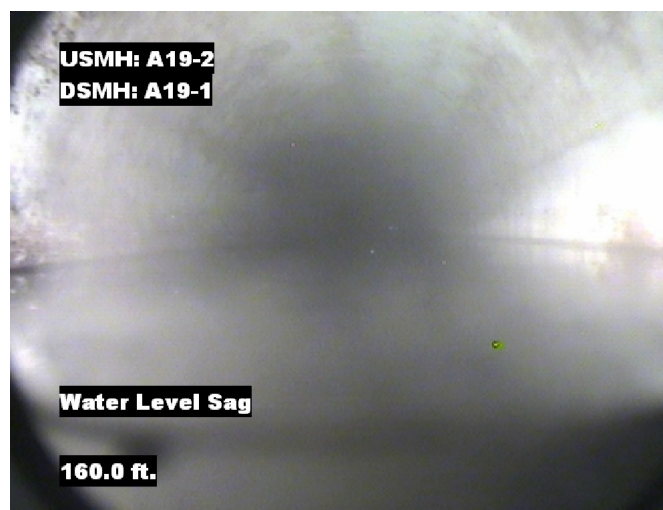
Distance: 160.0 ft. Grade: 3
Condition: Water Level Sag
Remarks: N/A

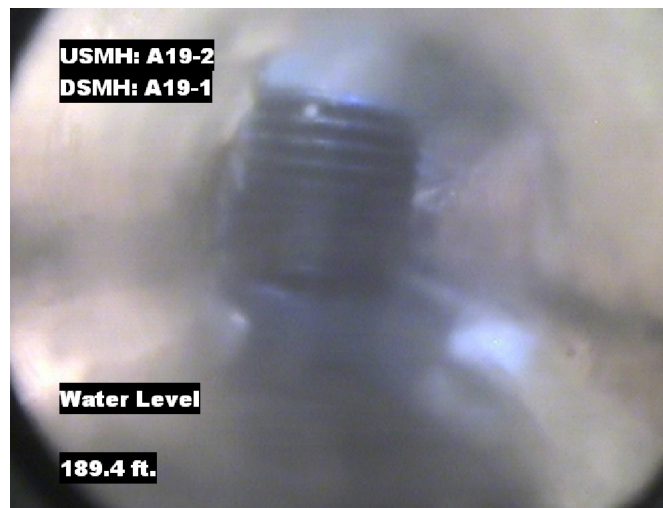
Distance: 189.4 ft. Grade: 0
Condition: Water Level
Remarks: N/A
