Defect Listing

Pipe Segment Refere... A19-2A_A19-2	City Oliver Springs	Street Roane st	Material Fibreglass Reinforc...	Location C... Light High...	Sewer Use Sanitary
Upstream MH A19-2A	Total Length 194	Year Laid	Shape Circular	Location Details	
DS Manhole A19-2	Length surveyed 194	Year Renewed	Height 8	Width 8	Pipe Joint... N/A

SPR N/A	MPR N/A	PO Number 4397-03	Customer GRW
SPRI N/A	MPRI N/A	Work Order 4397-02	Purpose Pre-Rehabilitation Survey
QSR N/A	QMR N/A		
OPR N/A	Surveyed By Barry Rogers	Direction Downstream	Date 20150812
OPRI N/A	Certificate Number U-1012-16405	Pre-Cleaning Jetting	Time 08:53
	Date Cleaned 20150812	End Time 09:07	Weather Dry
			Additional Info

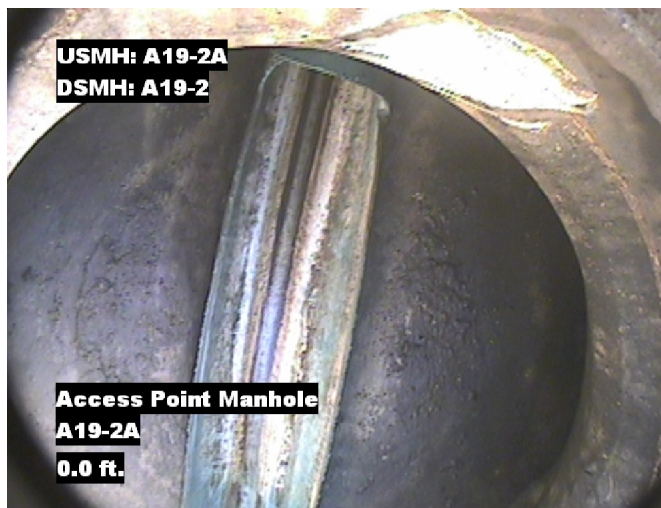
Distance: 0.0 ft. Grade: 0
Condition: Access Point Manhole
Remarks: A19-2A

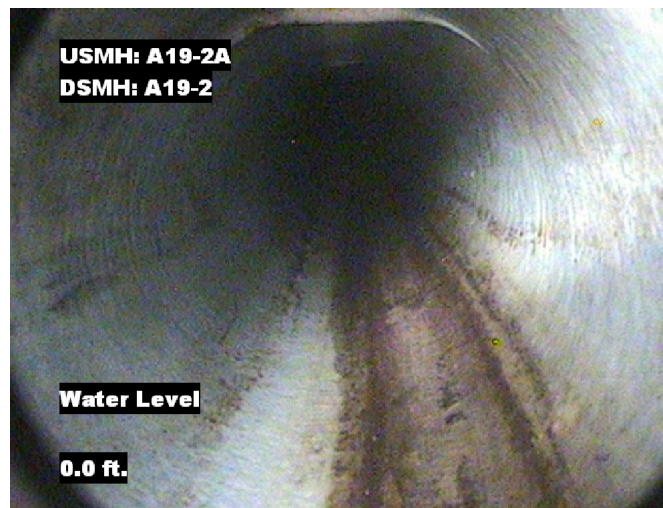
Distance: 0.0 ft. Grade: 0
Condition: Water Level
Remarks: N/A

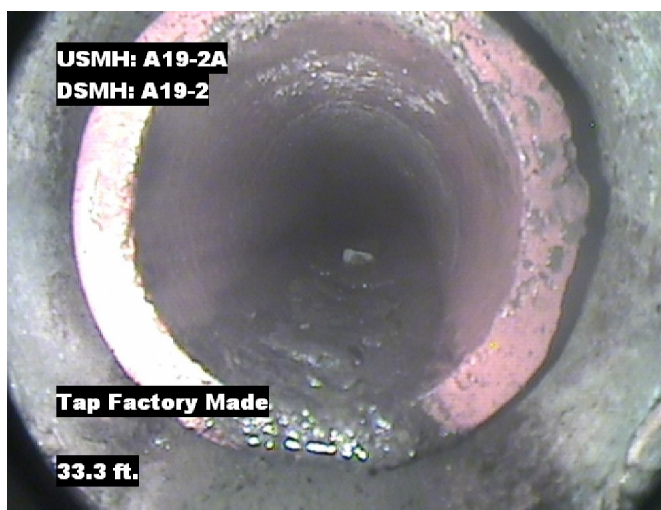
Distance: 33.3 ft. Grade: 0
Condition: Tap Factory Made
Remarks: N/A

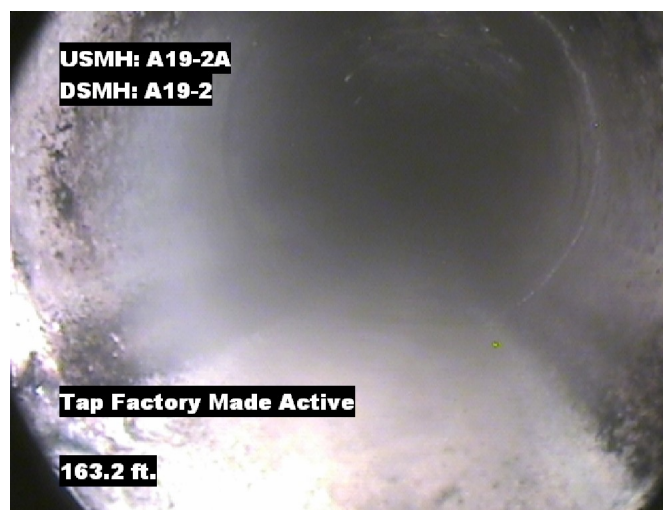
Distance: 163.2 ft. Grade: 0
Condition: Tap Factory Made Active
Remarks: N/A

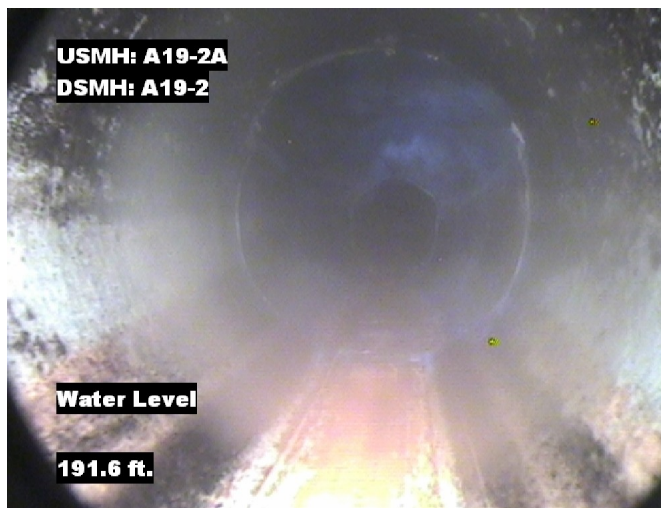
Distance: 191.5 ft. Grade: 0
Condition: Water Level
Remarks: N/A

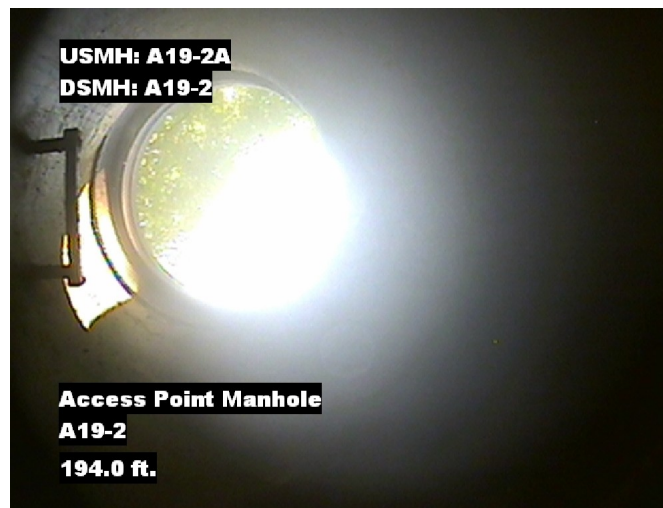
Distance: 194.0 ft. Grade: 0
Condition: Access Point Manhole
Remarks: A19-2
