Defect Listing

Pipe Segment Refere... A19-3_A19-2A	City Oliver Springs	Street Roane St	Material Fibreglass Reinforc...	Location C... Light High...	Sewer Use Sanitary
Upstream MH A19-3	Total Length 145.5	Year Laid	Shape Circular	Location Details	
DS Manhole A19-2A	Length surveyed 145.5	Year Renewed	Height 8	Width 8	Pipe Joint... N/A

SPR N/A	MPR N/A	PO Number 4397-03		Customer GRW	
SPRI N/A	MPRI N/A	Work Order 4397-02		Purpose Pre-Rehabilitation Survey	
QSR N/A	QMR N/A				
OPR N/A	Surveyed By Barry Rogers	Direction Downstream	Date 20150812	Media label	
OPRI N/A	Certificate Number U-1012-16405	Pre-Cleaning Jetting	Time 08:10	Weather Dry	
Date Cleaned 20150812			End Time 08:20	Additional Info

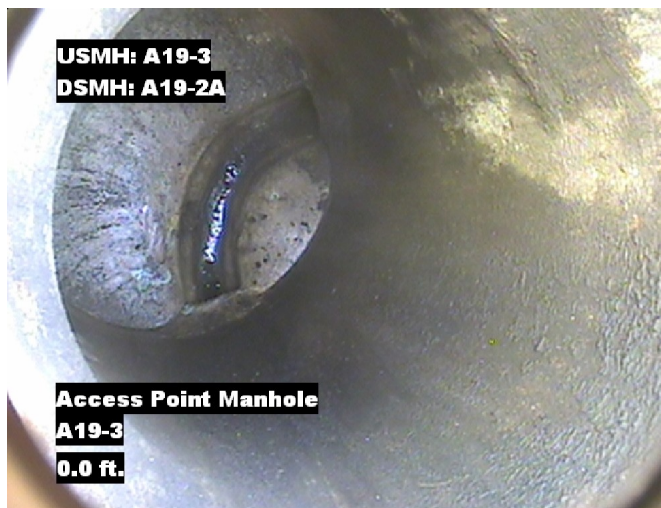
Distance: 0.0 ft. Grade: 0
Condition: Access Point Manhole
Remarks: A19-3

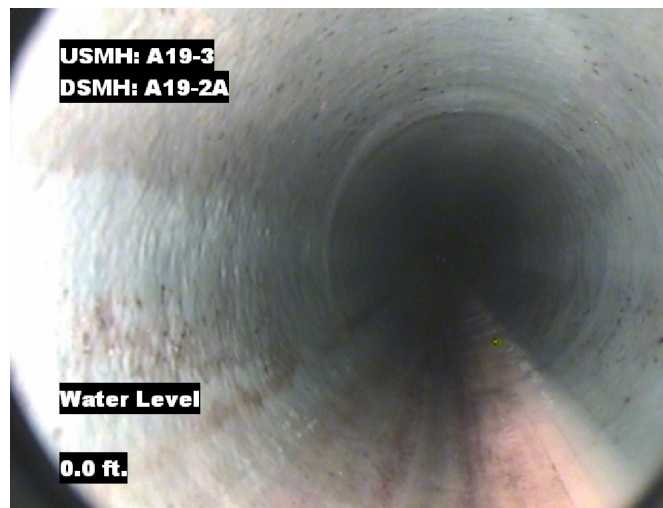
Distance: 0.0 ft. Grade: 0
Condition: Water Level
Remarks: N/A

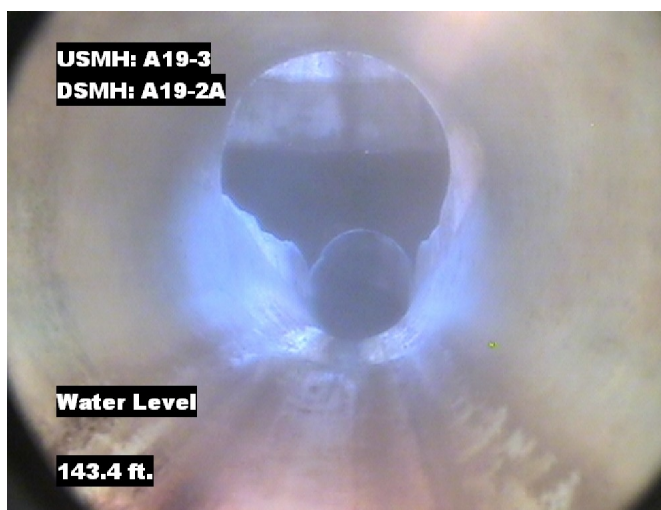
Distance: 143.4 ft. Grade: 0
Condition: Water Level
Remarks: N/A

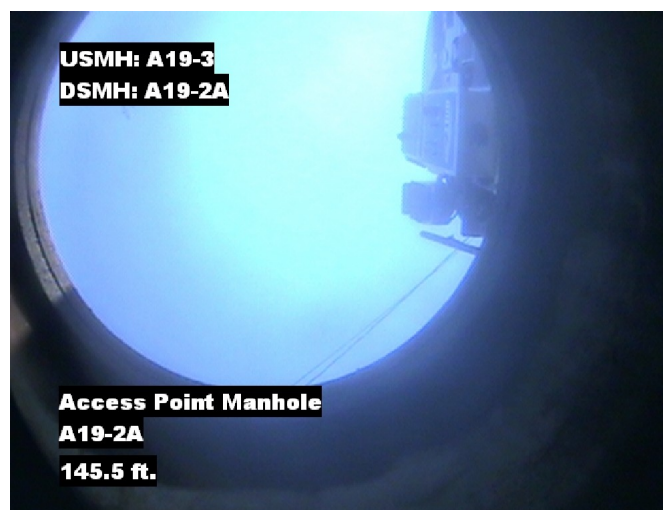
Distance: 145.5 ft. Grade: 0
Condition: Access Point Manhole
Remarks: A19-2A
