Defect Listing

Pipe Segment Refere... A19-4_A19-3	City Oliver Springs	Street Pine St	Material Concrete Pipe (non-...	Location C... Light High...	Sewer Use Sanitary
Upstream MH A19-4	Total Length 175.5	Year Laid	Shape Circular	Location Details	
DS Manhole A19-3	Length surveyed 175.5	Year Renewed	Height 8	Width 8	Pipe Joint... 4

SPR 1	MPR N/A	PO Number 4397-03	Customer GRW
SPRI 1	MPRI N/A	Work Order 4397-02	Purpose Pre-Rehabilitation Survey
QSR 1100	QMR N/A		
OPR 1	Surveyed By Barry Rogers	Direction Upstream	Date 20150812
OPRI 1	Certificate Number U-1012-16405	Pre-Cleaning Jetting	Time 07:34
	Date Cleaned 20150812	End Time 07:56	Weather Dry
			Media label
			Additional Info

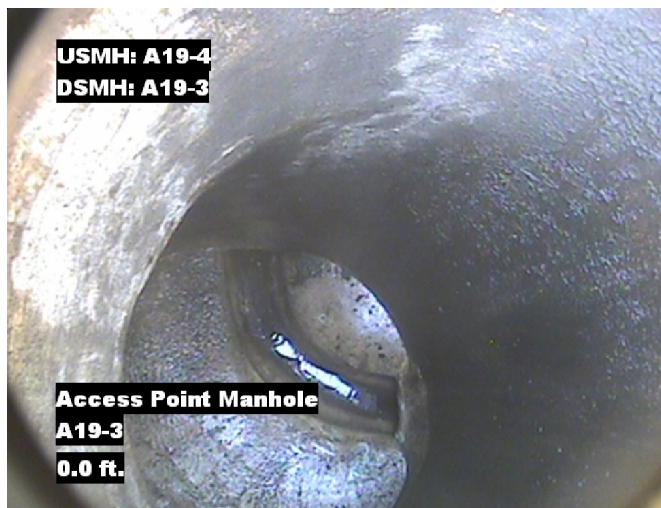
Distance: 0.0 ft. Grade: 0
Condition: Access Point Manhole
Remarks: A19-3

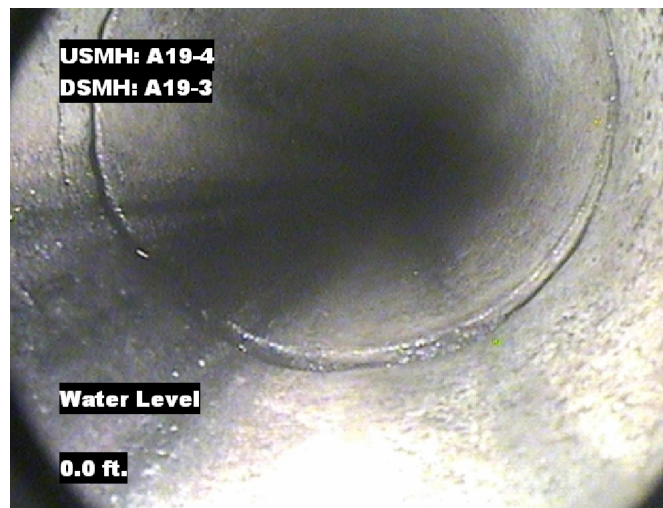
Distance: 0.0 ft. Grade: 0
Condition: Water Level
Remarks: N/A

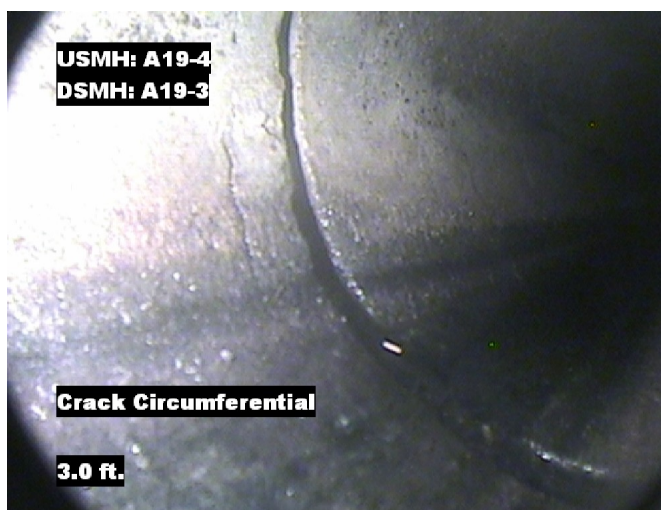
Distance: 3.0 ft. Grade: 1
Condition: Crack Circumferential
Remarks: N/A

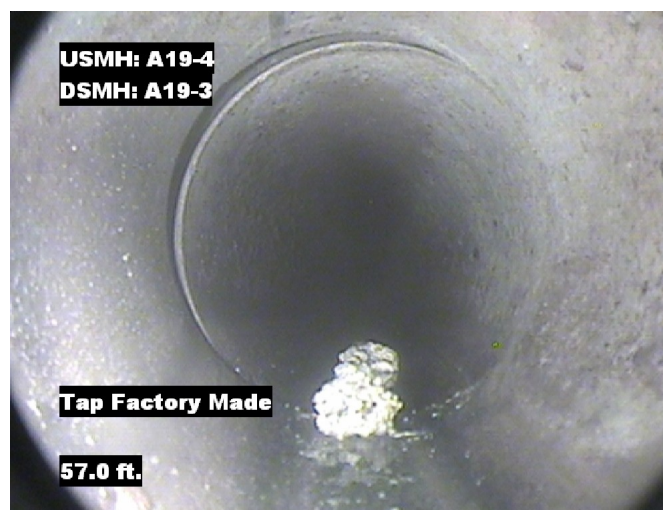
Distance: 57.0 ft. Grade: 0
Condition: Tap Factory Made
Remarks: N/A

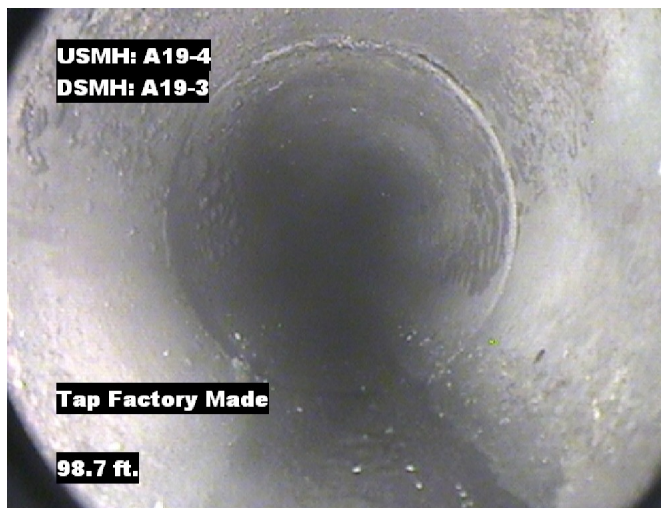
Distance: 98.7 ft. Grade: 0
Condition: Tap Factory Made
Remarks: N/A

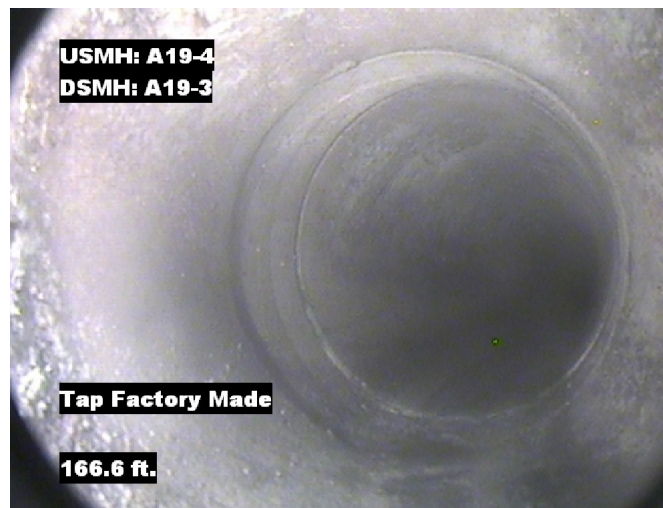
Distance: 166.6 ft. Grade: 0
Condition: Tap Factory Made
Remarks: N/A

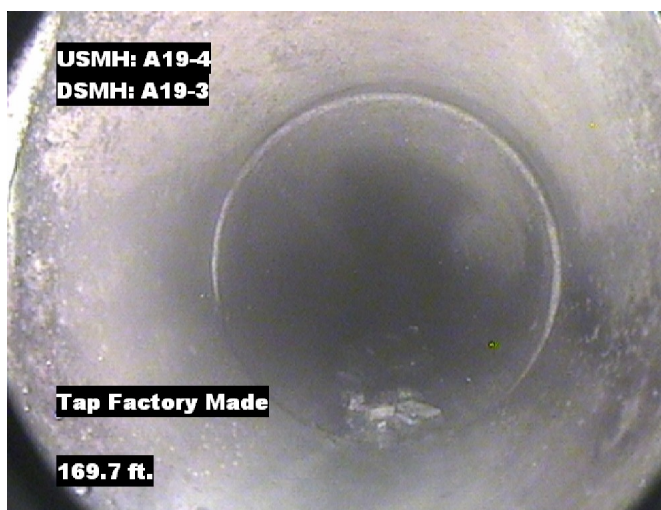
Distance: 169.7 ft. Grade: 0
Condition: Tap Factory Made
Remarks: N/A

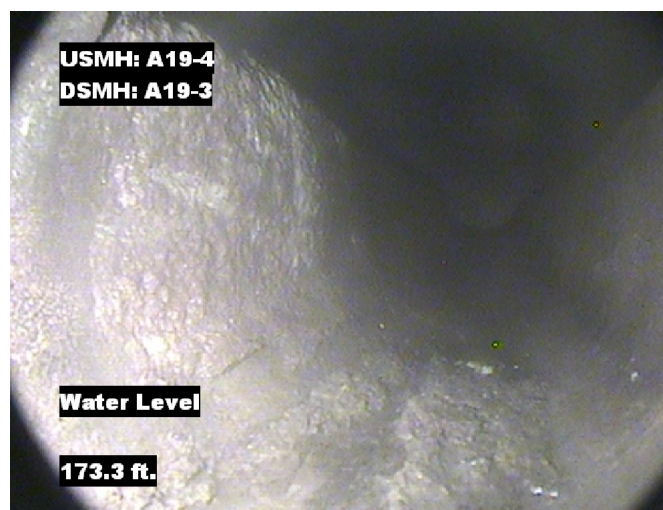
Distance: 173.3 ft. Grade: 0
Condition: Water Level
Remarks: N/A

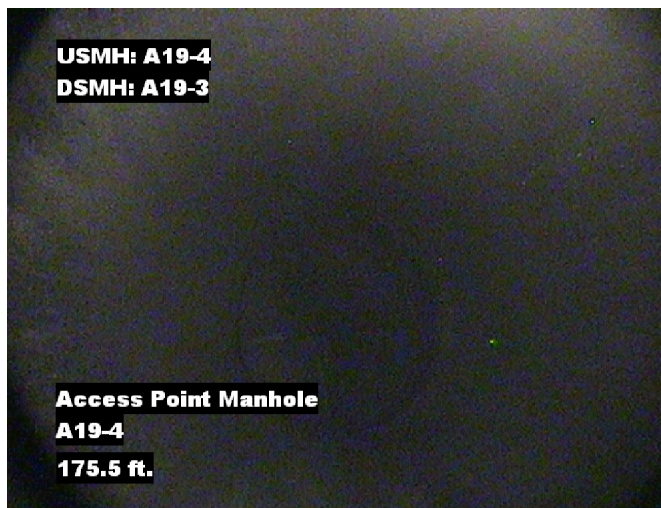
Distance: 175.5 ft. Grade: 0
Condition: Access Point Manhole
Remarks: A19-4
