Defect Listing

Pipe Segment Refere... A2-1_A-37	City Oliver Springs	Street Kington Ave	Material Ductile Iron Pipe	Location C... Easement/R...	Sewer Use Sanitary
Upstream MH A2-1	Total Length 121.8	Year Laid	Shape Circular	Location Details	
DS Manhole A-37	Length surveyed 121.8	Year Renewed	Height 8	Width 8	Pipe Joint... 13

SPR N/A	MPR 3	PO Number 4397-03	Customer GRW
SPRI N/A	MPRI 3	Work Order 4397-02	Purpose Pre-Rehabilitation Survey
QSR N/A	QMR 3100		
OPR 3	Surveyed By Charlie Gordon	Direction Downstream	Date 20150831
OPRI 3	Certificate Number U-615-07000491	Pre-Cleaning Jetting	Time 11:49
	Date Cleaned 20150831	End Time 11:57	Weather Dry
			Additional Info

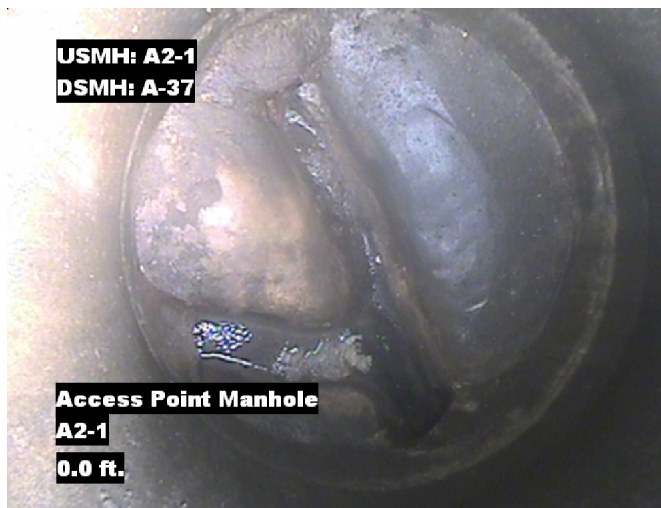
Distance: 0.0 ft. Grade: 0
Condition: Access Point Manhole
Remarks: A2-1

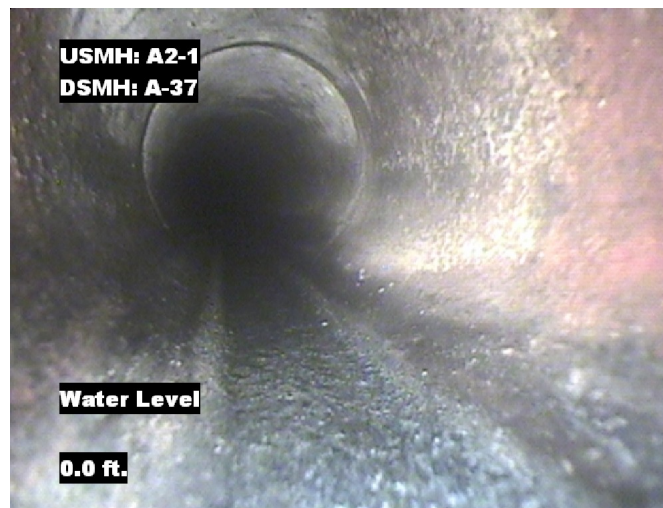
Distance: 0.0 ft. Grade: 0
Condition: Water Level
Remarks: N/A

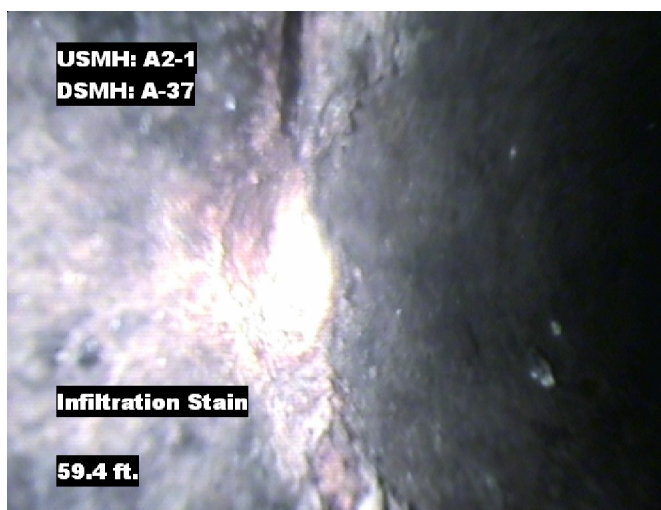
Distance: 59.4 ft. Grade: 0
Condition: Infiltration Stain
Remarks: N/A

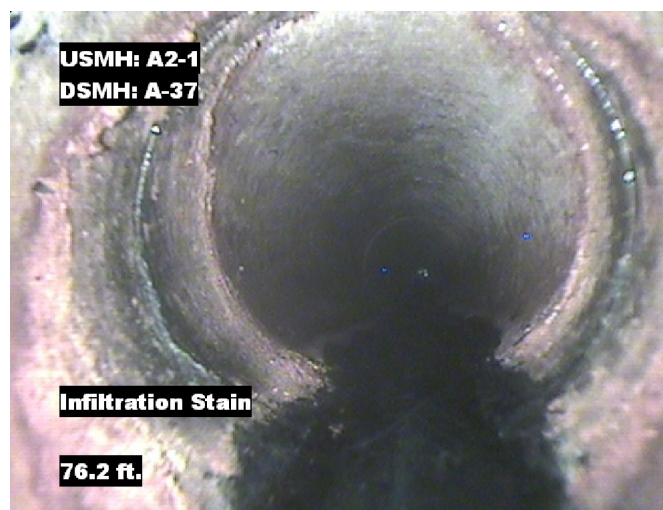
Distance: 76.2 ft. Grade: 0
Condition: Infiltration Stain
Remarks: N/A

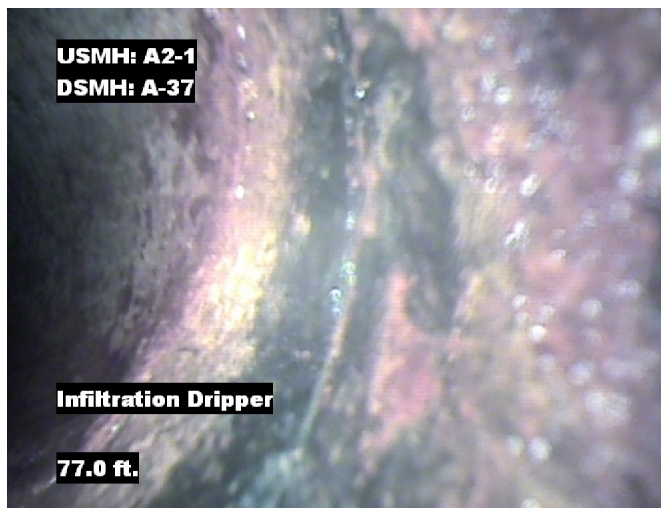
Distance: 77.0 ft. Grade: 3
Condition: Infiltration Dripper
Remarks: N/A

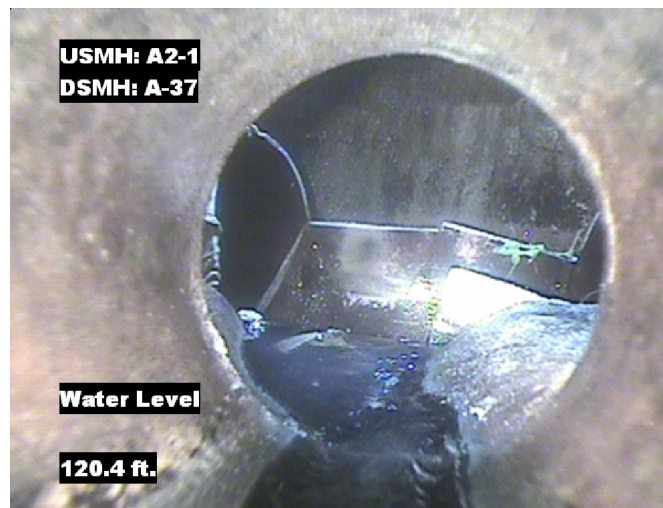
Distance: 120.3 ft. Grade: 0
Condition: Water Level
Remarks: N/A

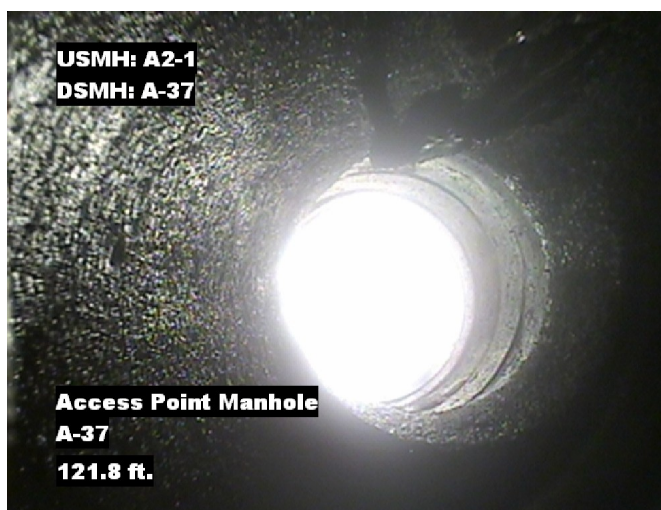
Distance: 121.8 ft. Grade: 0
Condition: Access Point Manhole
Remarks: A-37
