## Defect Listing

Pipe Segment Refere... <b>A2-2_A2-1</b>	City <b>Oliver Springs</b>	Street <b>Kington St</b>	Material <b>Fibreglass Reinforc...</b>	Location C... <b>Light High...</b>	Sewer Use <b>Sanitary</b>
Upstream MH <b>A2-2</b>	Total Length <b>349.7</b>	Year Laid	Shape <b>Circular</b>	Location Details	
DS Manhole <b>A2-1</b>	Length surveyed <b>349.7</b>	Year Renewed	Height <b>8</b>	Width <b>8</b>	Pipe Joint... <b>N/A</b>

## Image Report 4/Page

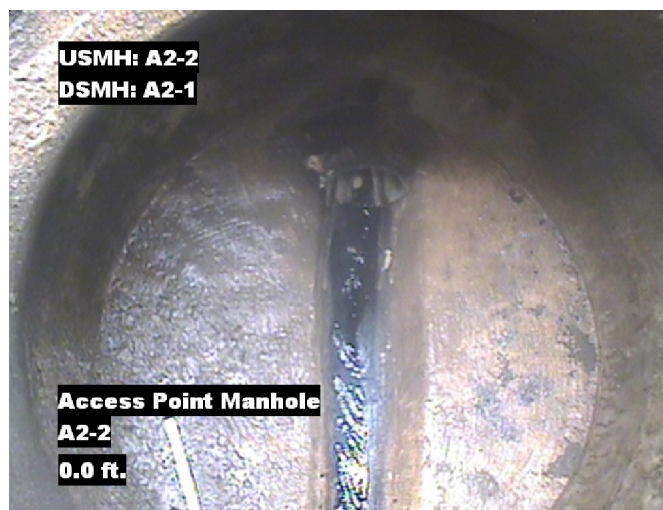
Distance: 0.0 ft. Grade: 0  
Condition: Access Point Manhole  
Remarks: A2-2

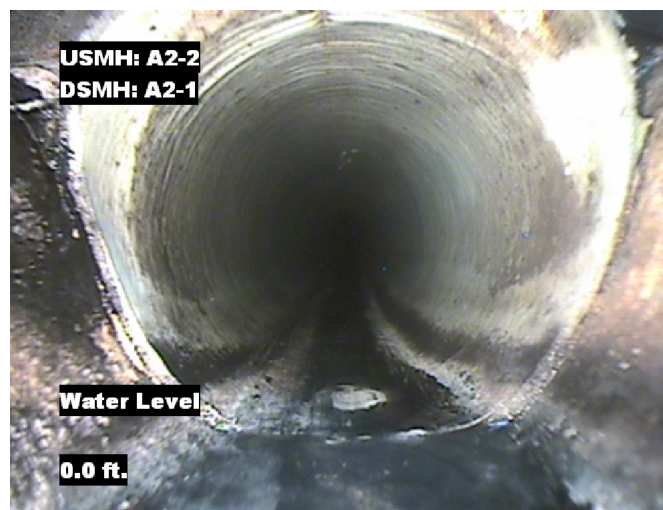
Distance: 0.0 ft. Grade: 0  
Condition: Water Level  
Remarks: N/A

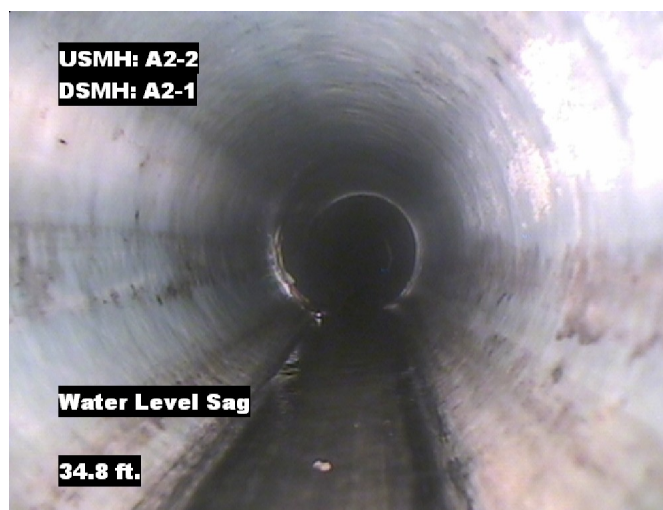
Distance: 34.8 ft. Grade: 2  
Condition: Water Level Sag  
Remarks: N/A

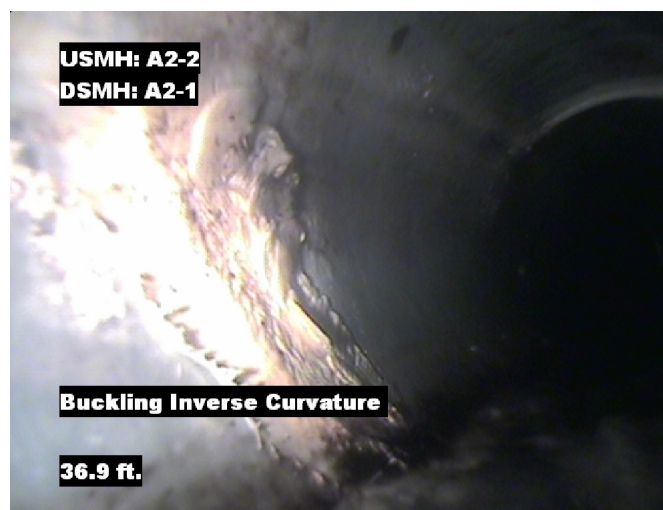
Distance: 36.9 ft. Grade: 0  
Condition: Buckling Inverse Curvature  
Remarks: N/A

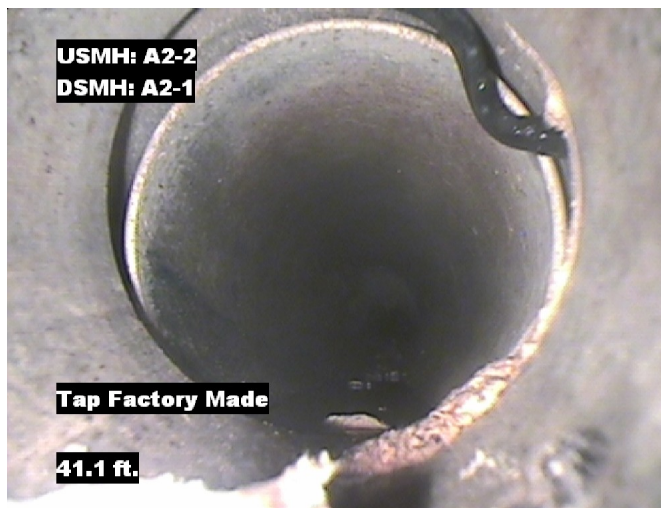
Distance: 41.1 ft. Grade: 0  
Condition: Tap Factory Made  
Remarks: N/A

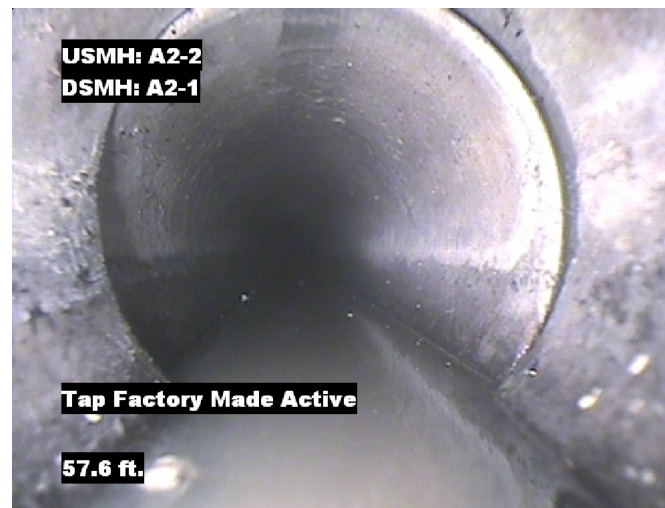
Distance: 57.6 ft. Grade: 0  
Condition: Tap Factory Made Active  
Remarks: N/A

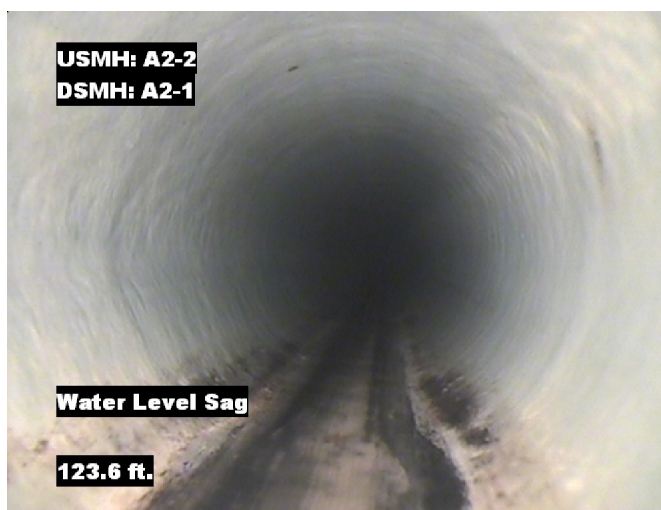
Distance: 123.6 ft. Grade: 2  
Condition: Water Level Sag  
Remarks: N/A

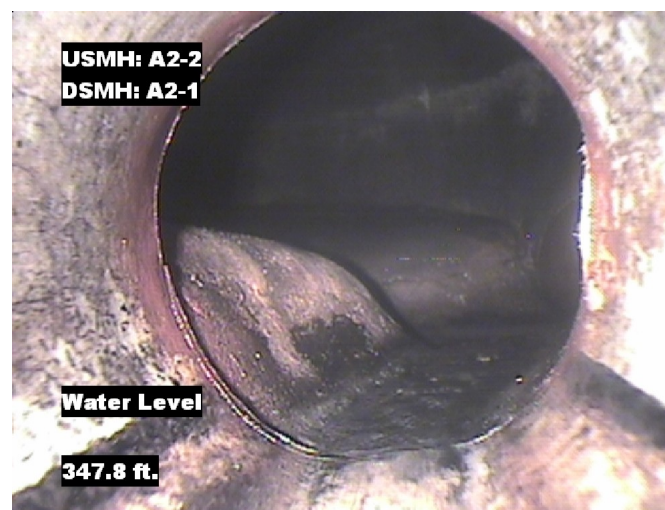
Distance: 347.8 ft. Grade: 0  
Condition: Water Level  
Remarks: N/A

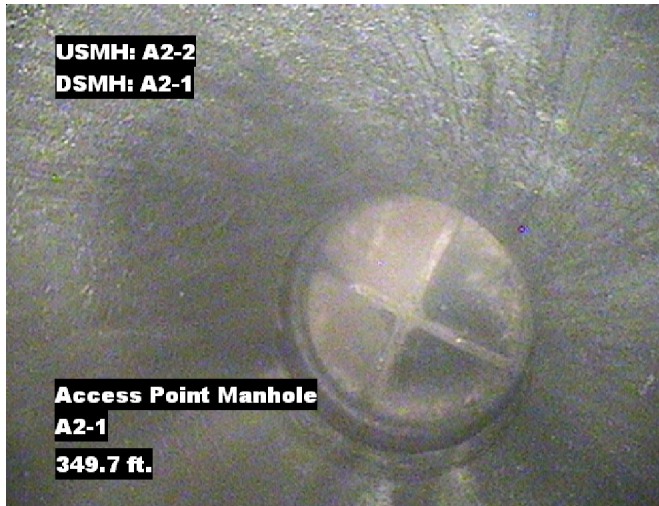
Distance: 349.7 ft. Grade: 0  
Condition: Access Point Manhole  
Remarks: A2-1
