Defect Listing

Pipe Segment Refere		City		Street	Mat	Material		Sewer Use
A2-3_A2-2		Oliver Springs		Kingtin St	Fibreglass	Fibreglass Reinforc		Sanitary
Upstream MH A2-3 DS Manhole		Total Length		Year Laid	Sh	ape	Location	Details
		31	0.7		Circ	Circular		
		Length surveyed		Year Renewed	Height	Width	Pipe Joint	
A2	A2-2		0.7		8	8	N/A	
SPR	N/A	MPR	6	PO Number		Pre-		
ODDI		MDDI		4397-03				
SPRI	N/A	MPRI	2	Work Order				
QSR	N/A	QMR	2300	4397-02				urvey
OF	PR	Surve	yed By	Direction	Di	Date		alabel
6	6	Charlie Gordon		Downstream	2015	20150818		
OP	PRI	Certificate Number		Pre-Cleaning	Ti	Time		
2		U-615-07000491		Jetting	10	10:30		
		Date C	End Time		Additional Info			
	20150818					10:54

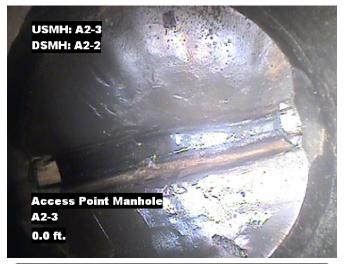
Distance: 0.0 ft. Grade: 0

Condition: Access Point Manhole

Remarks: A2-3

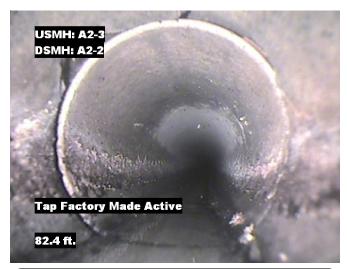
Distance: 82.4 ft. **Grade**: 0 **Condition**: Tap Factory Made Active

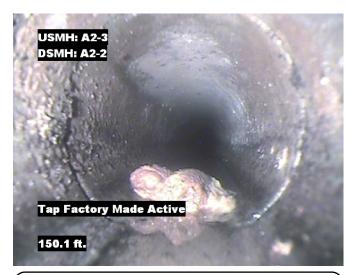
Distance: 150.1 ft. **Grade**: 0 **Condition**: Tap Factory Made Active

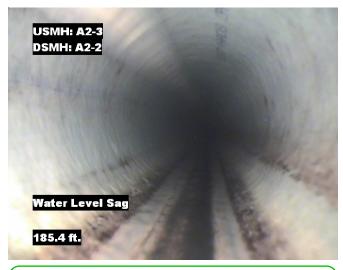
Distance: 185.4 ft. Grade: 2

Condition: Water Level Sag

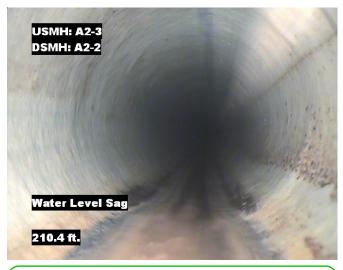
Distance: 210.4 ft. Grade: 2

Condition: Water Level Sag

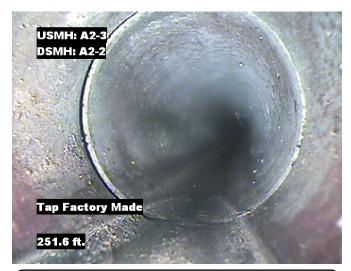
Distance: 251.6 ft. Grade: 0

Condition: Tap Factory Made

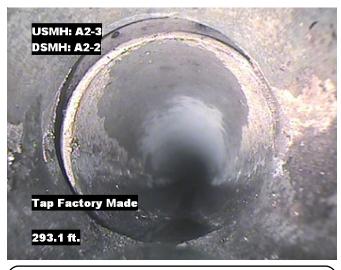
Distance: 293.1 ft. Grade: 0

Condition: Tap Factory Made

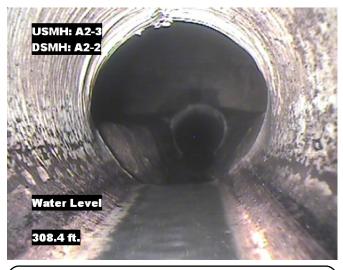
Distance: 308.3 ft. Grade: 0

Condition: Water Level

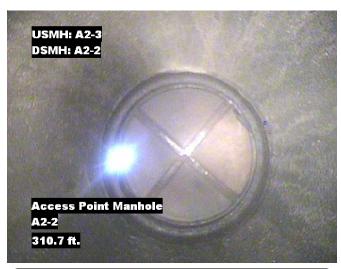
Distance: 310.7 ft. Grade: 0

Condition: Access Point Manhole

Remarks: A2-2
