Defect Listing

Pipe Segment Refere		City		Street	Mat	Material		Sewer Use	
A20-10	_A20-9	Oliver	Springs	Highway 62	Concrete Pipe (non		Main Highw	Sanitary	
Upstream MH		Total Length		Year Laid	Sh	Shape		Details	
A20-10		309.3			Circ	ular			
DS Ma	anhole	Length s	surveyed	Year Renewed	Height	Width	Pipe Joint		
A2	0-9	30	9.3		8	8 8 4			
SPR	N/A	MPR	12	PO Number 4397-03			Customer		
0001	NI/A	MDDI				GRW			
SPRI	N/A	MPRI	4	Work Order					
QSR	N/A	QMR	4300	4397-02		Pre-Rehabilitation Survey			
OF	PR .	Surve	yed By	Direction	Di	Date Media		label	
1	2	Barry_Rogers		Upstream	20150804				
OF	PRI	Certificate Number		Pre-Cleaning	Time		Weather		
4 U-1012-16		2-16405	Jetting 0		04:40				
		Date C	leaned	End Time		Additional Info			
		2015	0804		:57

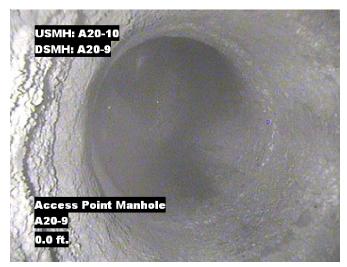
Distance: 0.0 ft. Grade: (

Condition: Access Point Manhole

Remarks: A20-9

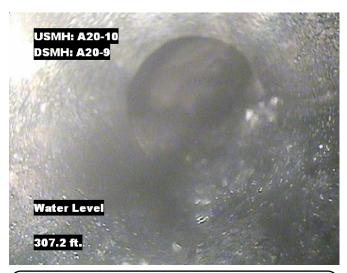
Distance: 307.2 ft. Grade: 0

Condition: Water Level
