Defect Listing

Pipe Segment Refere... A20-11_A20-10	City Oliver Springs	Street Hwy 62	Material Concrete Pipe (non-...	Location C... Main Highw...	Sewer Use Sanitary
Upstream MH A20-11	Total Length 318.2	Year Laid	Shape Circular	Location Details	
DS Manhole A20-10	Length surveyed 318.2	Year Renewed	Height 8	Width 8	Pipe Joint... 4

SPR 1	MPR N/A	PO Number 4397-03	Customer GRW
SPRI 1	MPRI N/A	Work Order 4397-02	Purpose Pre-Rehabilitation Survey
QSR 1100	QMR N/A		
OPR 1	Surveyed By Barry Rogers	Direction Downstream	Date 20150805
OPRI 1	Certificate Number U-1012-16405	Pre-Cleaning Heavy Cleaning	Time 02:59
	Date Cleaned 20150805	End Time 03:25	Weather Very Dry
			Media label
			Additional Info

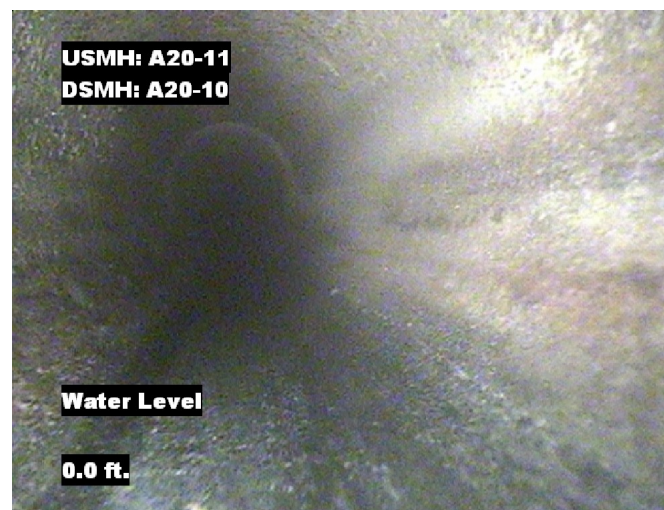
Distance: 0.0 ft. Grade: 0
Condition: Water Level
Remarks: N/A

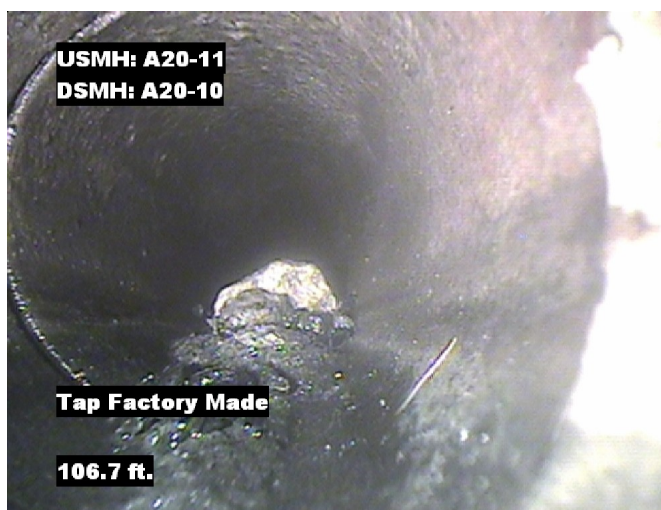
Distance: 106.7 ft. Grade: 0
Condition: Tap Factory Made
Remarks: N/A

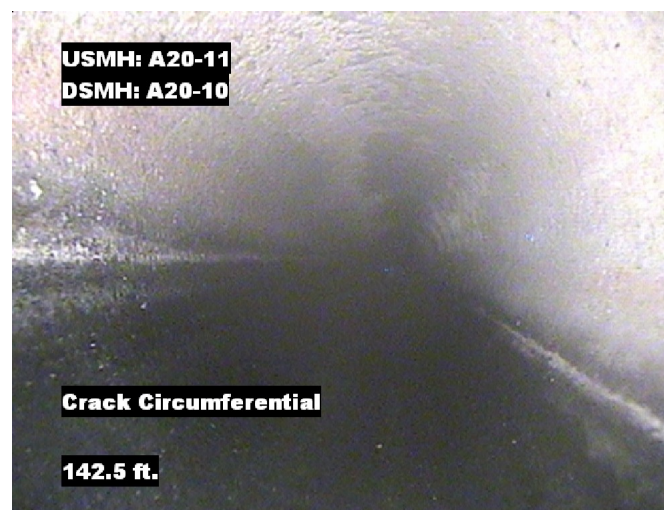
Distance: 142.5 ft. Grade: 1
Condition: Crack Circumferential
Remarks: N/A

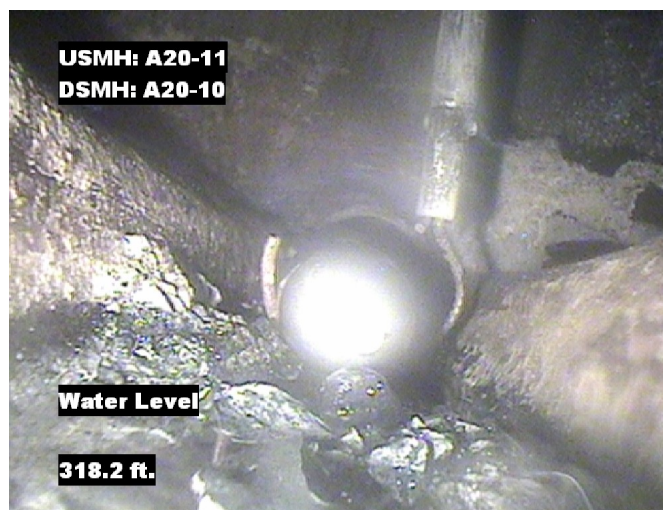
Distance: 318.2 ft. Grade: 0
Condition: Water Level
Remarks: N/A
