Defect Listing

Pipe Segment Refere		City		Street	Mat	Material		Sewer Use	
A20-12_A20-11		Oliver Springs		Richards Dr	Concrete F	Concrete Pipe (non		Sanitary	
Upstream MH		Total Length		Year Laid	Sh	ape Location Detail		Details	
A20-12		170.3			Circ	cular			
DS Manhole		Length surveyed		Year Renewed	Height	Width	Pipe Joint		
A20-11		170.3			8	8	4		
SPR	3	MPR	N/A	PO Number			Customer		
				4397-03			GRW		
SPRI	3	MPRI	N/A	Work Order			Purpose		
QSR	3100	QMR	N/A	4397-02		Pre-Rehabilitation Survey			
O	PR	Surveyed By		Direction	Date		Media label		
3	3	Barry_Rogers		Upstream	20150804				
OF	PRI	Certificate Number		Pre-Cleaning	Time		Weather		
3		U-1012-16405		Jetting	03:08		Dry		
		Date C	leaned		End Time		Additional Info		
		2015	0804	03:21

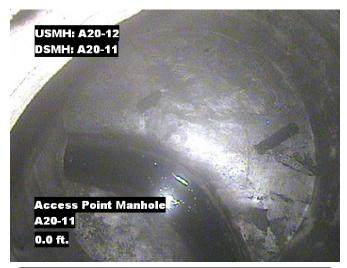
Distance: 0.0 ft. Grade: 0

Condition: Access Point Manhole

Remarks: A20-11

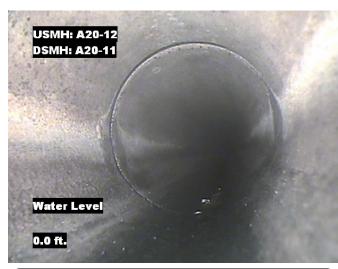
Distance: 0.0 ft. Grade: 0

Condition: Water Level

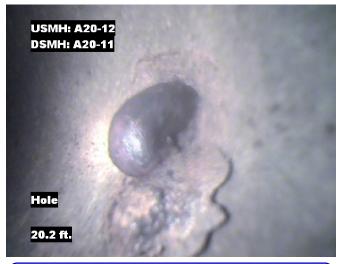
Distance: 20.2 ft. Grade: 3

Condition: Hole Remarks: N/A

Structural Ratings			0	& M Ratin	gs	Con	Combined Ratings		
Normal Defects	Grade Rating	No. Occur.	Rating	Grade Rating	No. Occur.	Rating	Grade Rating	No. Occur.	Rating	
	4			4		_	4		_	
	1	0	0	1	0	0	1	0	0	
	2	0	0	2	0	0	2	0	0	
	3	1	3	3	0	0	3	1	3	
	4	0	0	4	0	0	4	0	0	
	5	0	0	5	0	0	5	0	0	
Continuous Defects										
Code ID Length										
	1									
	1									
	Subtotals	1		Subtotals	0		Subtotals	1		
SUMMARY	Pi	ipe Rating	3	Pi	pe Rating	0	Overall Pi	ipe Rating	3	
SUMMAN	Struct	ural Index	3.0		&M Index	0		erall Index	3.0	
	Str. Quick Rating			O&M Quick Rating		0000			3100

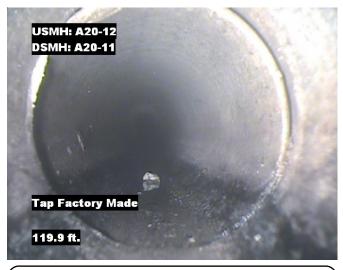
Distance: 119.9 ft. Grade: 0

Condition: Tap Factory Made

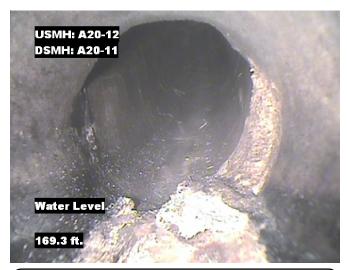
Distance: 169.3 ft. Grade:

Condition: Water Level

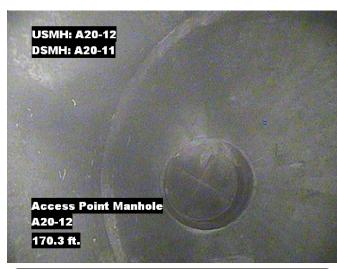
Distance: 170.3 ft. Grade: 0

Condition: Access Point Manhole

Remarks: A20-12
