Defect Listing

Pipe Segment Refere... A20-13_A20-12	City Oliver Springs	Street Richards Dr	Material Concrete Pipe (non-...	Location C... Light High...	Sewer Use Sanitary
Upstream MH A20-13	Total Length 186	Year Laid	Shape Circular	Location Details	
DS Manhole A20-12	Length surveyed 186	Year Renewed	Height 8	Width 8	Pipe Joint... 4

SPR 10	MPR N/A	PO Number 4397-03	Customer GRW
SPRI 3.3	MPRI N/A	Work Order 4397-02	Purpose Pre-Rehabilitation Survey
QSR 5131	QMR N/A		
OPR 10	Surveyed By Barry Rogers	Direction Downstream	Date 20150805
OPRI 3.3	Certificate Number U-1012-16405	Pre-Cleaning No Pre-Cleaning	Time 09:37
	Date Cleaned	End Time 09:49	Weather Dry
		Additional Info

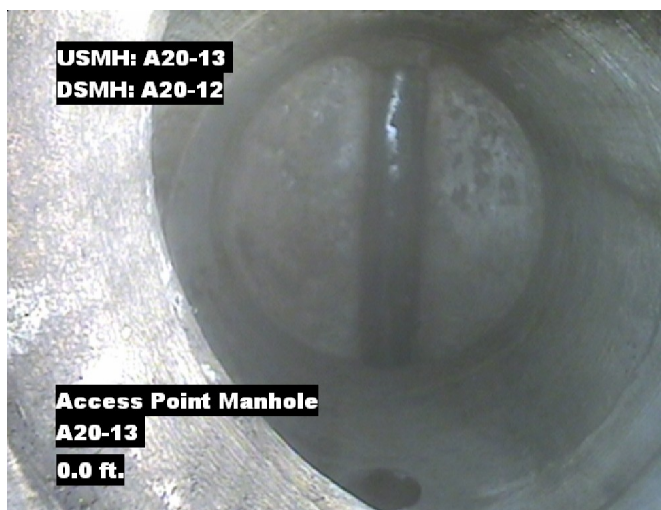
Distance: 0.0 ft. Grade: 0
Condition: Access Point Manhole
Remarks: A20-13

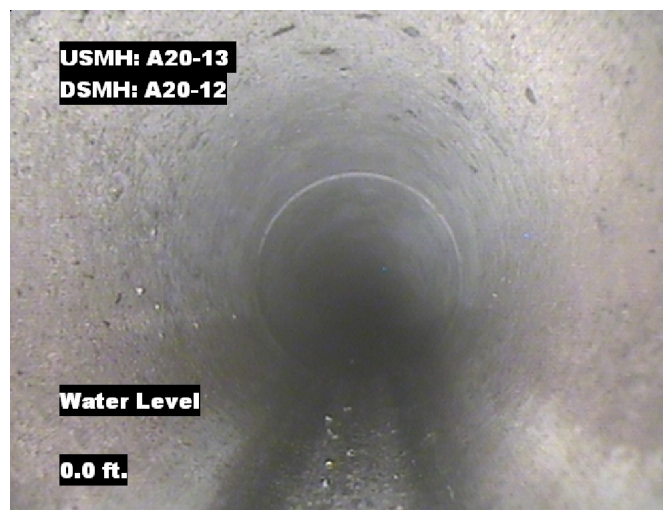
Distance: 0.0 ft. Grade: 0
Condition: Water Level
Remarks: N/A

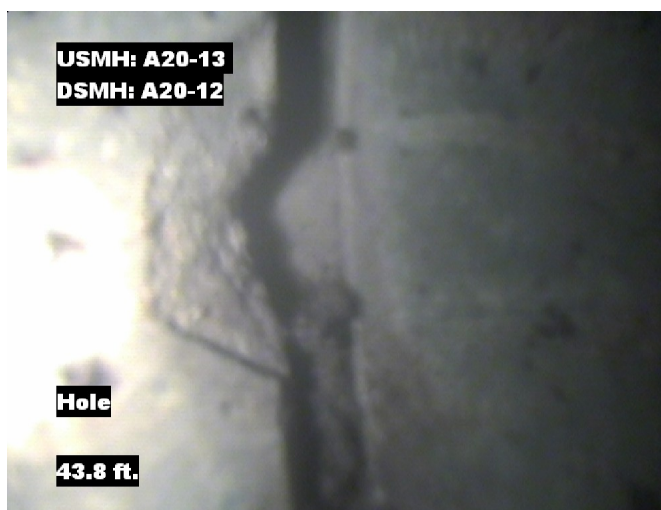
Distance: 43.8 ft. Grade: 3
Condition: Hole
Remarks: N/A

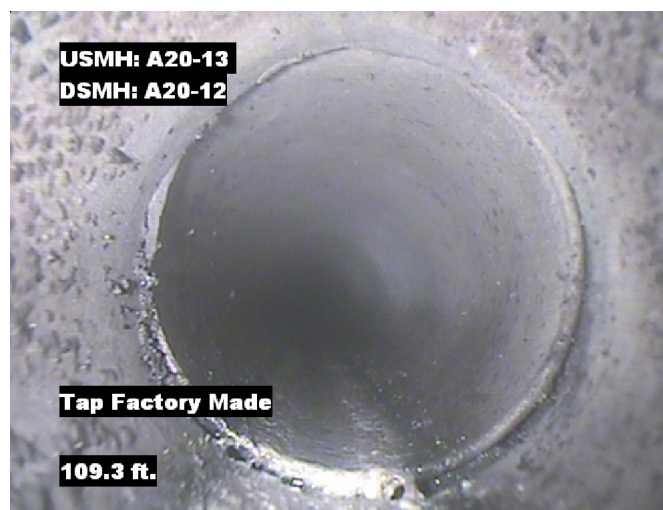
Distance: 109.3 ft. Grade: 0
Condition: Tap Factory Made
Remarks: N/A

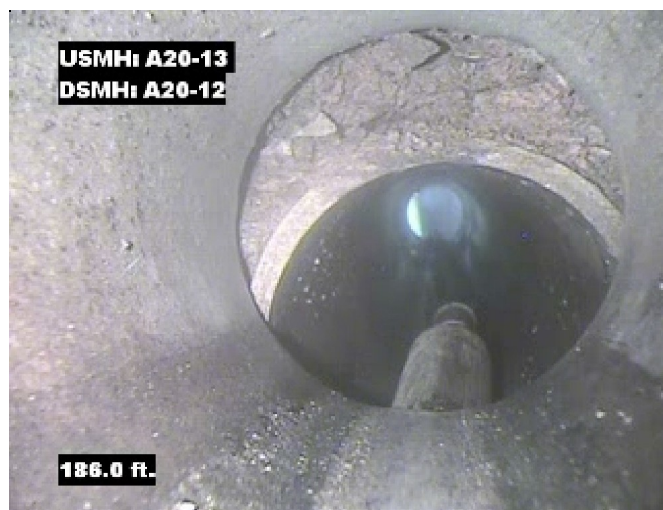
Distance: 185.9 ft. Grade: 2
Condition: Joint Offset Large
Remarks: N/A

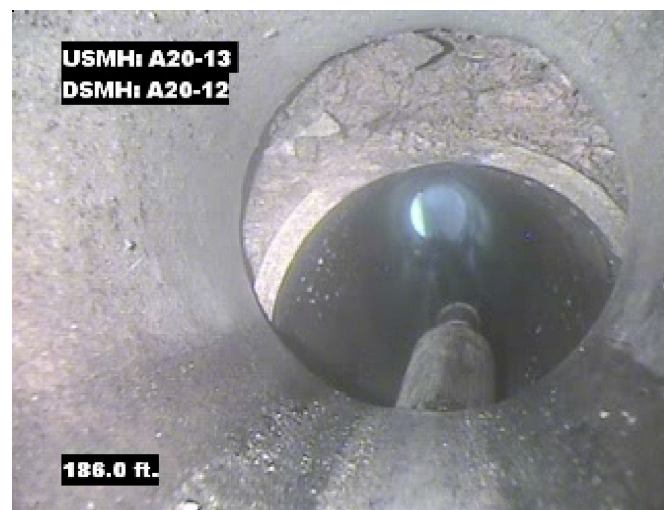
Distance: 185.9 ft. Grade: 5
Condition: Hole Soil Visible
Remarks: N/A

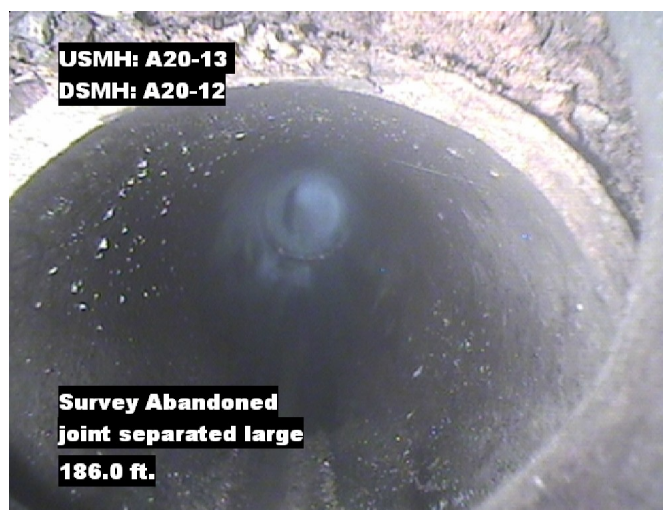
Distance: 186.0 ft. Grade: 0
Condition: Survey Abandoned
Remarks: JOINT OFFSET LARGE
