Defect Listing

Pipe Segment Refere... A20-14_A20-13	City Oliver Springs	Street Richarda Dr	Material Concrete Pipe (non-...	Location C... Light High...	Sewer Use Sanitary
Upstream MH A20-14	Total Length 318.5	Year Laid	Shape Circular	Location Details	
DS Manhole A20-13	Length surveyed 318.5	Year Renewed	Height 8	Width 8	Pipe Joint... 4

SPR N/A	MPR N/A	PO Number 4397-03	Customer GRW
SPRI N/A	MPRI N/A	Work Order 4397-02	Purpose Pre-Rehabilitation Survey
QSR N/A	QMR N/A		
OPR N/A	Surveyed By Barry Rogers	Direction Downstream	Date 20150805
OPRI N/A	Certificate Number U-1012-16405	Pre-Cleaning Jetting	Time 09:03
	Date Cleaned 20150805	End Time 09:23	Weather Dry
			Additional Info

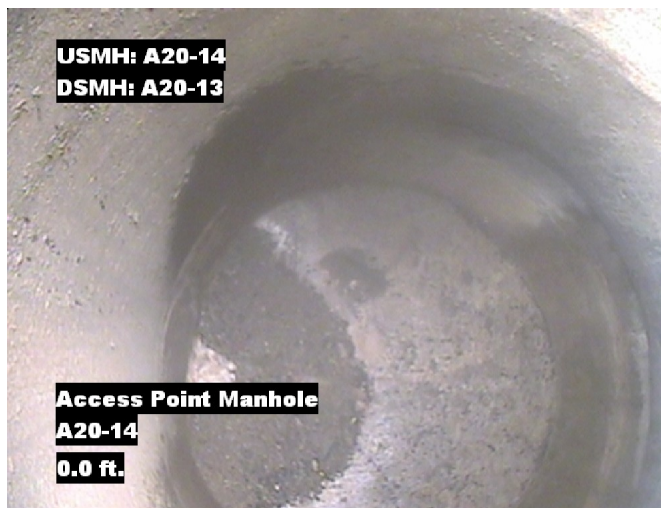
Distance: 0.0 ft. Grade: 0
Condition: Access Point Manhole
Remarks: A20-14

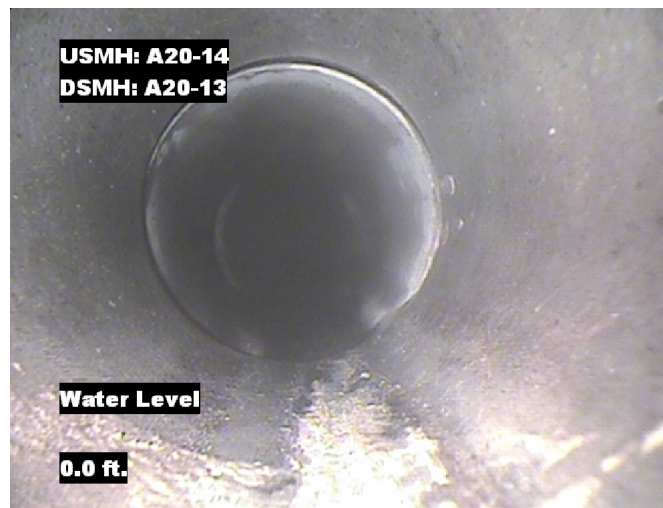
Distance: 0.0 ft. Grade: 0
Condition: Water Level
Remarks: N/A

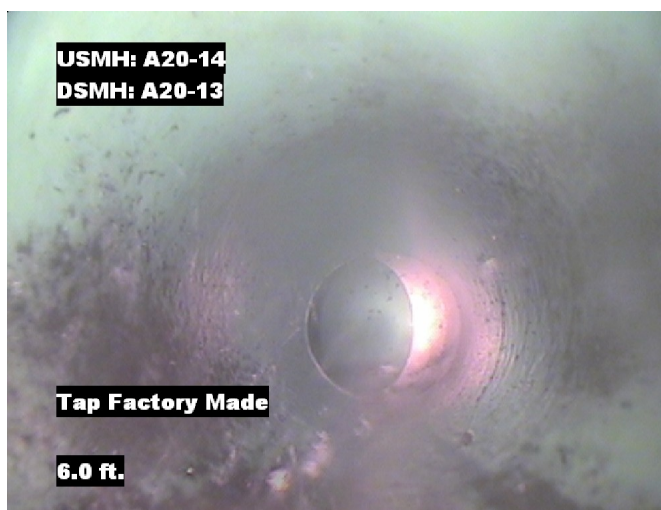
Distance: 6.0 ft. Grade: 0
Condition: Tap Factory Made
Remarks: N/A

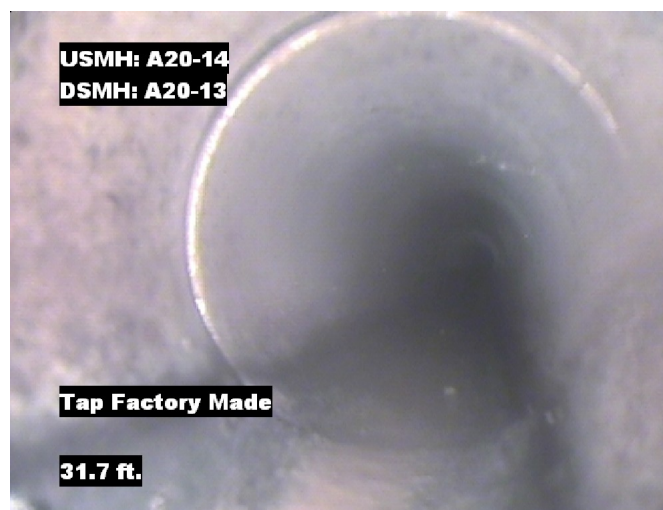
Distance: 31.7 ft. Grade: 0
Condition: Tap Factory Made
Remarks: N/A

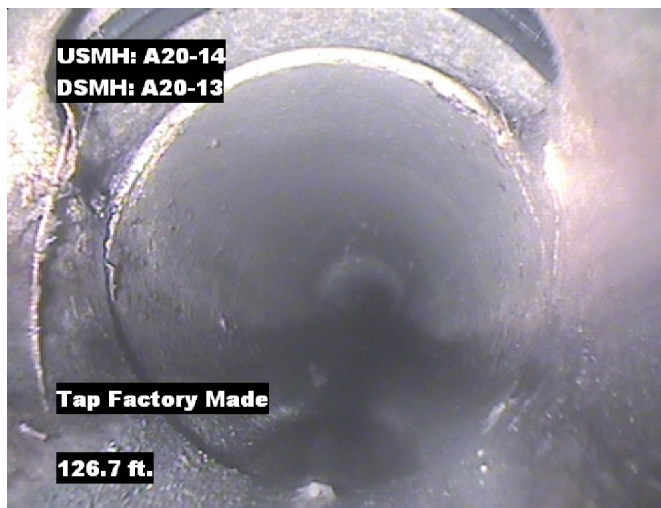
Distance: 126.7 ft. Grade: 0
Condition: Tap Factory Made
Remarks: N/A

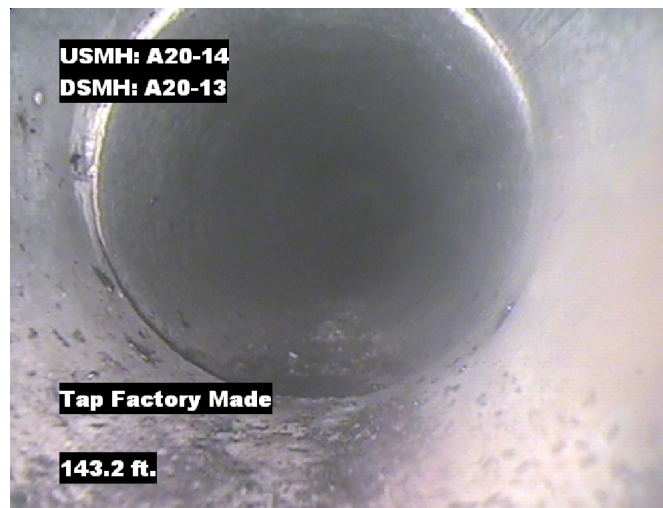
Distance: 143.2 ft. Grade: 0
Condition: Tap Factory Made
Remarks: N/A

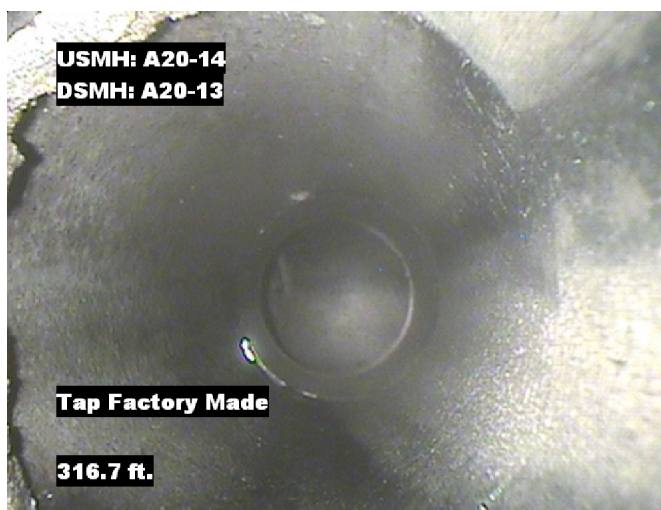
Distance: 316.7 ft. Grade: 0
Condition: Tap Factory Made
Remarks: N/A

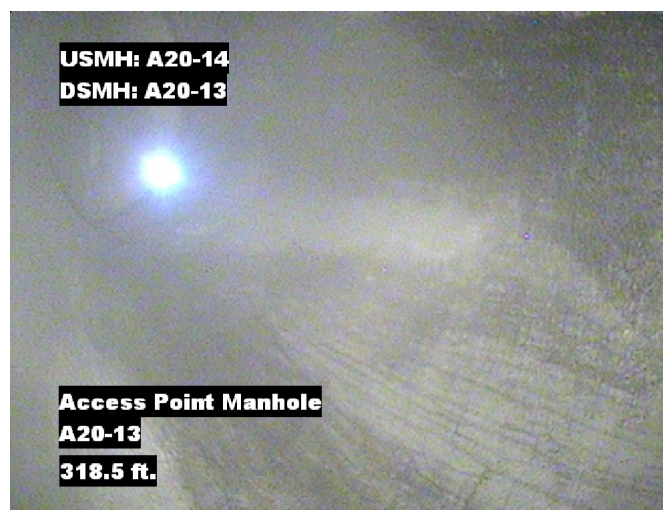
Distance: 318.5 ft. Grade: 0
Condition: Access Point Manhole
Remarks: A20-13
