Defect Listing

| Pipe Segment Refere... A20-2_A8-7 | City Oliver Springs | Street Main St | Material Fibreglass Reinforc... | Location C... Light High... | Sewer Use Sanitary |

| SPRI N/A | MPRI 2.2 | Work Order 4397-02 | Purpose Pre-Rehabilitation Survey |

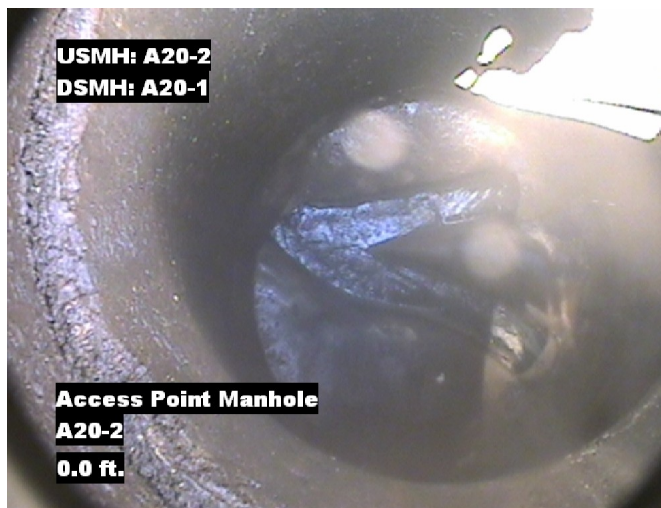
Distance: 0.0 ft. Grade: 0
Condition: Access Point Manhole
Remarks: A20-2

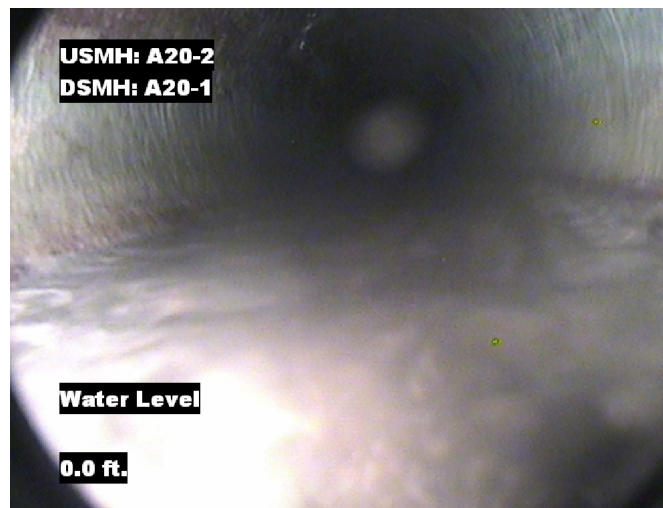
| Distance | Condition | Cont. Dfct. | Values | | | Joint | Clock Position | | Grade |
|---|---|---|---|---|---|---|---|---|---|
| 0.0 ft. | Water Level | | | | 15 | <input type="checkbox"/> | | | |

Distance: 0.0 ft. Grade: 0
Condition: Water Level
Remarks: N/A

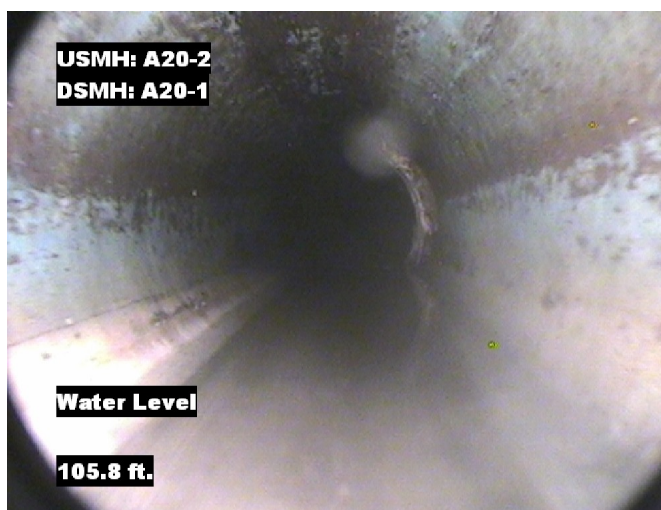
| Distance | Condition | Cont. Dfct. | Values | | | Joint | Clock Position | | Grade |
|---|---|---|---|---|---|---|---|---|---|
| 105.8 ft. | Water Level | | | | 10 | <input type="checkbox"/> | | | |

Distance: 105.8 ft. Grade: 0
Condition: Water Level
Remarks: N/A

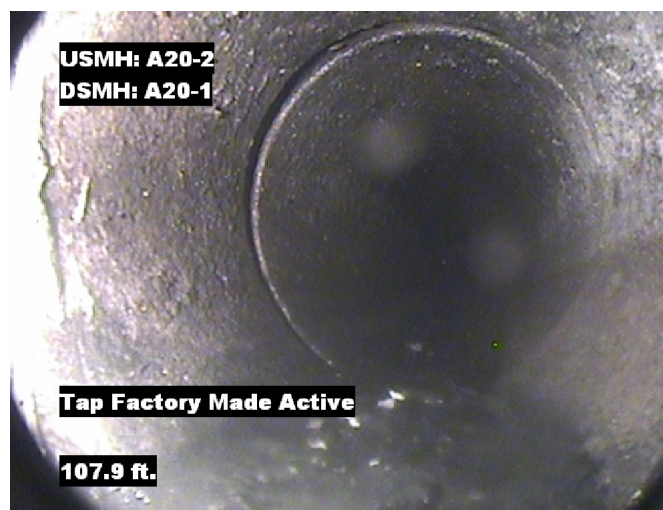
| Distance | Condition | Cont. Dfct. | Values | | | Joint | Clock Position | | Grade |
|---|---|---|---|---|---|---|---|---|---|
| 107.9 ft. | Tap Factory Made Active | | 6 | | 0 | <input type="checkbox"/> | 3 | | |

Distance: 107.9 ft. Grade: 0
Condition: Tap Factory Made Active
Remarks: N/A

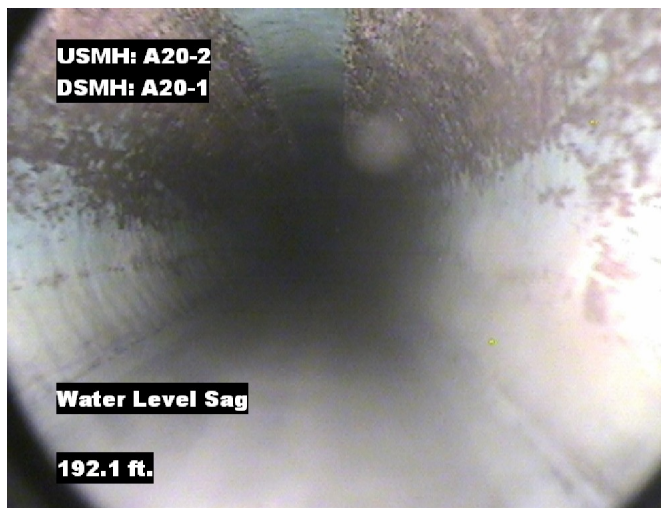
| Distance | Condition | Cont. Dfct. | Values | | | Joint | Clock Position | | Grade |
|---|---|---|---|---|---|---|---|---|---|
| 192.1 ft. | Water Level Sag | | | | 15 | <input type="checkbox"/> | | | 2 |

Distance: 192.1 ft. Grade: 2
Condition: Water Level Sag
Remarks: N/A

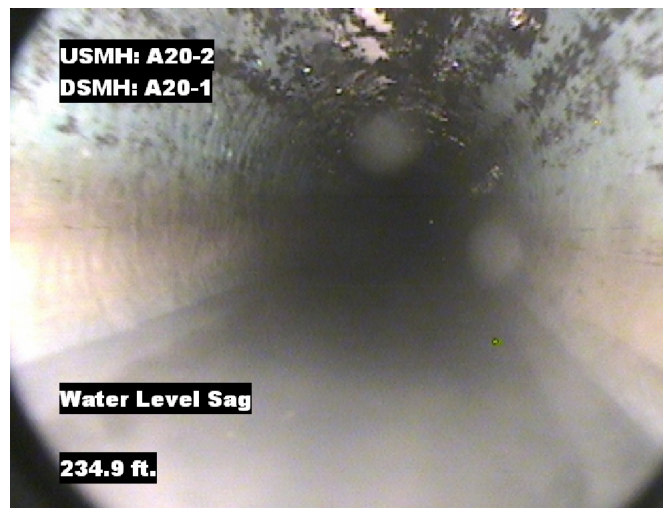
| Distance | Condition | Cont. Dfct. | Values | | | Joint | Clock Position | | Grade |
|---|---|---|---|---|---|---|---|---|---|
| 234.7 ft. | Water Level Sag | | | | 15 | <input type="checkbox"/> | | | 2 |

Distance: 234.7 ft. Grade: 2
Condition: Water Level Sag
Remarks: N/A

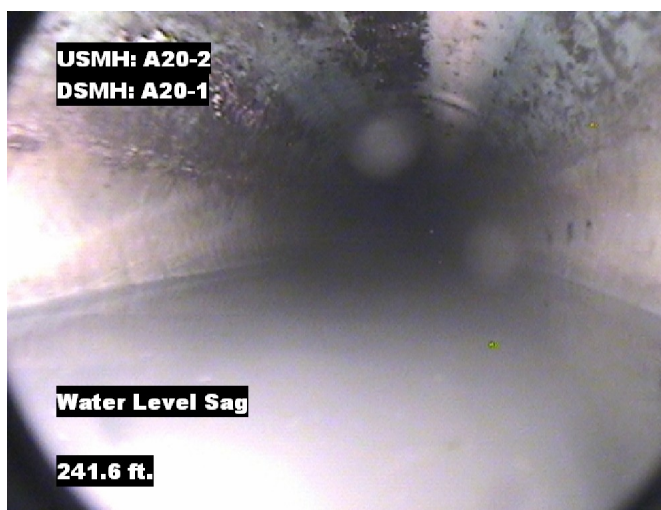
| Distance | Condition | Cont. Dfct. | Values | | | Joint | Clock Position | | Grade |
|---|---|---|---|---|---|---|---|---|---|
| 241.5 ft. | Water Level Sag | | | | 30 | <input type="checkbox"/> | | | 2 |

Distance: 241.5 ft. Grade: 2
Condition: Water Level Sag
Remarks: N/A

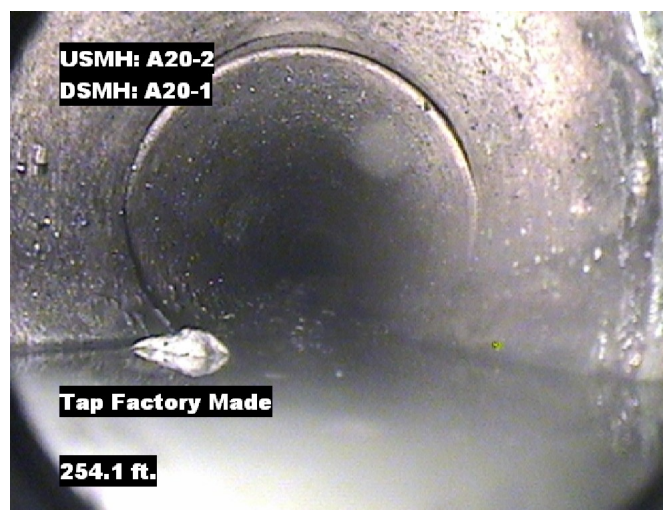
| Distance | Condition | Cont. Dfct. | Values | | | Joint | Clock Position | | Grade |
|---|---|---|---|---|---|---|---|---|---|
| 254.1 ft. | Tap Factory Made | | 6 | | 0 | <input type="checkbox"/> | 3 | | |

Distance: 254.1 ft. Grade: 0
Condition: Tap Factory Made
Remarks: N/A

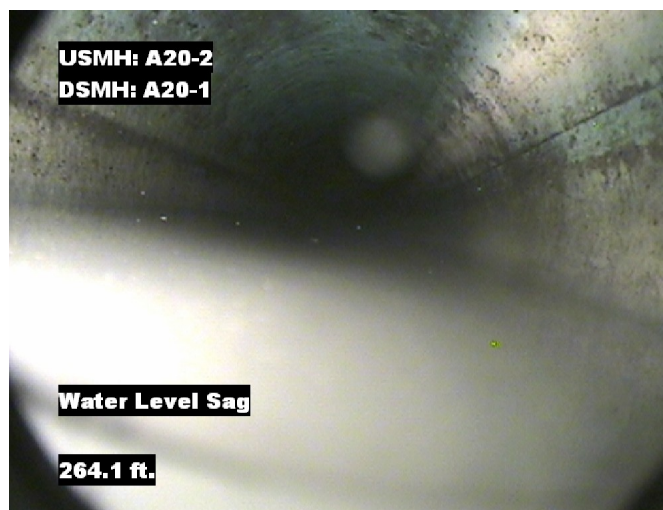
| Distance | Condition | Cont. Dfct. | Values | | | Joint | Clock Position | | Grade |
|---|---|---|---|---|---|---|---|---|---|
| 264.1 ft. | Water Level Sag | | | | 40 | <input type="checkbox"/> | | | 3 |

Distance: 264.1 ft. Grade: 3
Condition: Water Level Sag
Remarks: N/A

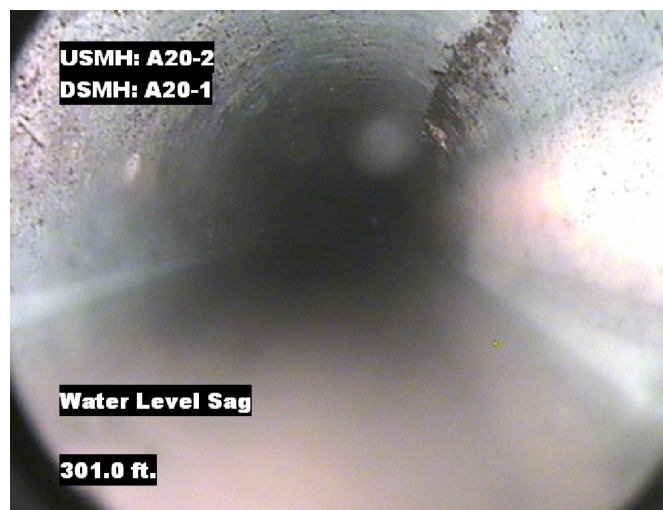
| Distance | Condition | Cont. Dfct. | Values | | | Joint | Clock Position | | Grade |
|---|---|---|---|---|---|---|---|---|---|
| 301.0 ft. | Water Level Sag | | | | 15 | <input type="checkbox"/> | | | 2 |

Distance: 301.0 ft. Grade: 2
Condition: Water Level Sag
Remarks: N/A

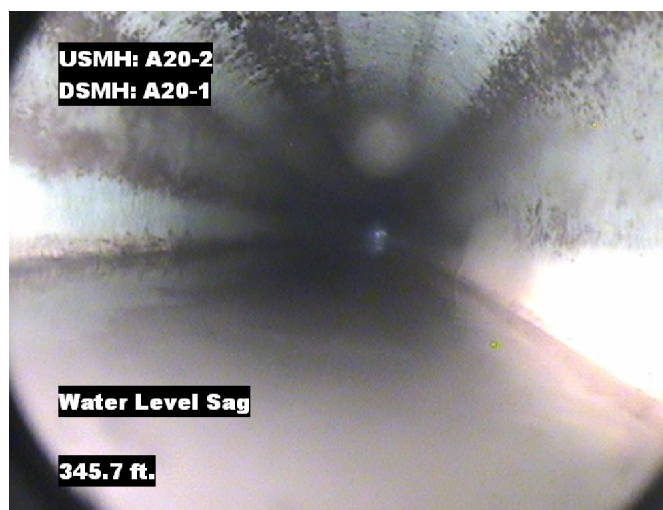
| Distance | Condition | Cont. Dfct. | Values | | | Joint | Clock Position | | Grade |
|---|---|---|---|---|---|---|---|---|---|
| 345.7 ft. | Water Level Sag | | | | 25 | <input type="checkbox"/> | | | 2 |

Distance: 345.7 ft. Grade: 2
Condition: Water Level Sag
Remarks: N/A

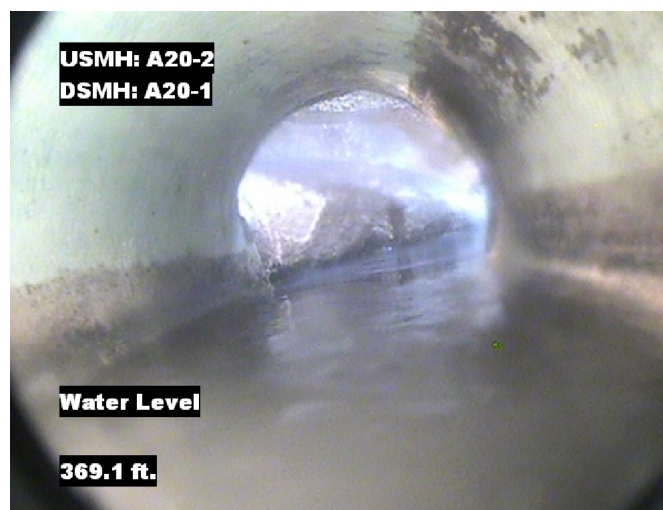
| Distance | Condition | Cont. Dfct. | Values | | | Joint | Clock Position | | Grade |
|---|---|---|---|---|---|---|---|---|---|
| 369.1 ft. | Water Level | | | | 20 | <input type="checkbox"/> | | | |

Distance: 369.1 ft. Grade: 0
Condition: Water Level
Remarks: N/A

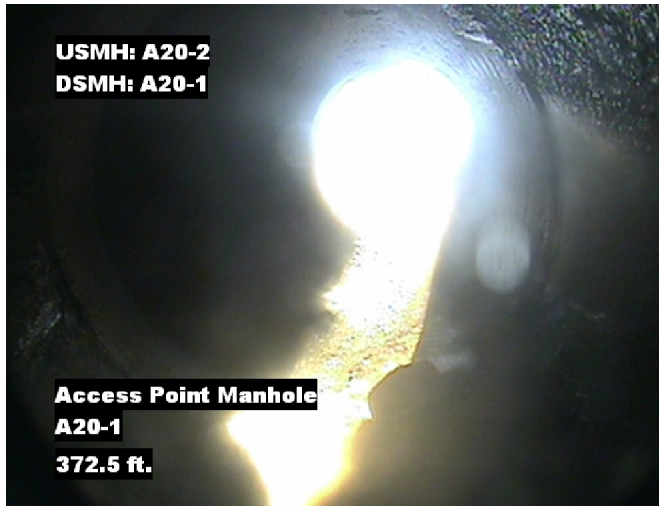
Distance: 372.5 ft. Grade: 0
Condition: Access Point Manhole
Remarks: A8-8
