Defect Listing

Pipe Segment Refere... A20-3_A20-2	City Oliver Springs	Street Main St	Material Concrete Pipe (non-...	Location C... Light High...	Sewer Use Sanitary
Upstream MH A20-3	Total Length 293.6	Year Laid	Shape Circular	Location Details	
DS Manhole A20-2	Length surveyed 293.6	Year Renewed	Height 8	Width 8	Pipe Joint... 4

SPR 4	MPR N/A	PO Number 4397-03	Customer GRW
SPRI 2	MPRI N/A	Work Order 4397-02	Purpose Pre-Rehabilitation Survey
QSR 3111	QMR N/A		
OPR 4	Surveyed By Barry Rogers	Direction Downstream	Date 20150811
OPRI 2	Certificate Number U-1012-16405	Pre-Cleaning Jetting	Time 11:29
	Date Cleaned 20150811	End Time 11:55	Weather Dry
			Media label
			Additional Info

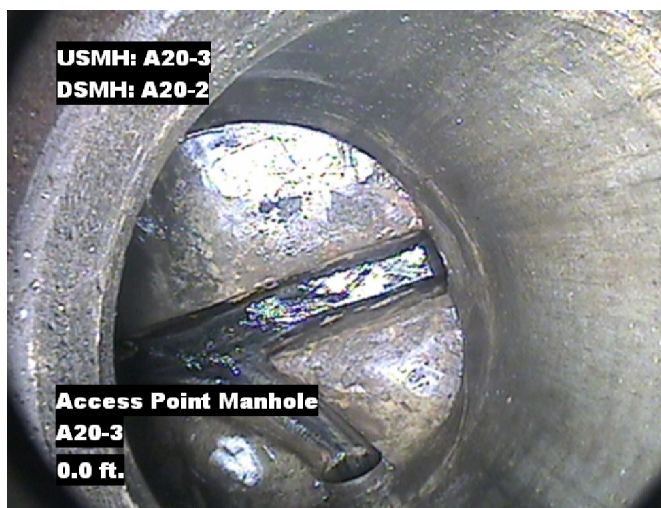
Distance: 0.0 ft. Grade: 0
Condition: Access Point Manhole
Remarks: A20-3

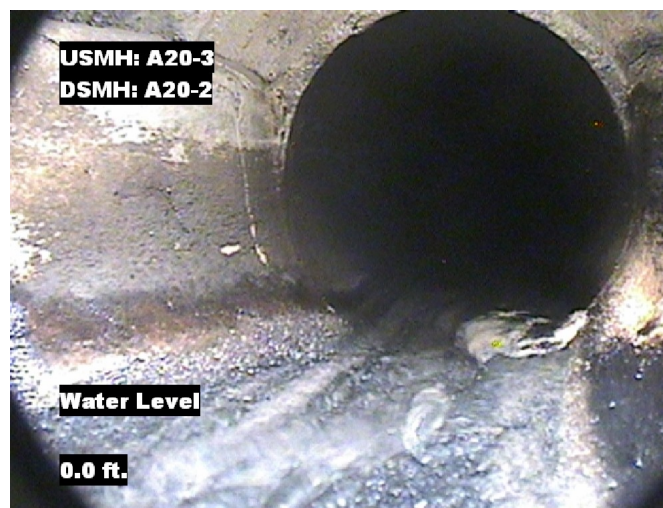
Distance: 0.0 ft. Grade: 0
Condition: Water Level
Remarks: N/A

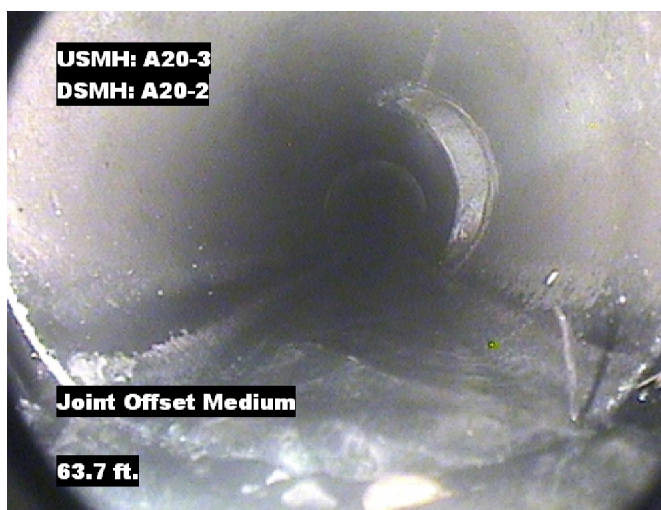
Distance: 63.7 ft. Grade: 1
Condition: Joint Offset Medium
Remarks: N/A

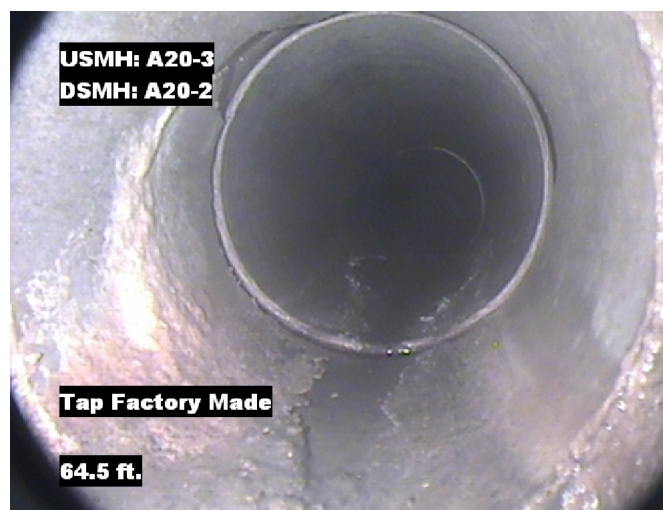
Distance: 64.5 ft. Grade: 0
Condition: Tap Factory Made
Remarks: N/A

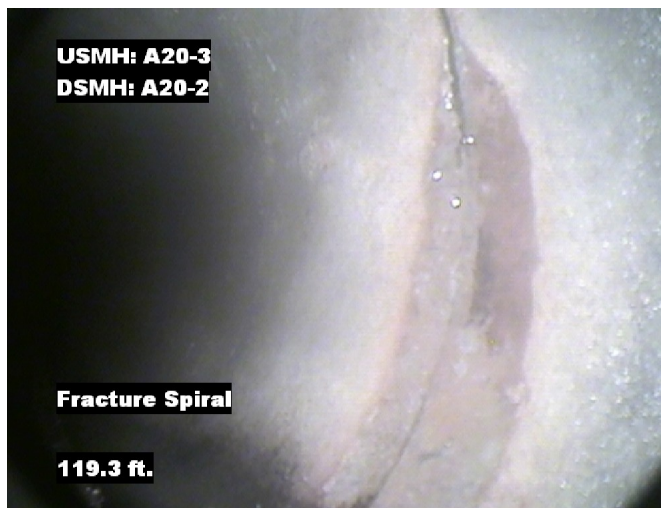
Distance: 119.3 ft. Grade: 3
Condition: Fracture Spiral
Remarks: N/A

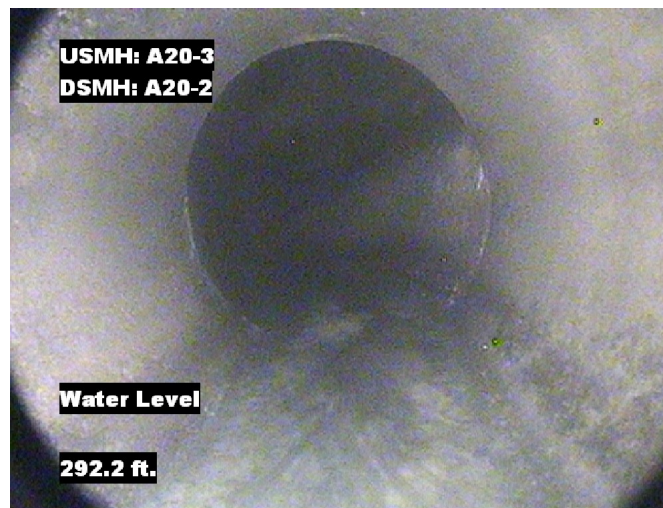
Distance: 292.2 ft. Grade: 0
Condition: Water Level
Remarks: N/A

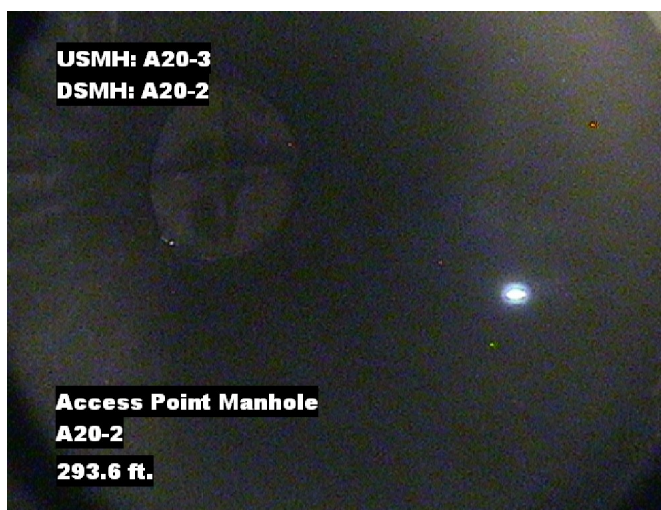
Distance: 293.6 ft. Grade: 0
Condition: Access Point Manhole
Remarks: A20-2
