Defect Listing

Pipe Segment Refere... A20-4_A20-3	City Oliver Springs	Street Main St	Material Concrete Pipe (non-...	Location C... Light High...	Sewer Use Sanitary
Upstream MH A20-4	Total Length 324.6	Year Laid	Shape Circular	Location Details	
DS Manhole A20-3	Length surveyed 324.6	Year Renewed	Height 8	Width 8	Pipe Joint... 4

Image Report 4/Page

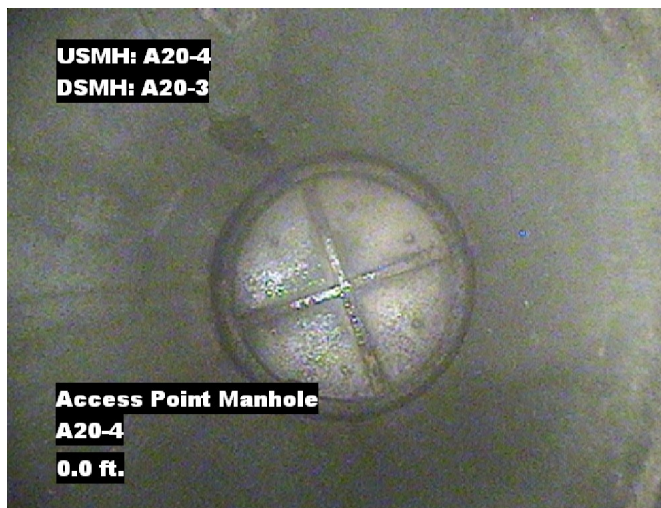
Distance: 0.0 ft. Grade: 0
Condition: Access Point Manhole
Remarks: A20-4

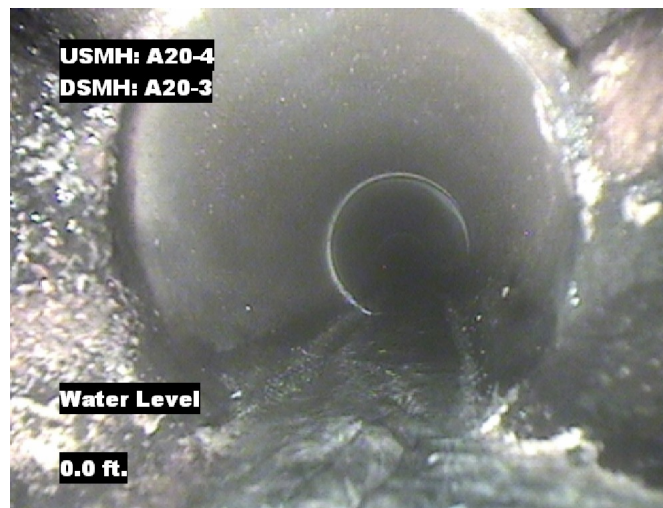
Distance: 0.0 ft. Grade: 0
Condition: Water Level
Remarks: N/A

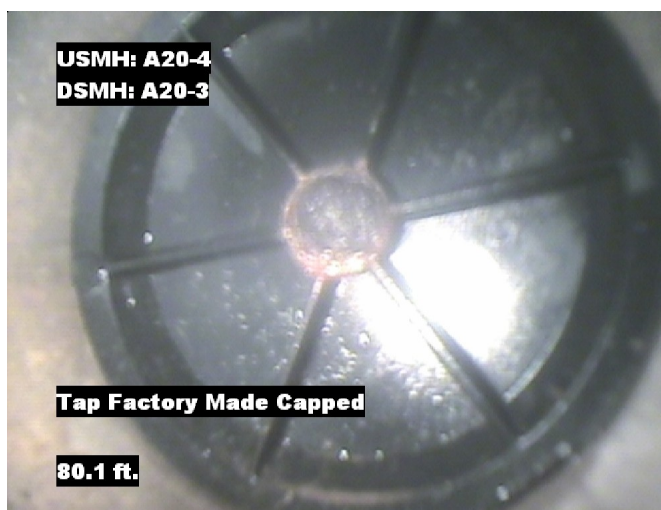
Distance: 80.1 ft. Grade: 0
Condition: Tap Factory Made Capped
Remarks: N/A

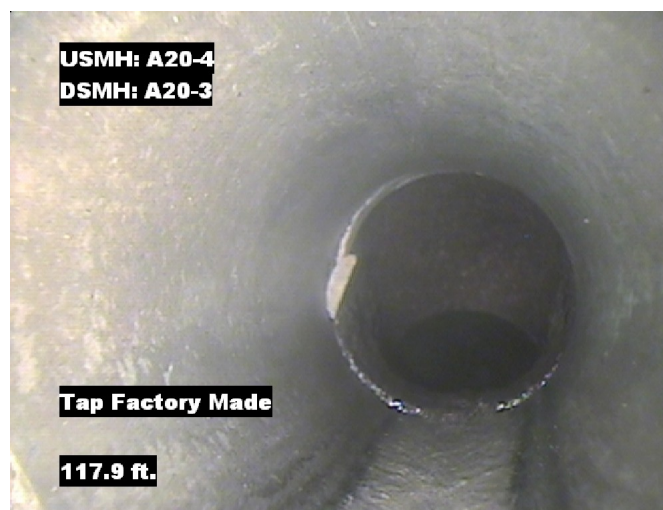
Distance: 117.9 ft. Grade: 0
Condition: Tap Factory Made
Remarks: N/A

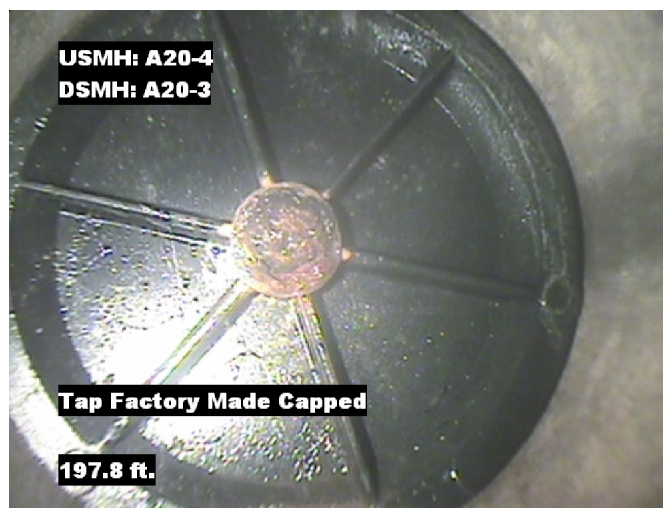
Distance: 197.8 ft. Grade: 0
Condition: Tap Factory Made Capped
Remarks: N/A

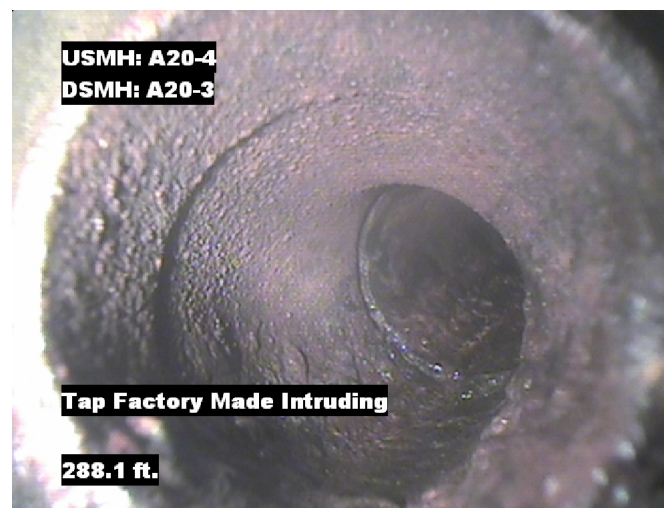
Distance: 288.1 ft. Grade: 2
Condition: Tap Factory Made Intruding
Remarks: N/A

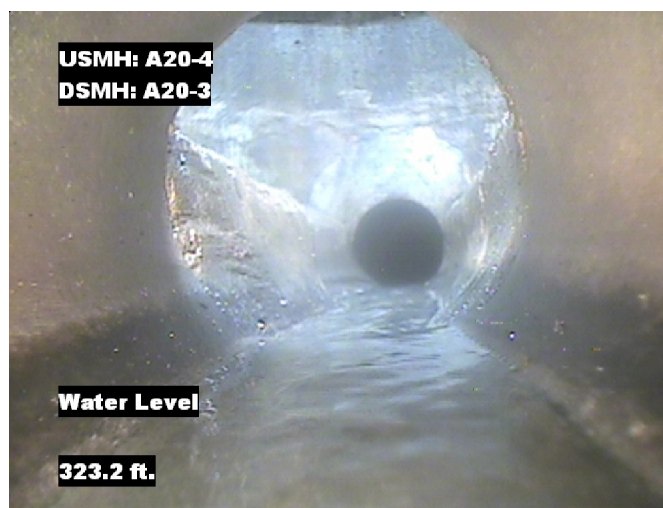
Distance: 323.2 ft. Grade: 0
Condition: Water Level
Remarks: N/A

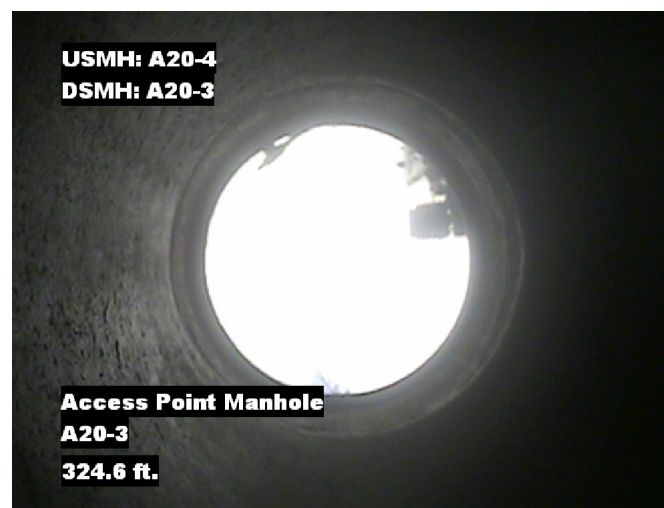
Distance: 324.6 ft. Grade: 0
Condition: Access Point Manhole
Remarks: A20-3
