## Defect Listing

Pipe Segment Refere... <b>A20-6_A20-5</b>	City <b>Oliver Springs</b>	Street <b>Hwy62 Exit Ramp</b>	Material <b>PolyVinyl Chloride</b>	Location C... <b>Main Highw...</b>	Sewer Use <b>Sanitary</b>
Upstream MH <b>A20-6</b>	Total Length <b>270.2</b>	Year Laid	Shape <b>Circular</b>	Location Details	
DS Manhole <b>A20-5</b>	Length surveyed <b>270.2</b>	Year Renewed	Height <b>8</b>	Width <b>8</b>	Pipe Joint... <b>13</b>

SPR <b>N/A</b>	MPR <b>2</b>	PO Number <b>4397-03</b>	Customer <b>GRW</b>
SPRI <b>N/A</b>	MPRI <b>2</b>	Work Order <b>4397-02</b>	Purpose <b>Pre-Rehabilitation Survey</b>
QSR <b>N/A</b>	QMR <b>2100</b>		
OPR <b>2</b>	Surveyed By <b>Barry Rogers</b>	Direction <b>Downstream</b>	Date <b>20150806</b>
OPRI <b>2</b>	Certificate Number <b>U-1012-16405</b>	Pre-Cleaning <b>Jetting</b>	Time <b>14:49</b>
	Date Cleaned <b>20150806</b>	End Time <b>15:06</b>	Weather <b>Heavy Rain</b>
			Media label
			Additional Info

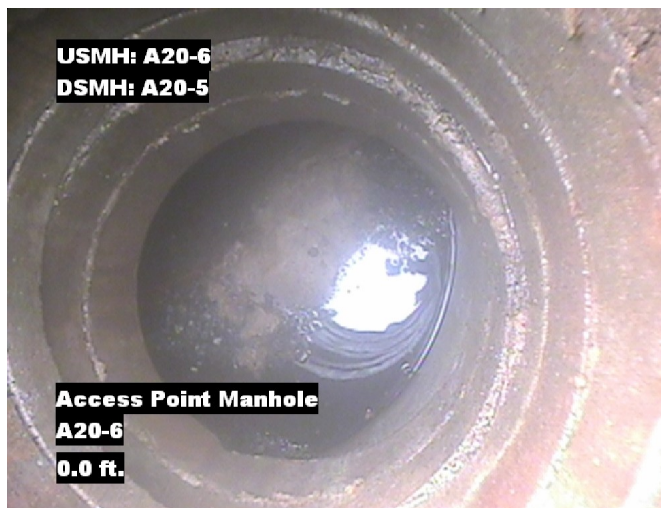
Distance: 0.0 ft. Grade: 0  
Condition: Access Point Manhole  
Remarks: A20-6

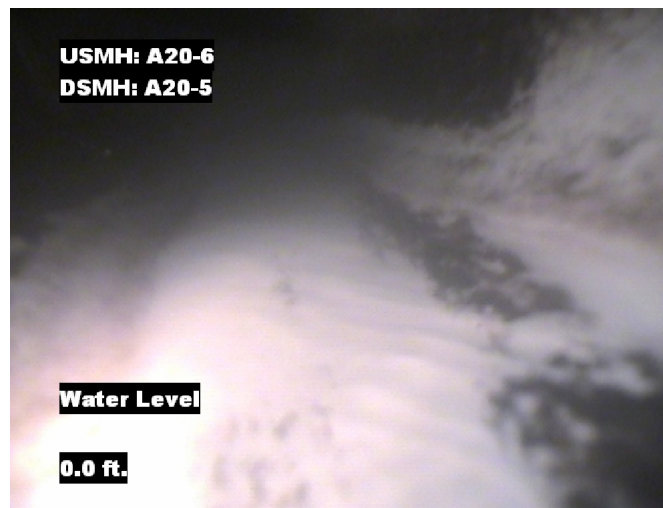
Distance: 0.0 ft. Grade: 0  
Condition: Water Level  
Remarks: N/A

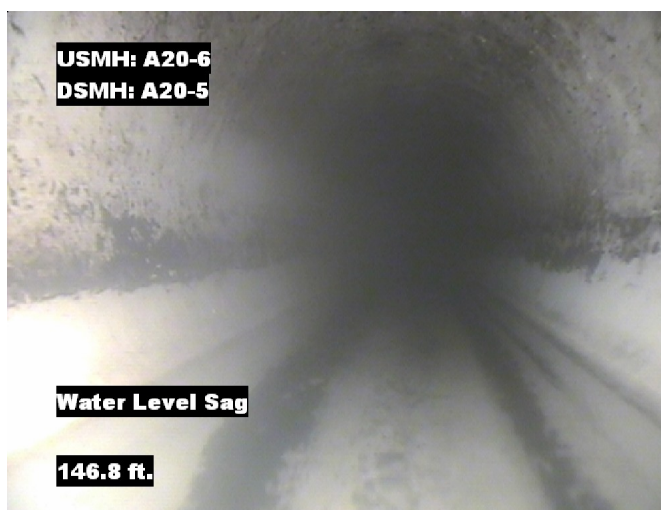
Distance: 146.8 ft. Grade: 2  
Condition: Water Level Sag  
Remarks: N/A

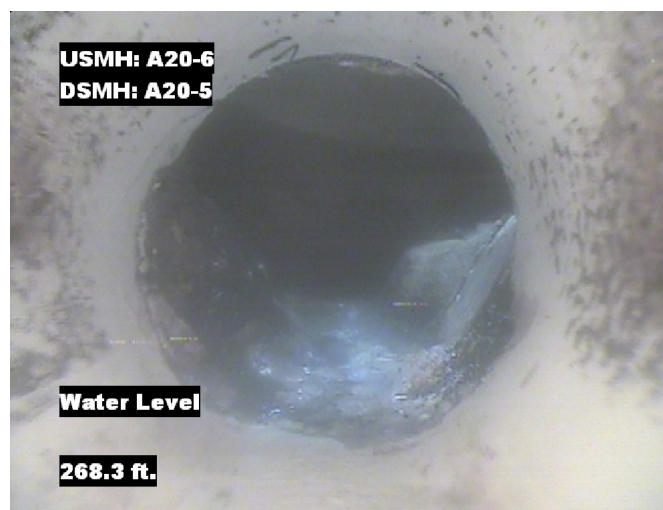
Distance: 268.2 ft. Grade: 0  
Condition: Water Level  
Remarks: N/A

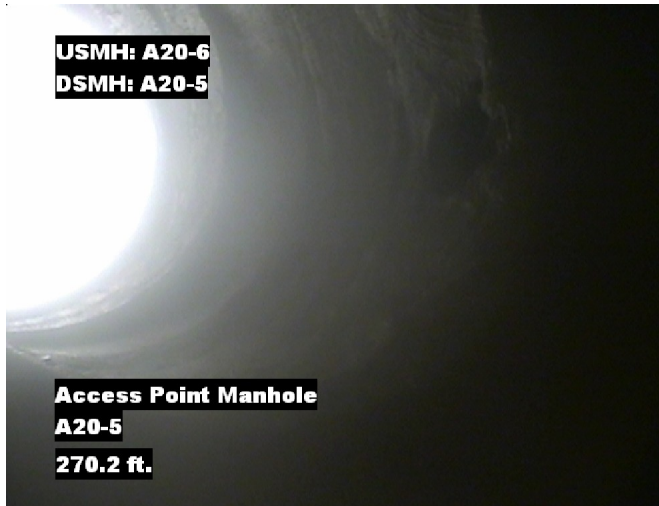
Distance: 270.2 ft.      Grade: 0  
Condition: Access Point Manhole  
Remarks: A20-5
