Defect Listing

Pipe Segment Refere		City		Street	Mat	Material		Sewer Use	
A20-7_A20-6		Oliver Springs		Hwy 62 Exit Ramp	PolyVinyl Chloride		Main Highw	Sanitary	
Upstream MH A20-7 DS Manhole		Total Length 270.8 Length surveyed		Year Laid	Shape Circular		Location Details		
				Year Renewed	Height Width		Pipe Joint		
A2	0-6	27	0.8		8	8	8 13		
SPR	N/A	MPR	N/A	PO Number 4397-03			Customer		
-						GRW			
SPRI	N/A	MPRI	N/A	Work Order			Purpose		
QSR	N/A	QMR	N/A	4397-02		Pre-Rehabilitation Survey			
OF	PR	Surveyed By		Direction	Date		Media label		
N/	/A	Barry_Rogers		Downstream	20150806				
OF	OPRI		e Number	Pre-Cleaning	Time		Weather		
N/A		U-1012-16405		Jetting	13:34		Heavy Rain		
		Date C	leaned		End Time Ad		Addition	nal Info	
		2015	0806	13	:41

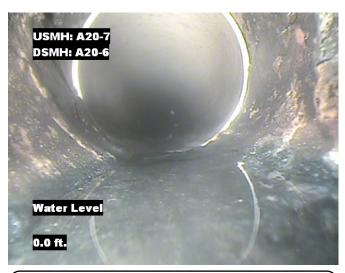
Distance: 0.0 ft. Grade: 0

Condition: Water Level

Remarks: N/A

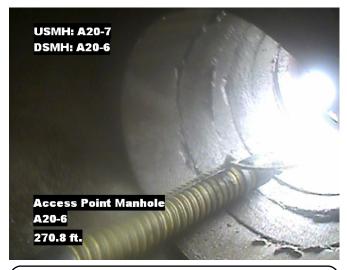
Distance: 270.8 ft. Grade: 0

Condition: Access Point Manhole

Remarks: A20-6
