Defect Listing

Pipe Segment Refere... A20-8_A20-7	City Oliver Springs	Street Hwy62	Material Concrete Pipe (non-...	Location C... Main Highw...	Sewer Use Sanitary
Upstream MH A20-8	Total Length 212.2	Year Laid	Shape Circular	Location Details	
DS Manhole A20-7	Length surveyed 212.2	Year Renewed	Height 8	Width 8	Pipe Joint... 4

Image Report 4/Page

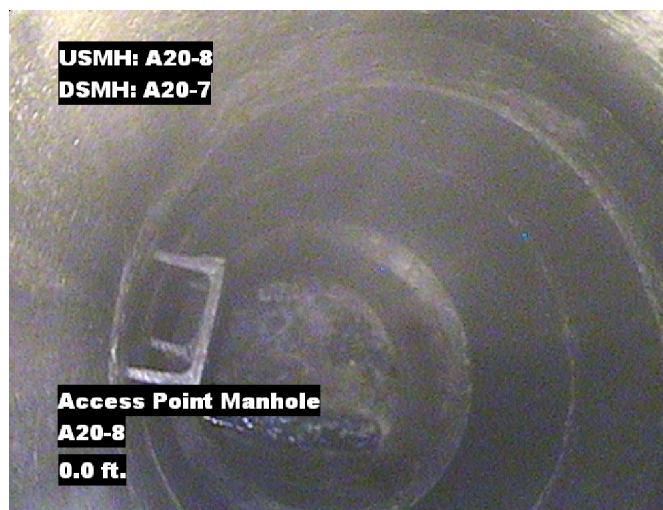
Distance: 0.0 ft. Grade: 0
Condition: Access Point Manhole
Remarks: A20-8

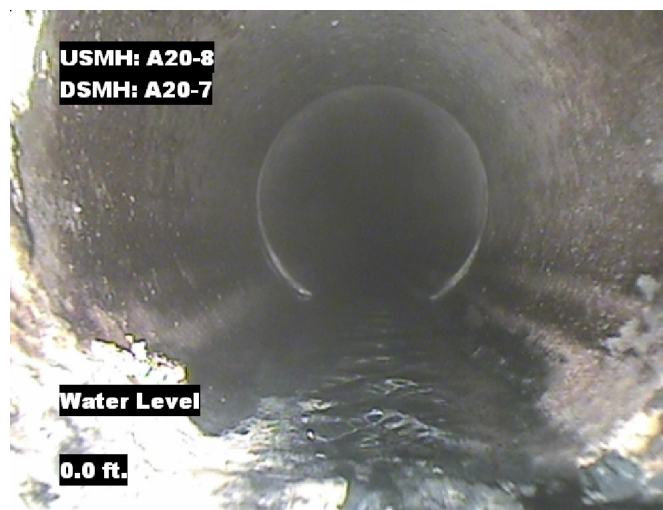
Distance: 0.0 ft. Grade: 0
Condition: Water Level
Remarks: N/A

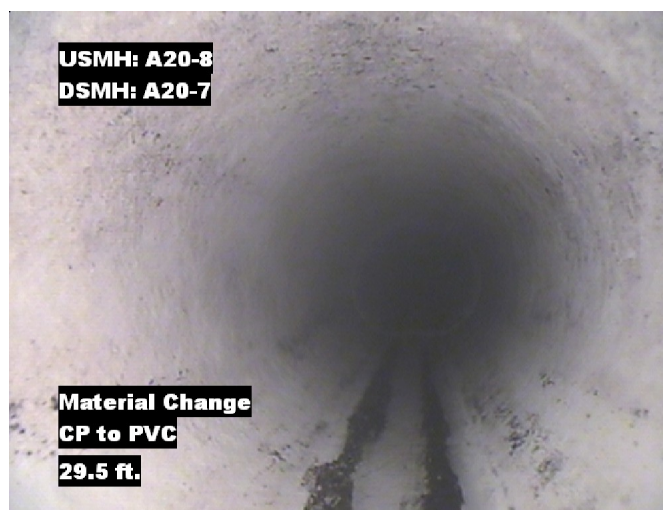
Distance: 29.5 ft. Grade: 0
Condition: Material Change
Remarks: CP to PVC

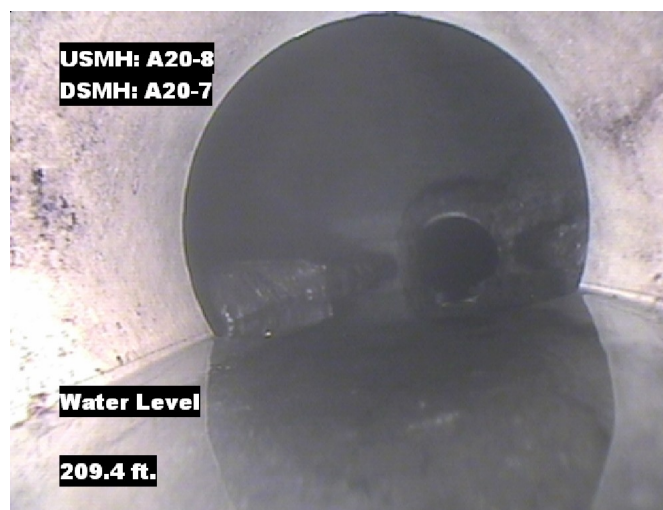
Distance: 209.3 ft. Grade: 0
Condition: Water Level
Remarks: N/A

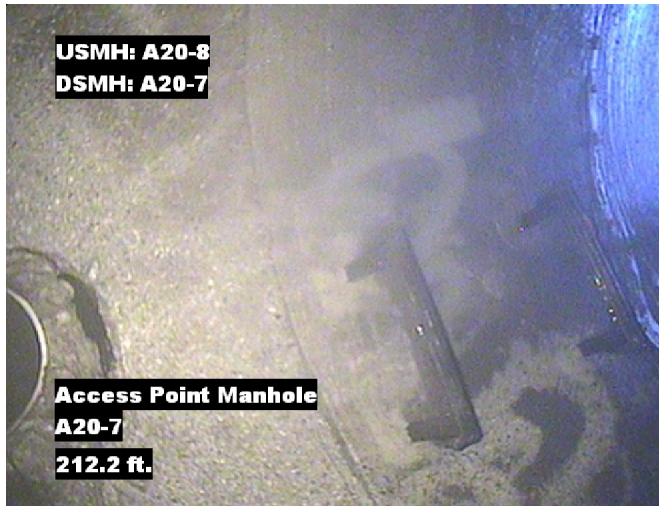
Distance: 212.2 ft. Grade: 0
Condition: Access Point Manhole
Remarks: A20-7
