Defect Listing

Pipe Segment Refere		City		Street	Mat	erial	Location C	Sewer Use	
A20-9_	A20-8	Oliver S	Springs	Hwy 62	Concrete F	Concrete Pipe (non		Sanitary	
Upstream MH Total Length		_ength	Year Laid	Sh	ape	Location Details			
A20-9		288.7			Circ	cular			
DS Ma	nhole	Length s	surveyed	Year Renewed	Year Renewed Height Width Pipe Joint		Pipe Joint		
A20	0-8	288.7			8	8	4		
SPR	N/A	MPR	N/A	PO Number		Customer GRW			
SPRI	N/A	MPRI	N/A	4397-03					
OI 101	19/7	IVII IXI	11//	Work Order					
QSR	N/A	QMR	N/A	4397-02		Pre-	re-Rehabilitation Survey		
OF	PR	Survey	yed By	Direction	Di	Date		label	
N/	Ά	Barry_Rogers		Downstream	2015	20150805			
OP	OPRI		e Number	Pre-Cleaning	Time		Weather		
N/A U-1012-16405		Jetting	04	04:52					
	Date Cleaned					End Time		nal Info	
		2015	0805	05	05:09

Image Report 4/Page

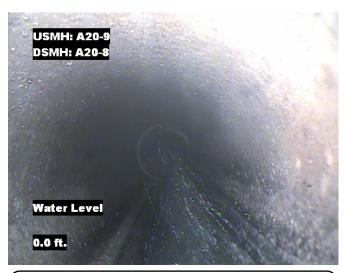
Distance: 0.0 ft. Grade: 0

Condition: Access Point Manhole

Remarks: A20-9

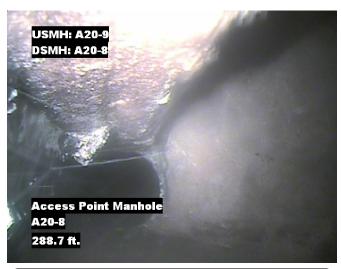
Distance: 288.7 ft. Grade: 0

Condition: Access Point Manhole

Remarks: A20-8
