Defect Listing

Pipe Segment Refere... A21-1_A20-9	City Oliver Springs	Street Strutt St	Material Concrete Pipe (non-...	Location C... Light High...	Sewer Use Sanitary
Upstream MH A21-1	Total Length 136.4	Year Laid	Shape Circular	Location Details	
DS Manhole A20-9	Length surveyed 136.4	Year Renewed	Height 8	Width 8	Pipe Joint... 4

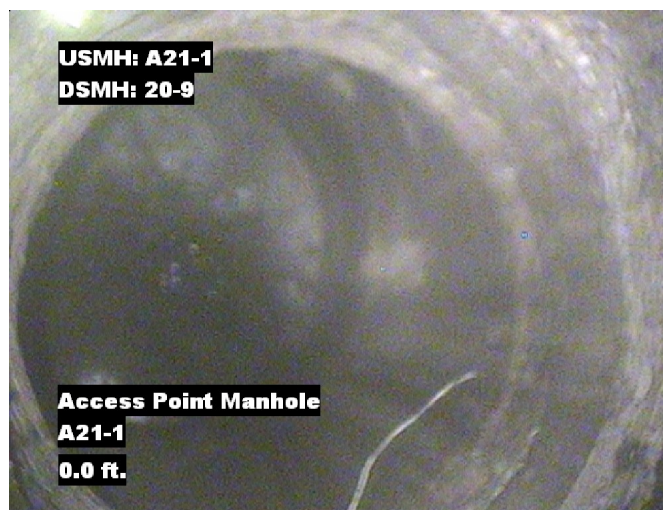
Distance: 0.0 ft. Grade: 0
Condition: Access Point Manhole
Remarks: A21-1

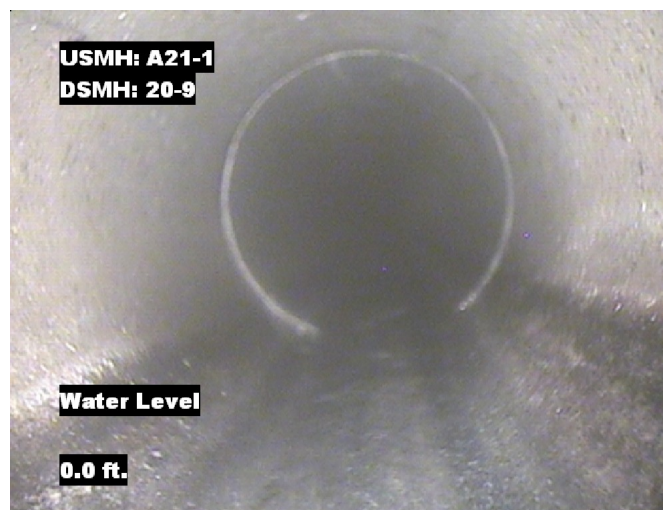
Distance: 0.0 ft. Grade: 0
Condition: Water Level
Remarks: N/A

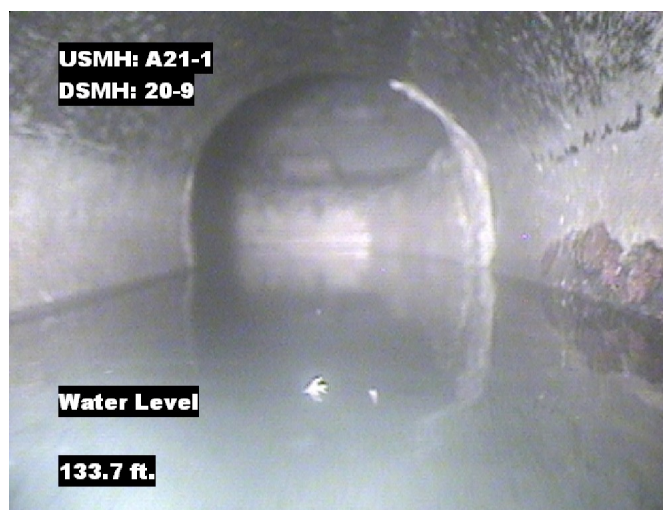
Distance: 133.6 ft. Grade: 0
Condition: Water Level
Remarks: N/A

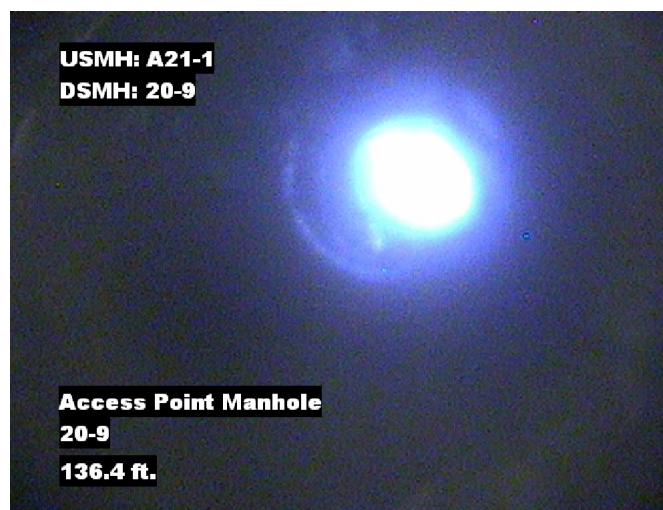
Distance: 136.4 ft. Grade: 0
Condition: Access Point Manhole
Remarks: 20-9
