Defect Listing

Pipe Segment Refere... A21-2_A21-1	City Oliver Springs	Street Strutt	Material Concrete Pipe (non-...	Location C... Light High...	Sewer Use Sanitary
Upstream MH A21-2	Total Length 332.9	Year Laid	Shape Circular	Location Details	
DS Manhole A21-1	Length surveyed 332.9	Year Renewed	Height 8	Width 8	Pipe Joint... 4

SPR 3	MPR N/A	PO Number 4397-03	Customer GRW
SPRI 3	MPRI N/A	Work Order 4397-02	Purpose Pre-Rehabilitation Survey
QSR 3100	QMR N/A		
OPR 3	Surveyed By Barry Rogers	Direction Downstream	Date 20150805
OPRI 3	Certificate Number U-1012-16405	Pre-Cleaning Jetting	Time 08:13
	Date Cleaned 20150805	End Time 08:27	Weather Very Dry
			Media label
			Additional Info

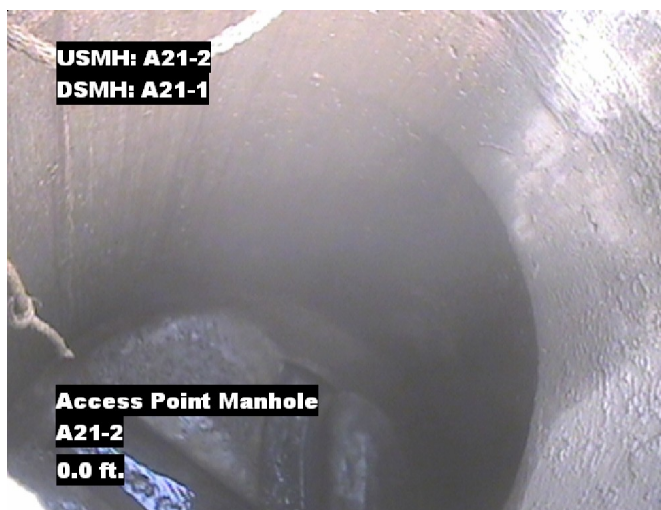
Distance: 0.0 ft. Grade: 0
Condition: Access Point Manhole
Remarks: A21-2

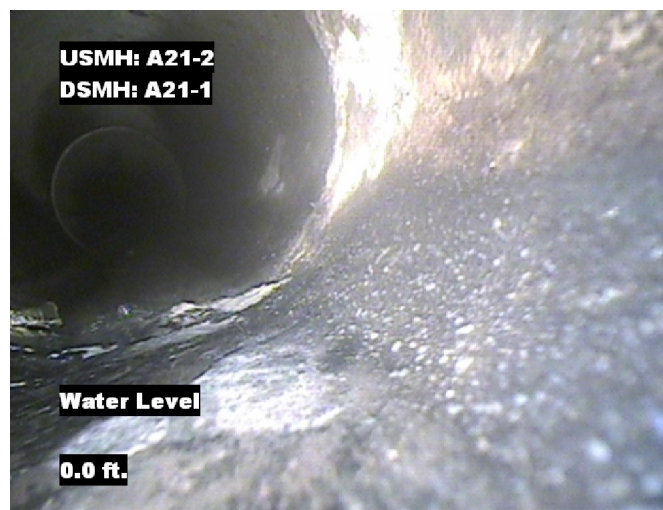
Distance: 0.0 ft. Grade: 0
Condition: Water Level
Remarks: N/A

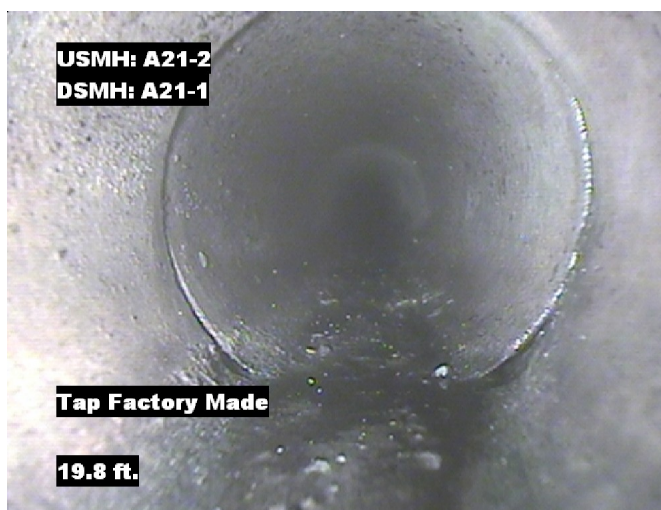
Distance: 19.8 ft. Grade: 0
Condition: Tap Factory Made
Remarks: N/A

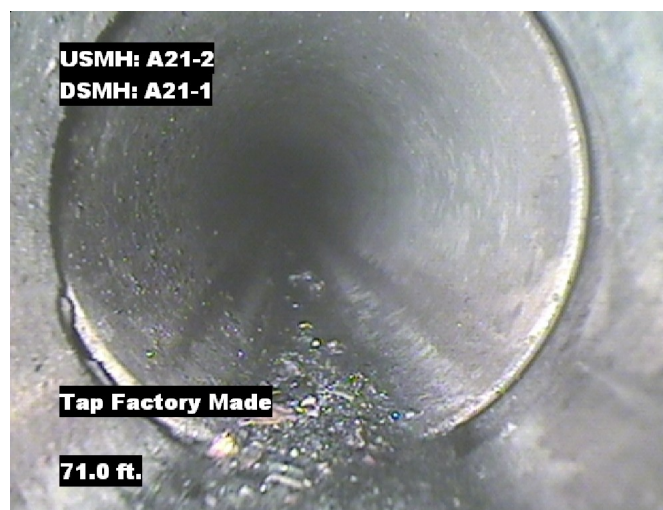
Distance: 71.0 ft. Grade: 0
Condition: Tap Factory Made
Remarks: N/A

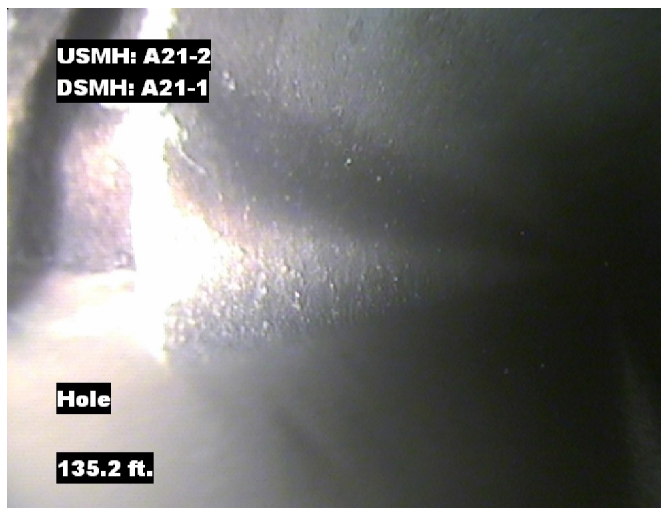
Distance: 135.2 ft. Grade: 3
Condition: Hole
Remarks: N/A

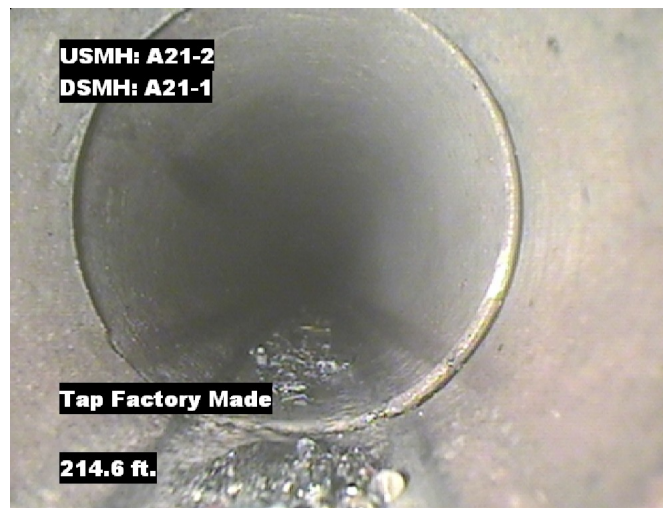
Distance: 214.6 ft. Grade: 0
Condition: Tap Factory Made
Remarks: N/A

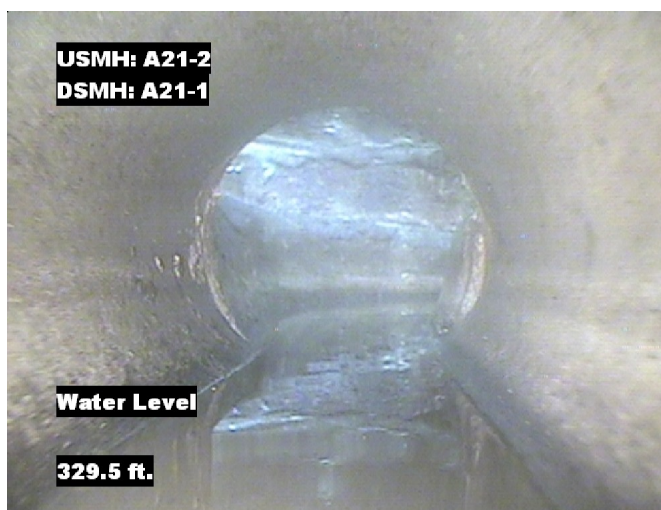
Distance: 329.5 ft. Grade: 0
Condition: Water Level
Remarks: N/A

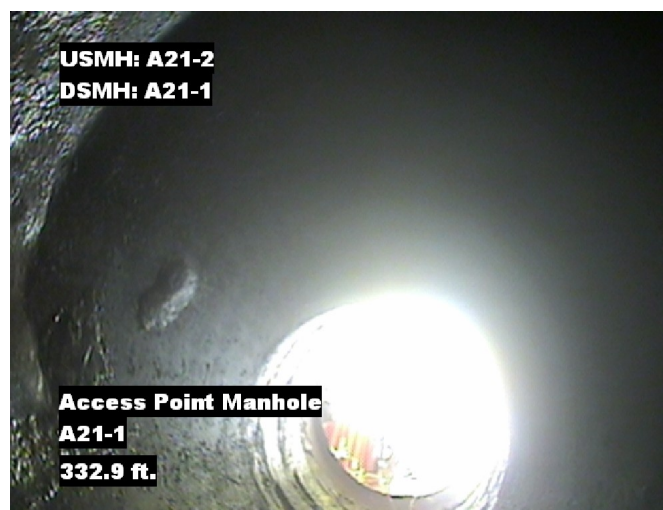
Distance: 332.9 ft. Grade: 0
Condition: Access Point Manhole
Remarks: A21-1
