Defect Listing

Pipe Segment Refere... A21-3_A21-2	City Oliver Springs	Street Strutt	Material Concrete Pipe (non-...	Location C... Light High...	Sewer Use Sanitary
Upstream MH A21-3	Total Length 218.6	Year Laid	Shape Circular	Location Details	
DS Manhole A21-2	Length surveyed 218.6	Year Renewed	Height 8	Width 8	Pipe Joint... 4

SPR N/A	MPR N/A	PO Number 4397-03	Customer GRW
SPRI N/A	MPRI N/A	Work Order 4397-02	Purpose Pre-Rehabilitation Survey
QSR N/A	QMR N/A		
OPR N/A	Surveyed By Barry Rogers	Direction Downstream	Date 20150804
OPRI N/A	Certificate Number U-1012-16405	Pre-Cleaning Jetting	Time 09:17
	Date Cleaned 20150804	End Time 09:26	Weather Dry
			Additional Info

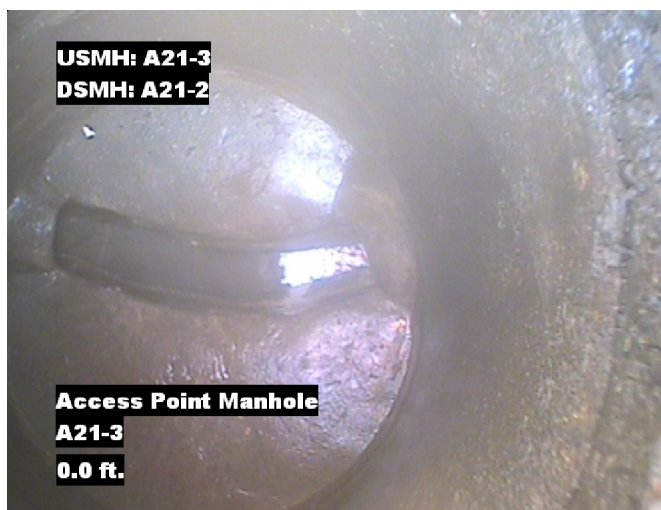
Distance: 0.0 ft. Grade: 0
Condition: Access Point Manhole
Remarks: A21-3

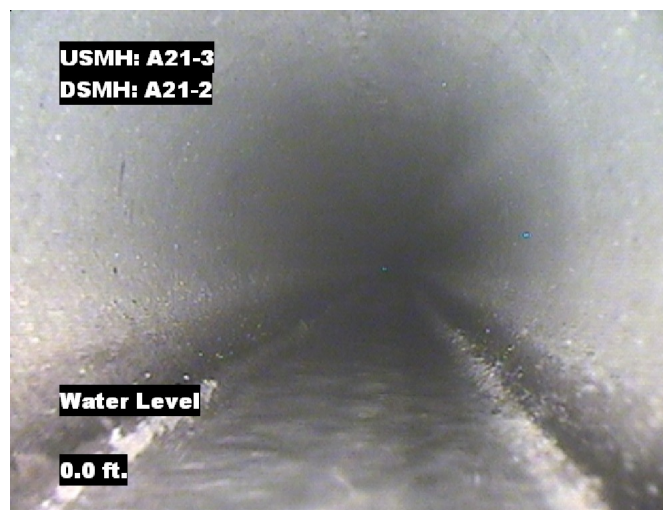
Distance: 0.0 ft. Grade: 0
Condition: Water Level
Remarks: N/A

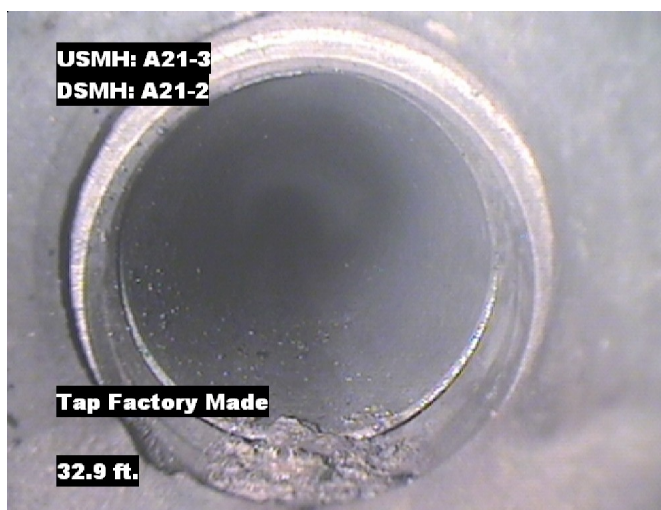
Distance: 32.9 ft. Grade: 0
Condition: Tap Factory Made
Remarks: N/A

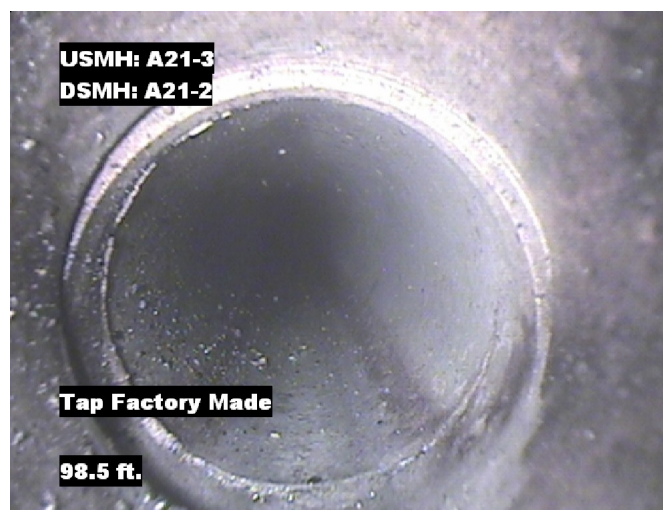
Distance: 98.5 ft. Grade: 0
Condition: Tap Factory Made
Remarks: N/A

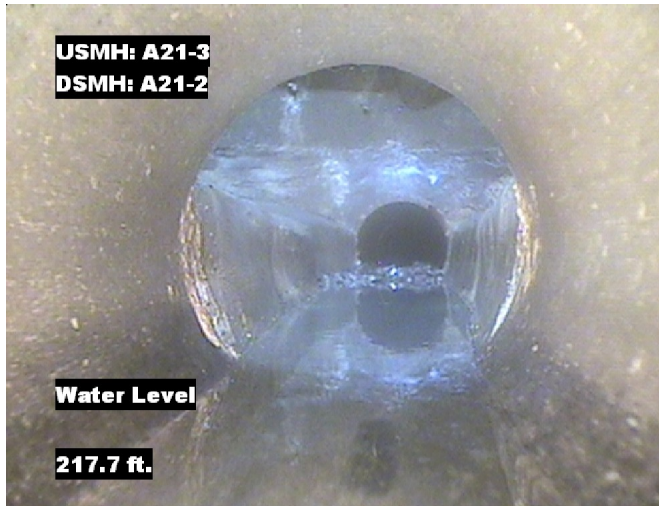
Distance: 217.7 ft. Grade: 0
Condition: Water Level
Remarks: N/A

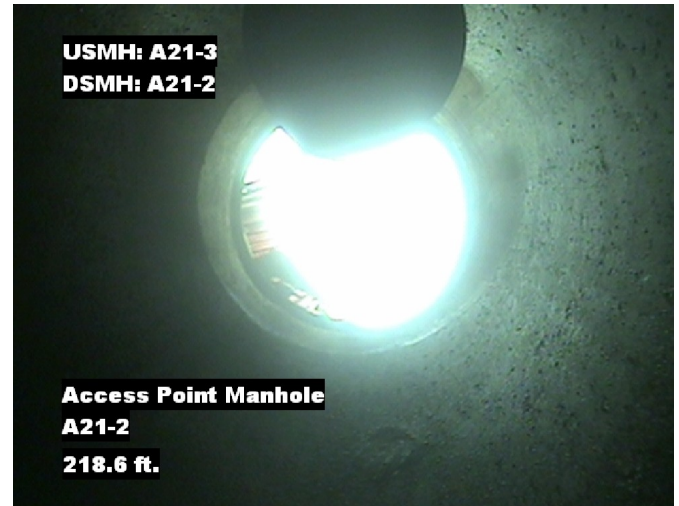
Distance: 218.6 ft. Grade: 0
Condition: Access Point Manhole
Remarks: A21-2
