Defect Listing

Pipe Segment Refere... A21-4_A21-3	City Oliver Springs	Street Strutt St	Material Concrete Pipe (non-...	Location C... Light High...	Sewer Use Sanitary
Upstream MH A21-4	Total Length 209.2	Year Laid	Shape Circular	Location Details	
DS Manhole A21-3	Length surveyed 209.2	Year Renewed	Height 8	Width 8	Pipe Joint... 4

SPR 11	MPR 2	PO Number 4397-03	Customer GRW
SPRI 2.8	MPRI 2	Work Order 4397-02	Purpose Pre-Rehabilitation Survey
QSR 5131	QMR 2100		
OPR 13	Surveyed By Barry Rogers	Direction Downstream	Date 20150804
OPRI 2.6	Certificate Number U-1012-16405	Pre-Cleaning Jetting	Time 07:51
	Date Cleaned 20150804	End Time 08:10	Weather Dry
			Media label
			Additional Info

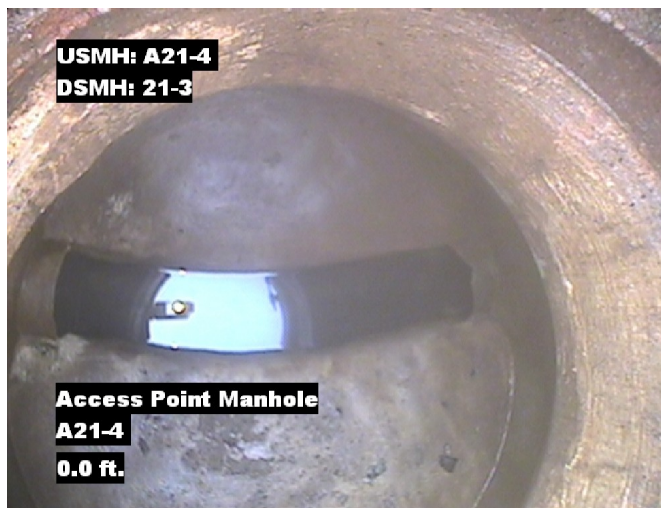
Distance: 0.0 ft. Grade: 0
Condition: Access Point Manhole
Remarks: A21-4

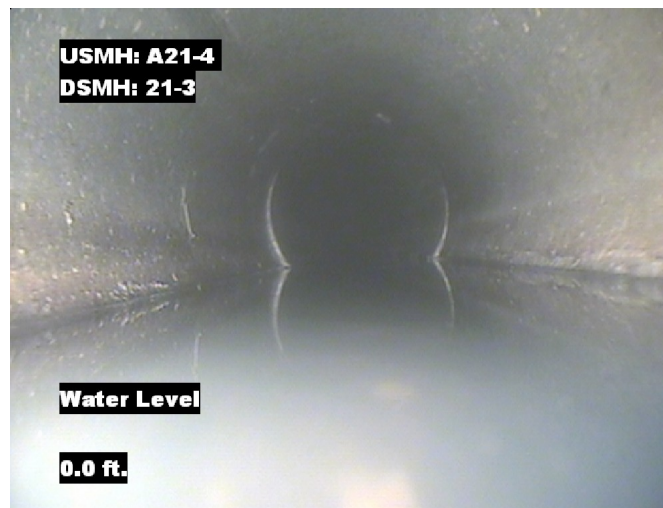
Distance: 0.0 ft. Grade: 0
Condition: Water Level
Remarks: N/A

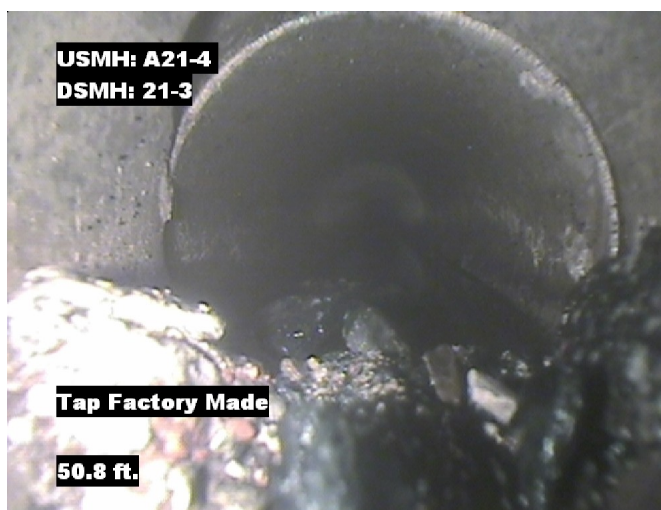
Distance: 50.8 ft. Grade: 0
Condition: Tap Factory Made
Remarks: N/A

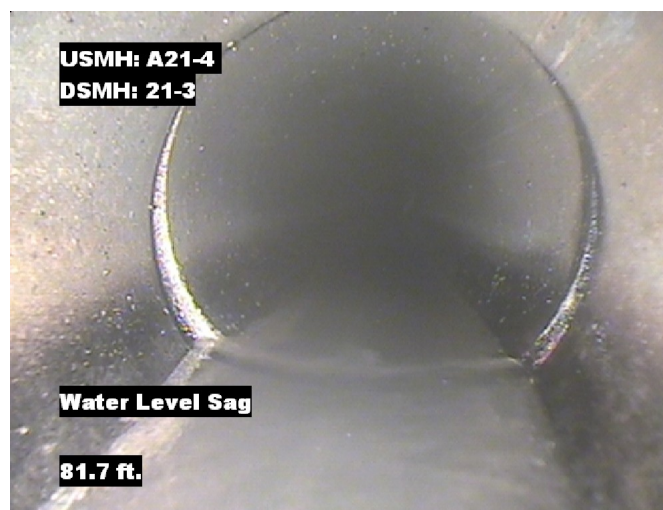
Distance: 81.7 ft. Grade: 2
Condition: Water Level Sag
Remarks: N/A

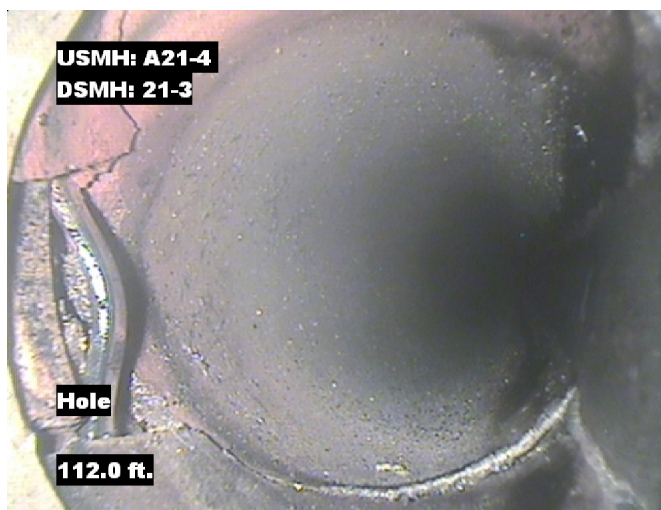
Distance: 112.0 ft. Grade: 3
Condition: Hole
Remarks: N/A

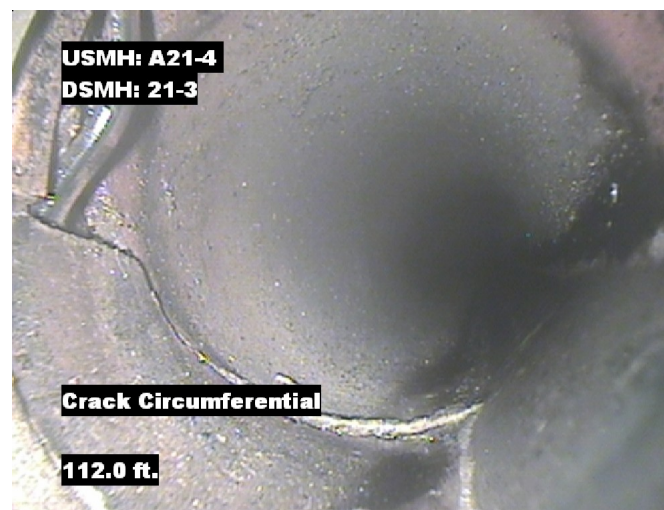
Distance: 112.0 ft. Grade: 1
Condition: Crack Circumferential
Remarks: N/A

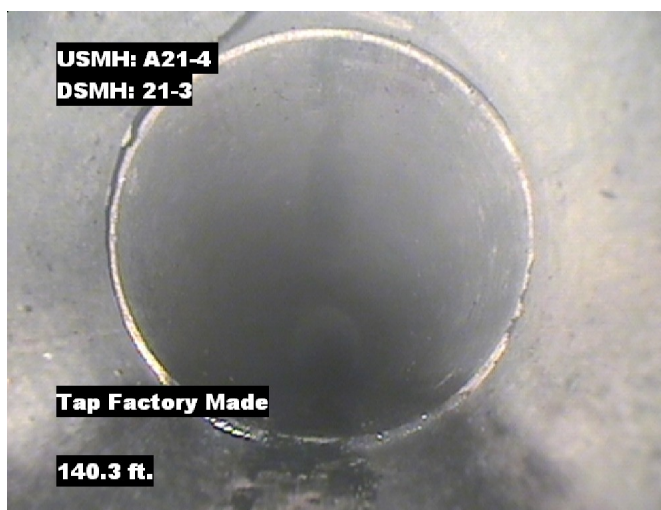
Distance: 140.3 ft. Grade: 0
Condition: Tap Factory Made
Remarks: N/A

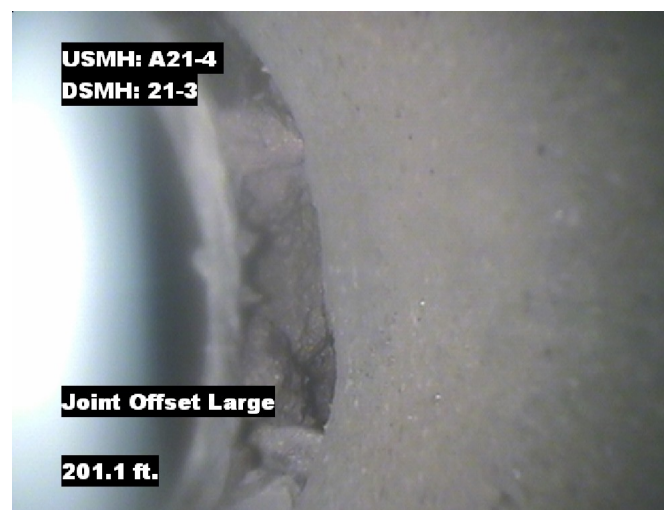
Distance: 201.1 ft. Grade: 2
Condition: Joint Offset Large
Remarks: N/A

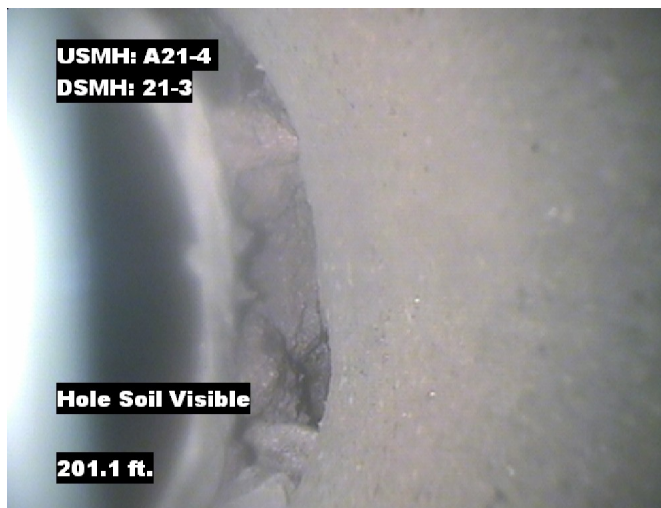
Distance: 201.1 ft. Grade: 5
Condition: Hole Soil Visible
Remarks: N/A

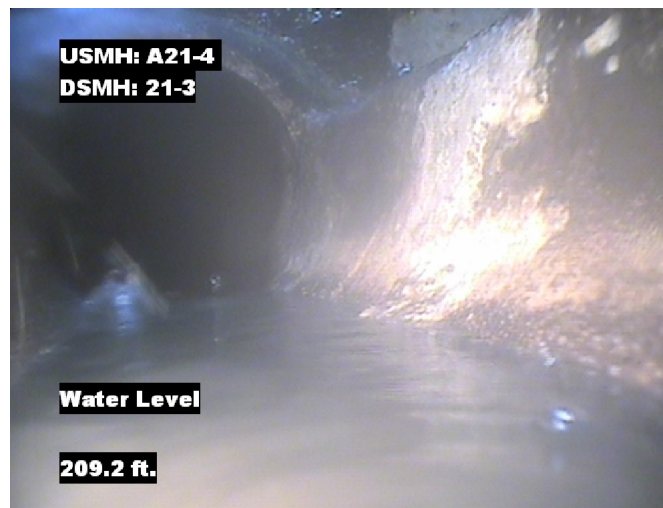
Distance: 209.2 ft. Grade: 0
Condition: Water Level
Remarks: N/A

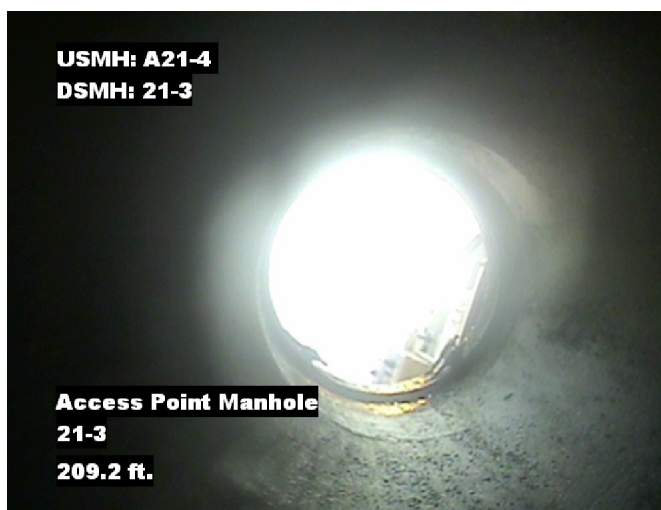
Distance: 209.2 ft. Grade: 0
Condition: Access Point Manhole
Remarks: 21-3
