Defect Listing

Pipe Segment Refere... A21-5_A21-4	City Oliver Springs	Street Strutt St	Material Concrete Pipe (non-...	Location C... Light High...	Sewer Use Sanitary
Upstream MH A21-5	Total Length 2	Year Laid	Shape Circular	Location Details	
DS Manhole A21-4	Length surveyed 2	Year Renewed	Height 8	Width 8	Pipe Joint... 4

Image Report 4/Page

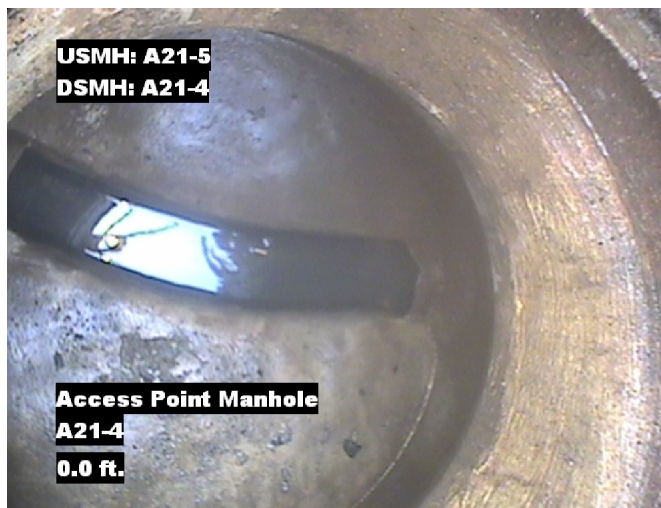
Distance: 0.0 ft. Grade: 0
Condition: Access Point Manhole
Remarks: A21-4

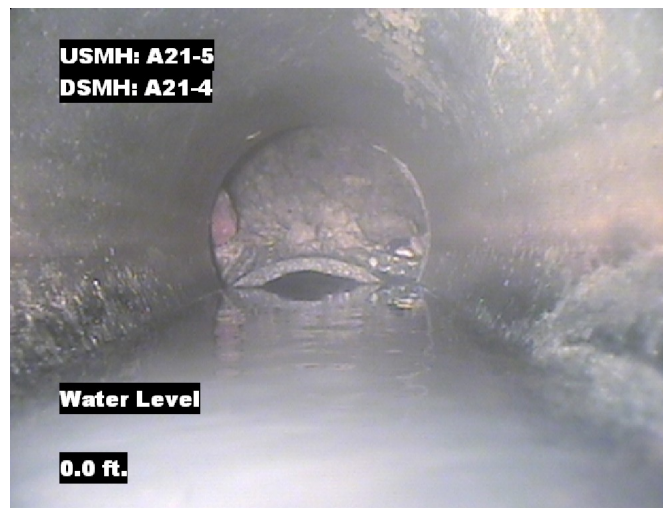
Distance: 0.0 ft. Grade: 0
Condition: Water Level
Remarks: N/A

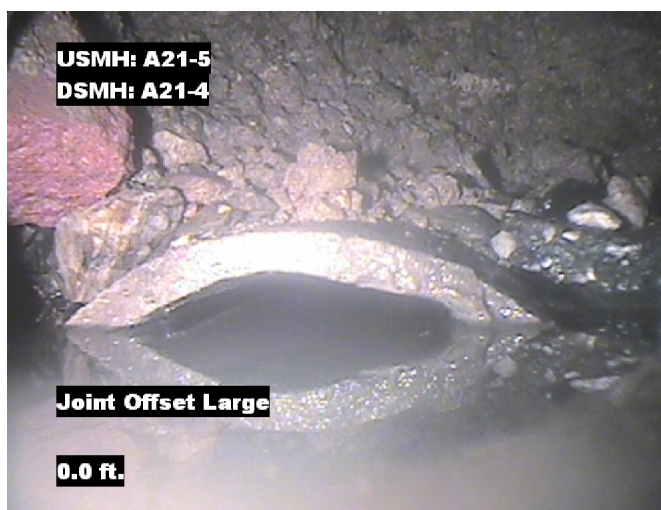
Distance: 0.0 ft. Grade: 2
Condition: Joint Offset Large
Remarks: N/A

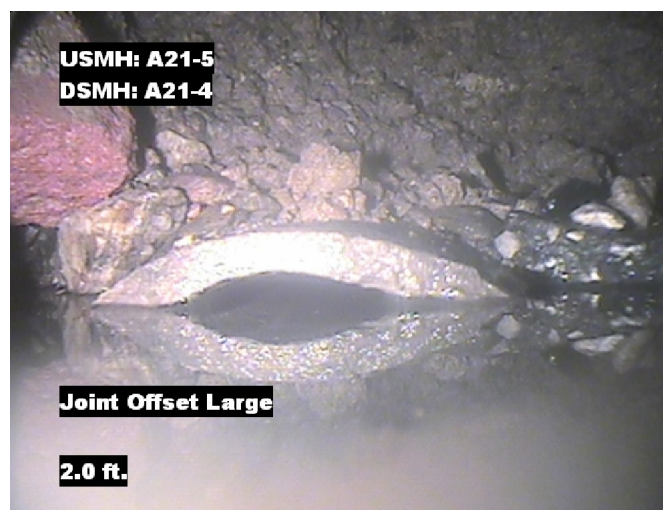
Distance: 2.0 ft. Grade: 2
Condition: Joint Offset Large
Remarks: N/A

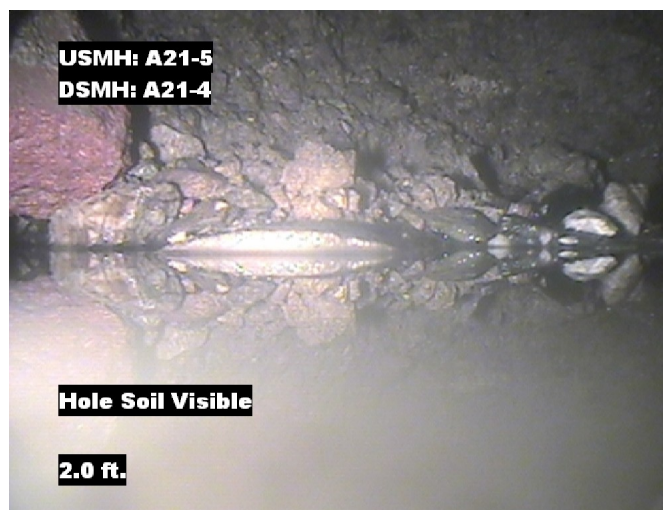
Distance: 2.0 ft. Grade: 5
Condition: Hole Soil Visible
Remarks: N/A

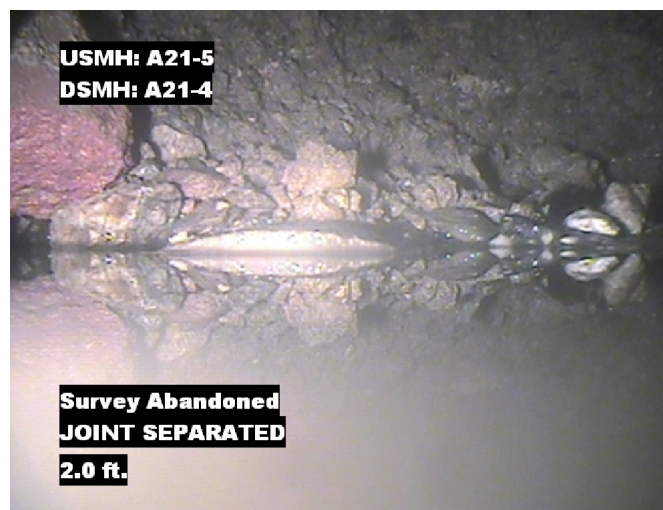
Distance: 2.0 ft. Grade: 0
Condition: Survey Abandoned
Remarks: JOINT SEPARATED
