## Defect Listing

Pipe Segment Refere... <b>A22-1_A21-2</b>	City <b>Oliver Springs</b>	Street <b>Fritts</b>	Material <b>Concrete Pipe (non-...</b>	Location C... <b>Light High...</b>	Sewer Use <b>Sanitary</b>
Upstream MH <b>A22-1</b>	Total Length <b>280</b>	Year Laid	Shape <b>Circular</b>	Location Details	
DS Manhole <b>A21-2</b>	Length surveyed <b>280</b>	Year Renewed	Height <b>8</b>	Width <b>8</b>	Pipe Joint... <b>4</b>

SPR <b>3</b>	MPR <b>N/A</b>	PO Number <b>4397-03</b>	Customer <b>GRW</b>
SPRI <b>3</b>	MPRI <b>N/A</b>	Work Order <b>4397-02</b>	Purpose <b>Pre-Rehabilitation Survey</b>
QSR <b>3100</b>	QMR <b>N/A</b>		
OPR <b>3</b>	Surveyed By <b>Barry Rogers</b>	Direction <b>Upstream</b>	Date <b>20150805</b>
OPRI <b>3</b>	Certificate Number <b>U-1012-16405</b>	Pre-Cleaning <b>Jetting</b>	Time <b>07:31</b>
	Date Cleaned <b>20150805</b>	End Time <b>07:52</b>	Weather <b>Very Dry</b>
			Media label
			Additional Info

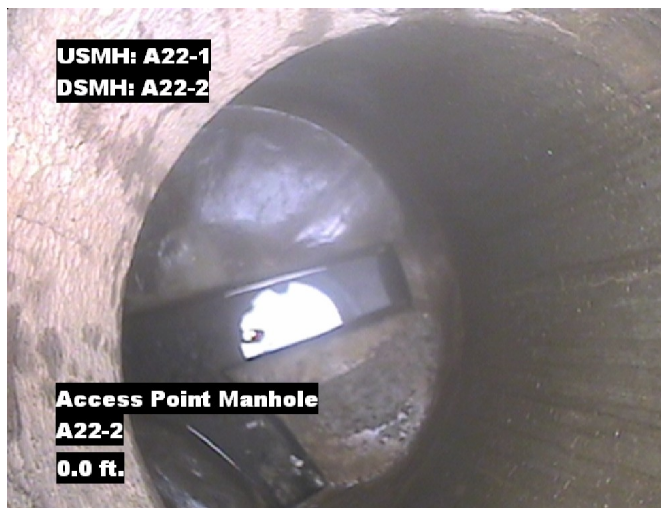
Distance: 0.0 ft. Grade: 0  
Condition: Access Point Manhole  
Remarks: A22-2

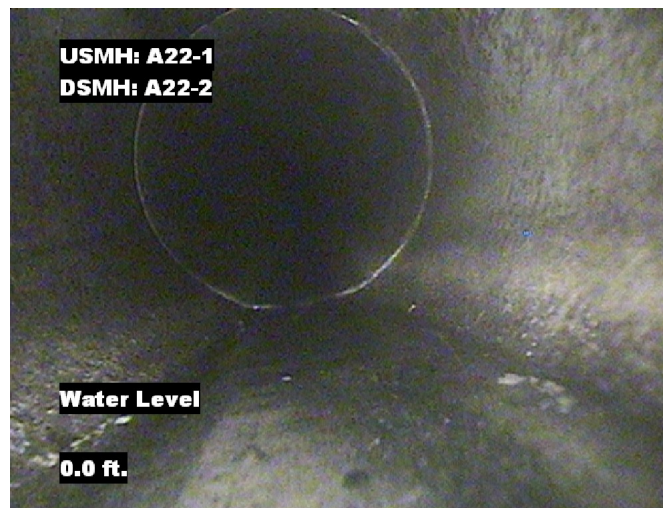
Distance: 0.0 ft. Grade: 0  
Condition: Water Level  
Remarks: N/A

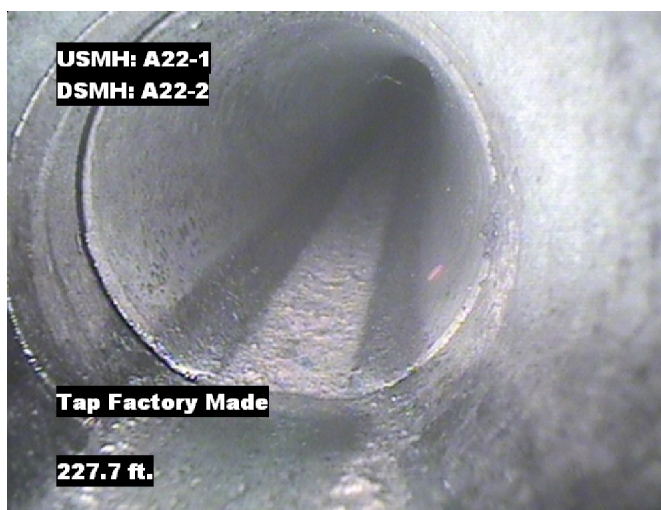
Distance: 227.7 ft. Grade: 0  
Condition: Tap Factory Made  
Remarks: N/A

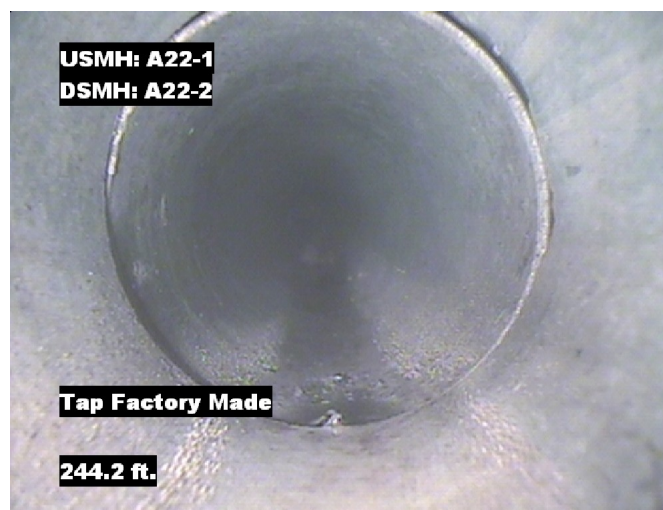
Distance: 244.2 ft. Grade: 0  
Condition: Tap Factory Made  
Remarks: N/A

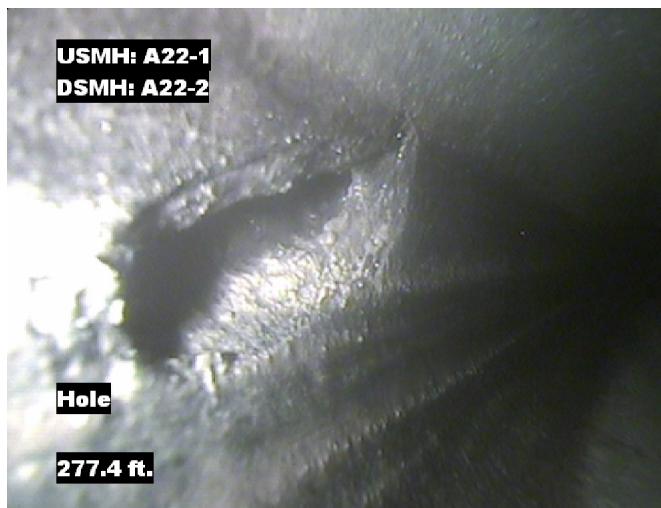
Distance: 277.4 ft. Grade: 3  
Condition: Hole  
Remarks: N/A

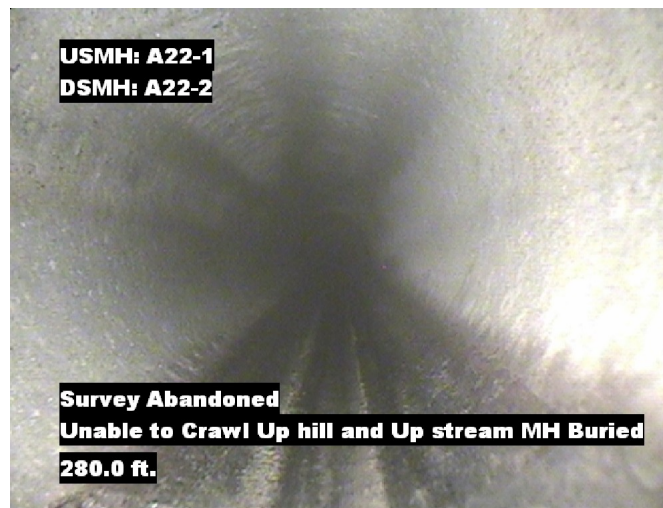
Distance: 280.0 ft. Grade: 0  
Condition: Survey Abandoned  
Remarks: Unable to Crawl Up hill and Up stream MH Buried
