## Defect Listing

Pipe Segment Refere... <b>A22-2_A22-1</b>	City <b>Oliver Springs</b>	Street <b>Fritts St</b>	Material <b>Concrete Pipe (non-...</b>	Location C... <b>Light High...</b>	Sewer Use <b>Sanitary</b>
Upstream MH <b>A22-2</b>	Total Length <b>146.5</b>	Year Laid	Shape <b>Circular</b>	Location Details	
DS Manhole <b>A22-1</b>	Length surveyed <b>146.5</b>	Year Renewed	Height <b>8</b>	Width <b>8</b>	Pipe Joint... <b>4</b>

SPR <b>N/A</b>	MPR <b>N/A</b>	PO Number <b>4397-03</b>	Customer <b>GRW</b>
SPRI <b>N/A</b>	MPRI <b>N/A</b>	Work Order <b>4397-02</b>	Purpose <b>Pre-Rehabilitation Survey</b>
QSR <b>N/A</b>	QMR <b>N/A</b>		
OPR <b>N/A</b>	Surveyed By <b>Barry Rogers</b>	Direction <b>Downstream</b>	Date <b>20150804</b>
OPRI <b>N/A</b>	Certificate Number <b>U-1012-16405</b>	Pre-Cleaning <b>No Pre-Cleaning</b>	Time <b>09:57</b>
	Date Cleaned	End Time <b>10:05</b>	Weather <b>Very Dry</b>
		Additional Info

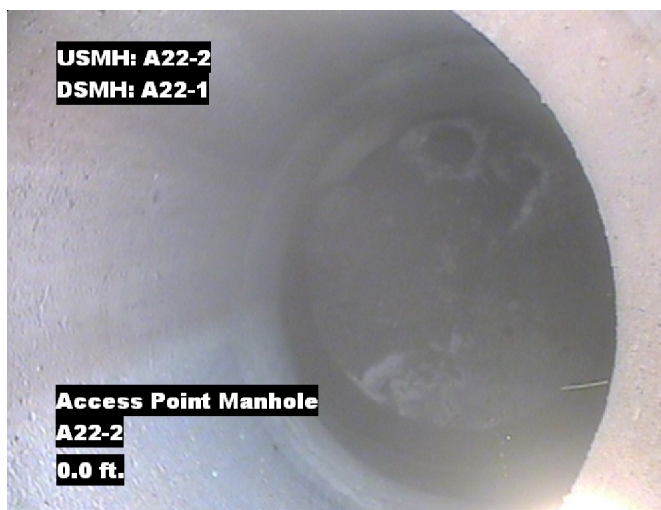
Distance: 0.0 ft. Grade: 0  
Condition: Access Point Manhole  
Remarks: A22-2

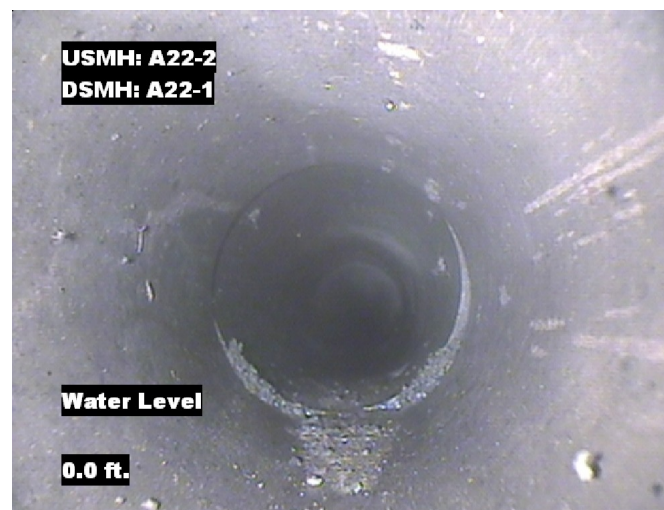
Distance: 0.0 ft. Grade: 0  
Condition: Water Level  
Remarks: N/A

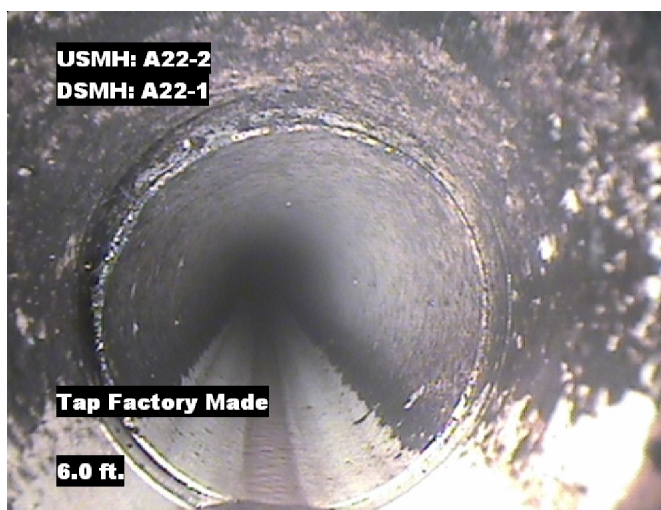
Distance: 6.0 ft. Grade: 0  
Condition: Tap Factory Made  
Remarks: N/A

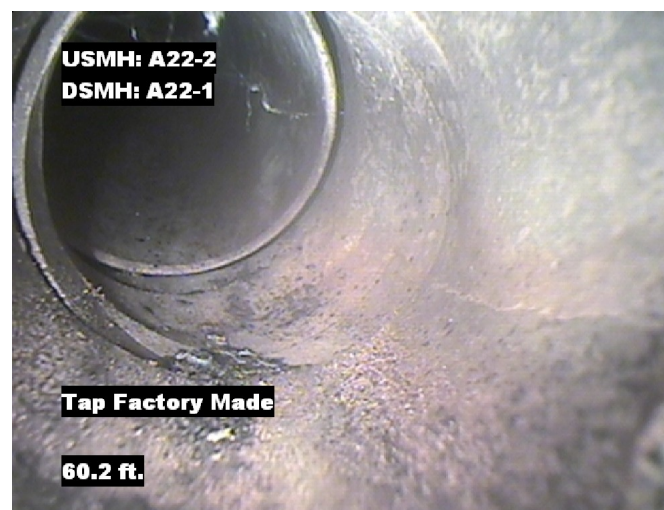
Distance: 60.2 ft. Grade: 0  
Condition: Tap Factory Made  
Remarks: N/A

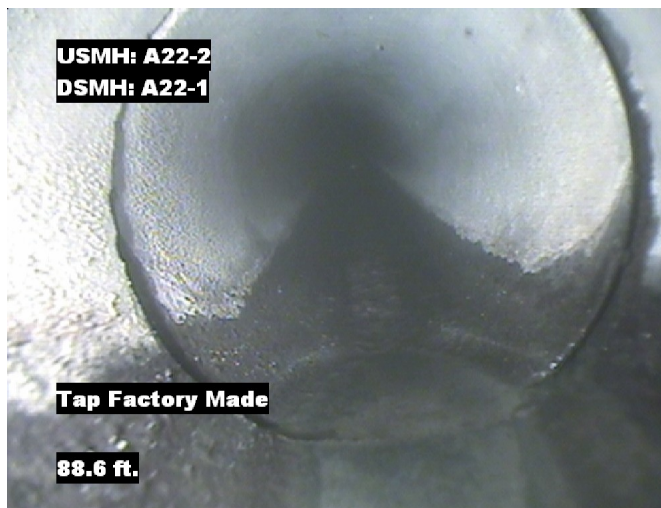
Distance: 88.6 ft. Grade: 0  
Condition: Tap Factory Made  
Remarks: N/A

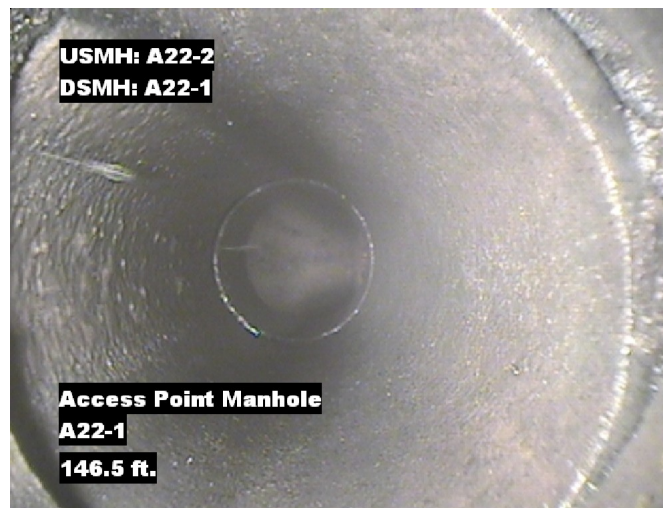
Distance: 146.5 ft. Grade: 0  
Condition: Access Point Manhole  
Remarks: A22-1
