Defect Listing

Pipe Segment Refere		City		Street	Mat	erial	Location C	Sewer Use	
A24-1_A20-3		Oliver Springs		Main St	Concrete F	Concrete Pipe (non		Sanitary	
Upstream MH Total Length		Length	Year Laid	Sha	Shape		Details		
A24-1		50.5			Circ	ular			
DS Ma	DS Manhole		surveyed	Year Renewed	Height	Width	Pipe Joint		
A20-3		50.5			8	8	4		
SPR	N/A	MPR	2	PO Number			Customer		
			_	4397-03		GRW			
SPRI	N/A	MPRI	2	Work Order			Purpose		
QSR	N/A	QMR	2100	4397-02		Pre-Rehabilitation Survey			
Ol	PR	Surveyed By		Direction	Date		Media label		
2	2	Barry_Rogers		Downstream	20150811				
OF	PRI	Certificate Number		Pre-Cleaning	Time		Weather		
2		U-1012-16405		Jetting	10:07		Dry		
		Date C	leaned		End Time		Addition	Additional Info	
		2015	0811	10:12

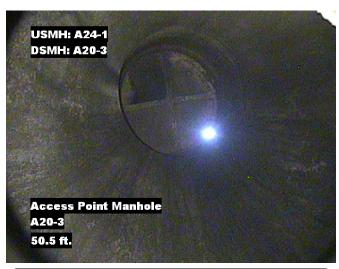
Distance: 50.5 ft. Grade: 0

Condition: Access Point Manhole

Remarks: A20-3
