Defect Listing

Pipe Segment Refere... A24-1A_A24-1	City Oliver Springs	Street Morgen St	Material Concrete Pipe (non-...	Location C... Light High...	Sewer Use Sanitary
Upstream MH A24-1A	Total Length 303.5	Year Laid	Shape Circular	Location Details	
DS Manhole A24-1	Length surveyed 303.5	Year Renewed	Height 8	Width 8	Pipe Joint... 4

SPR N/A	MPR N/A	PO Number 4397-03	Customer GRW
SPRI N/A	MPRI N/A	Work Order 4397-02	Purpose Pre-Rehabilitation Survey
QSR N/A	QMR N/A		
OPR N/A	Surveyed By Barry Rogers	Direction Downstream	Date 20150803
OPRI N/A	Certificate Number U-1012-16405	Pre-Cleaning Jetting	Time 09:09
	Date Cleaned 20150803	End Time 09:28	Weather Dry
			Additional Info

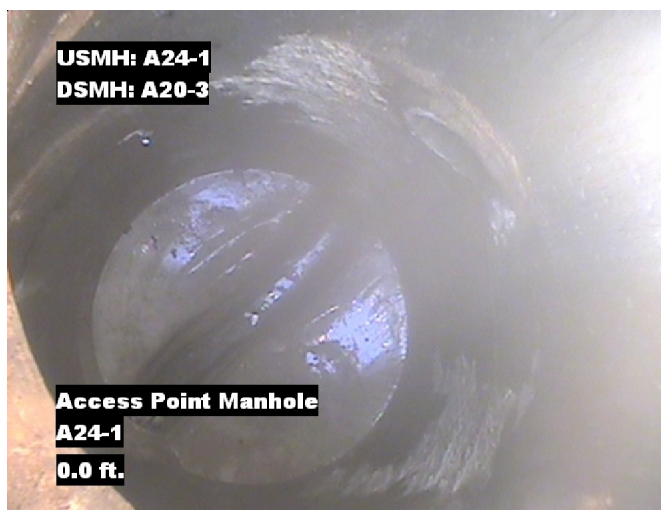
Distance: 0.0 ft. Grade: 0
Condition: Access Point Manhole
Remarks: A24-1A

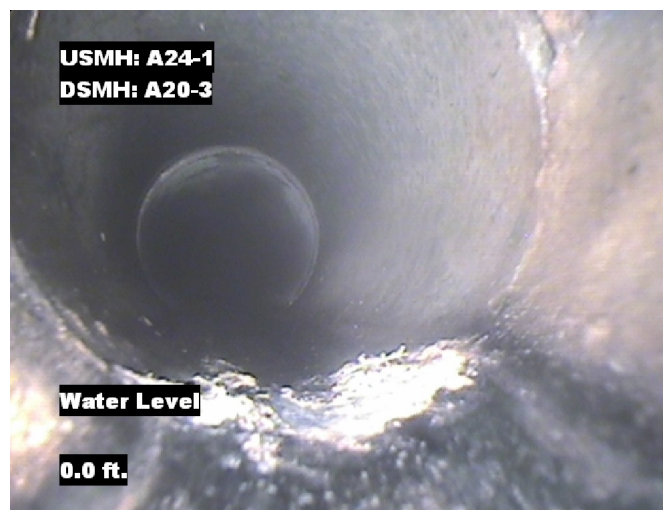
Distance: 0.0 ft. Grade: 0
Condition: Water Level
Remarks: N/A

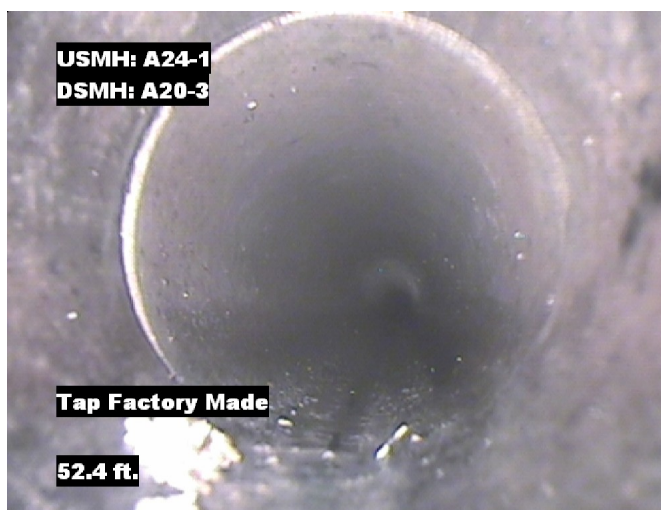
Distance: 52.4 ft. Grade: 0
Condition: Tap Factory Made
Remarks: N/A

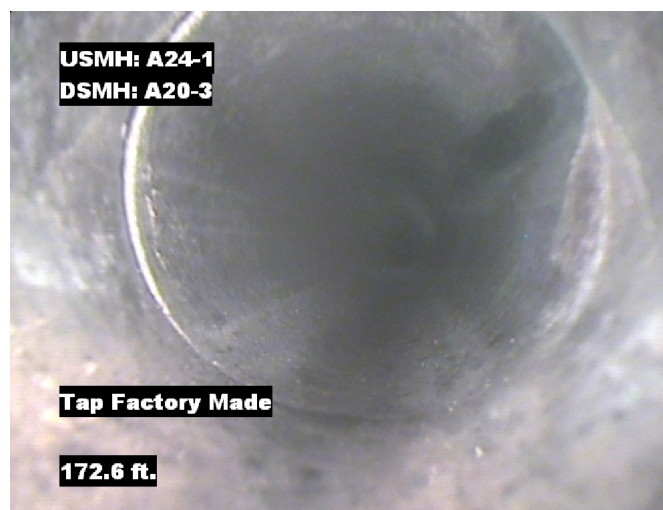
Distance: 172.6 ft. Grade: 0
Condition: Tap Factory Made
Remarks: N/A

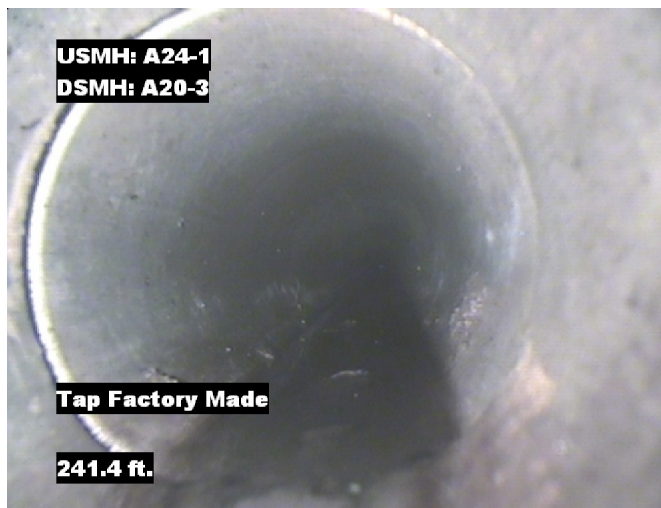
Distance: 241.4 ft. Grade: 0
Condition: Tap Factory Made
Remarks: N/A

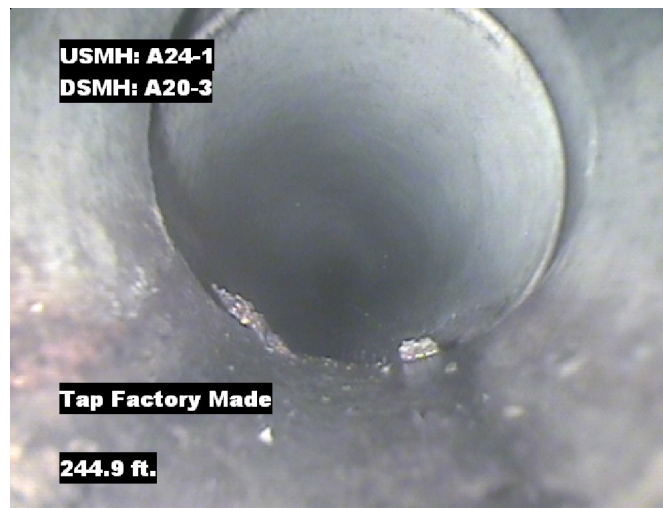
Distance: 244.9 ft. Grade: 0
Condition: Tap Factory Made
Remarks: N/A

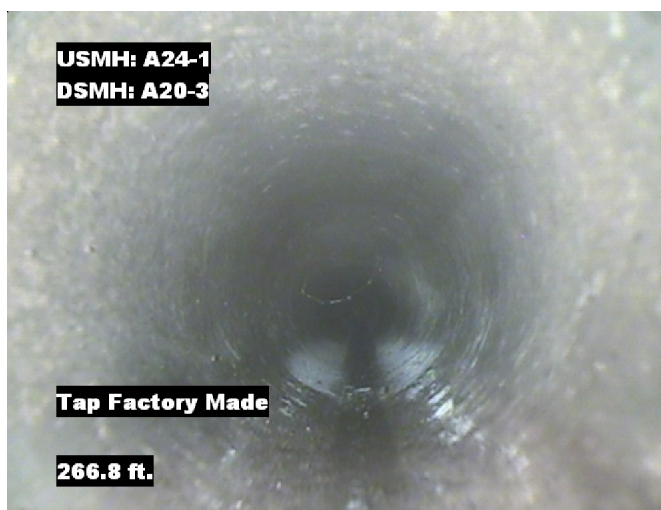
Distance: 266.8 ft. Grade: 0
Condition: Tap Factory Made
Remarks: N/A

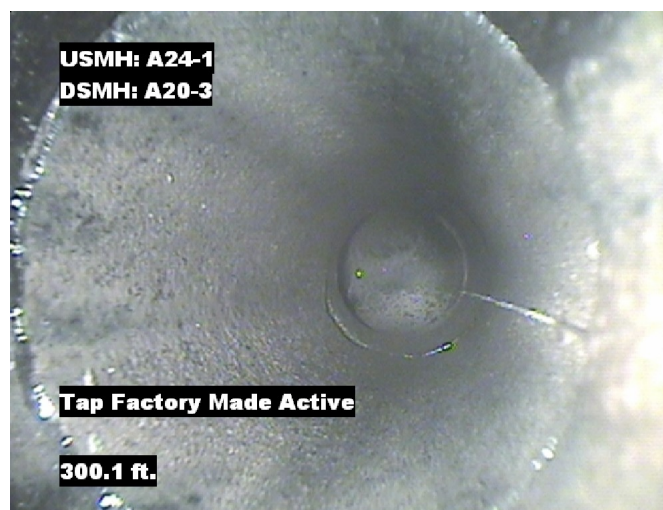
Distance: 300.1 ft. Grade: 0
Condition: Tap Factory Made Active
Remarks: N/A

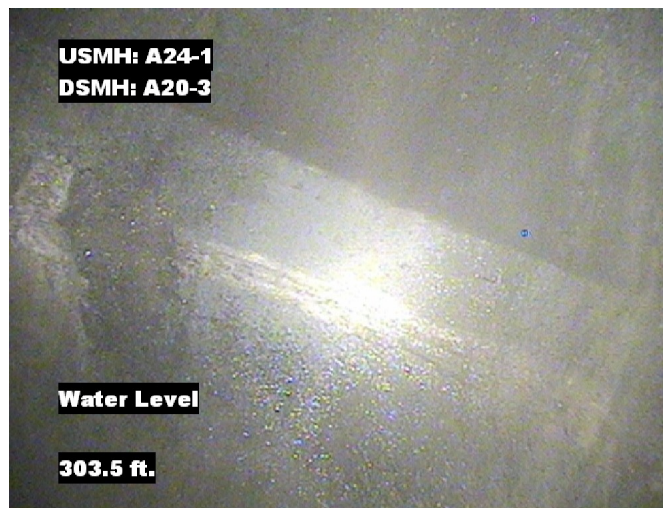
Distance: 303.5 ft. Grade: 0
Condition: Water Level
Remarks: N/A

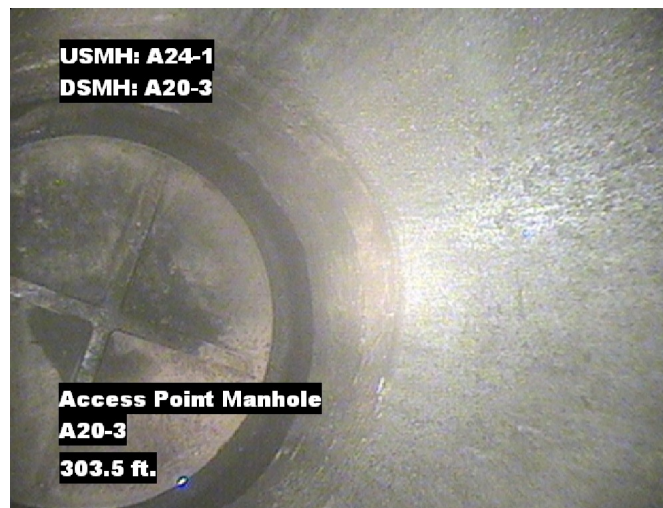
Distance: 303.5 ft. Grade: 0
Condition: Access Point Manhole
Remarks: A24-1
