## Defect Listing

Pipe Segment Refere... <b>A24-2_A24-1A</b>	City <b>Oliver Springs</b>	Street <b>Morgen St</b>	Material <b>Concrete Pipe (non-...</b>	Location C... <b>Light High...</b>	Sewer Use <b>Sanitary</b>
Upstream MH <b>A24-2</b>	Total Length <b>241.5</b>	Year Laid	Shape <b>Circular</b>	Location Details	
DS Manhole <b>A24-1A</b>	Length surveyed <b>241.5</b>	Year Renewed	Height <b>8</b>	Width <b>8</b>	Pipe Joint... <b>4</b>

## Image Report 4/Page

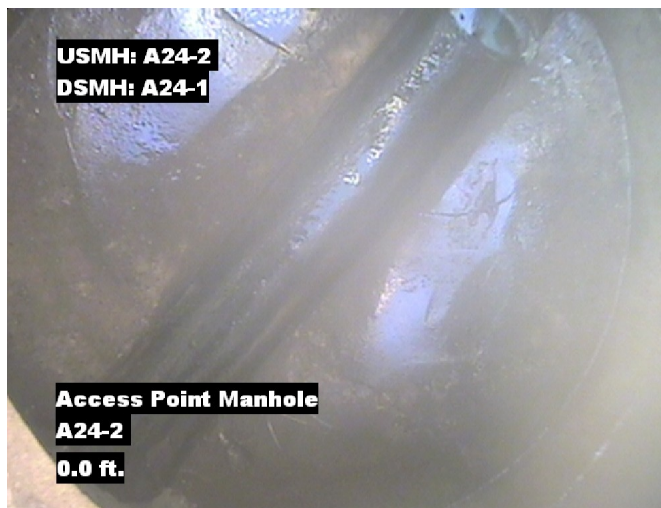
Distance: 0.0 ft. Grade: 0  
Condition: Access Point Manhole  
Remarks: A24-2

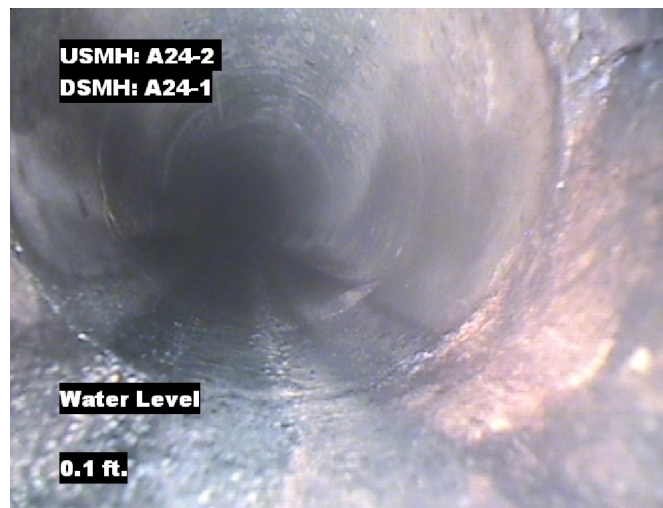
Distance: 0.0 ft. Grade: 0  
Condition: Water Level  
Remarks: N/A

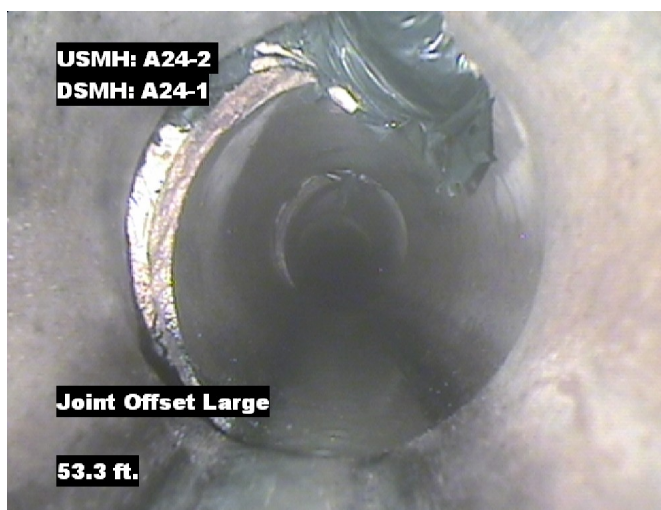
Distance: 53.3 ft. Grade: 2  
Condition: Joint Offset Large  
Remarks: N/A

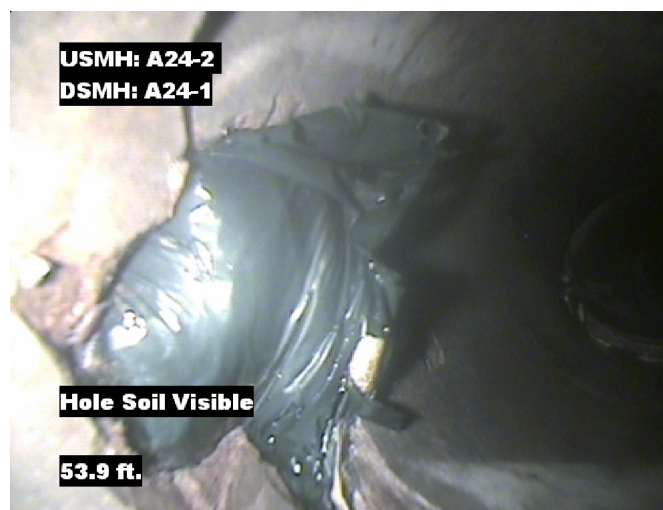
Distance: 53.9 ft. Grade: 5  
Condition: Hole Soil Visible  
Remarks: N/A

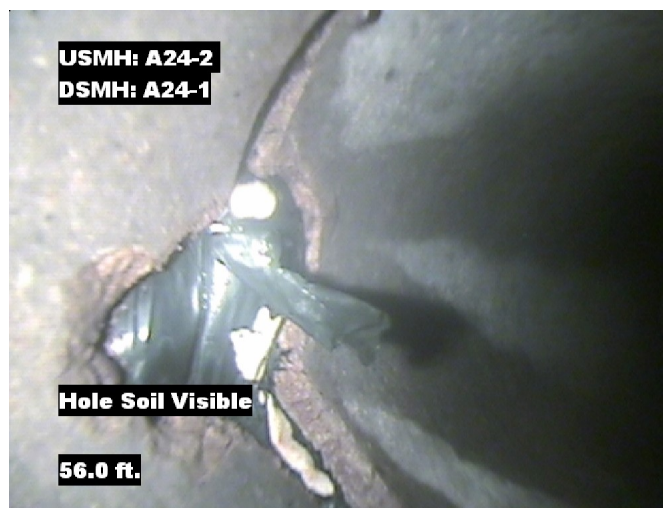
Distance: 56.0 ft. Grade: 5  
Condition: Hole Soil Visible  
Remarks: N/A

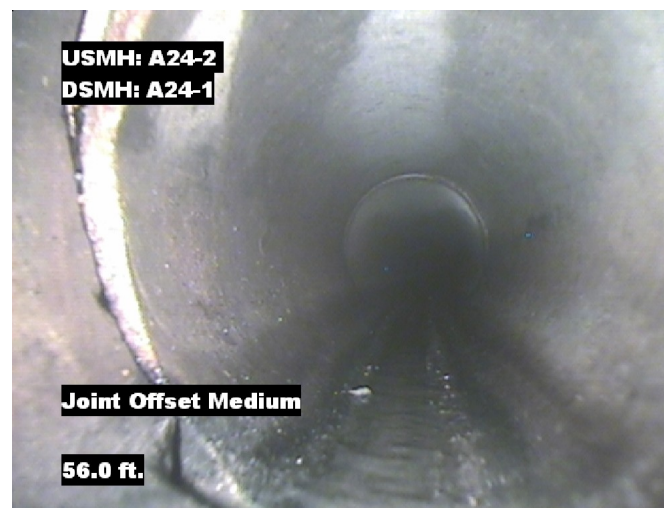
Distance: 56.0 ft. Grade: 1  
Condition: Joint Offset Medium  
Remarks: N/A

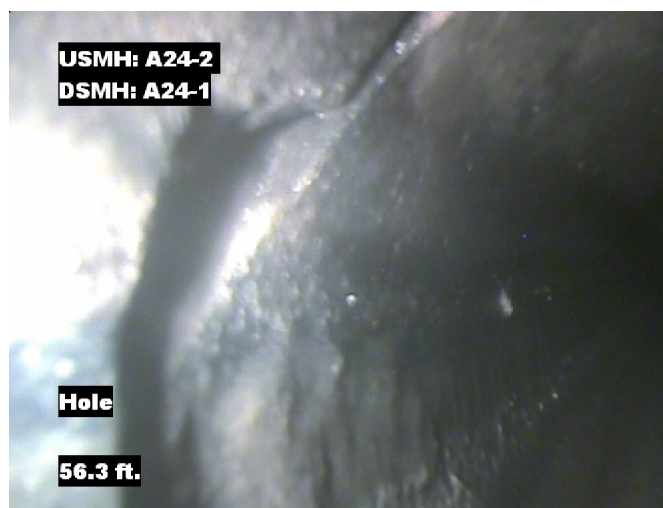
Distance: 56.3 ft. Grade: 3  
Condition: Hole  
Remarks: N/A

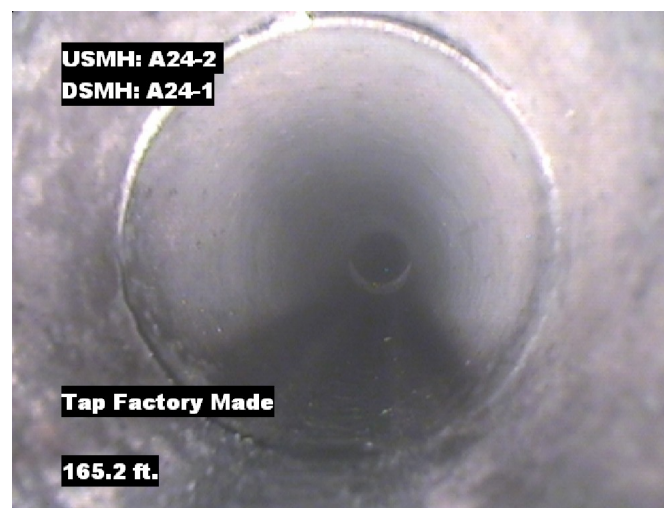
Distance: 165.2 ft. Grade: 0  
Condition: Tap Factory Made  
Remarks: N/A

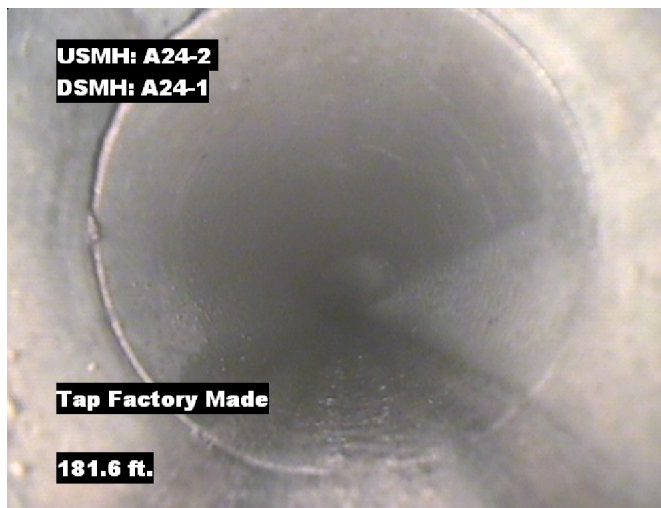
Distance: 181.6 ft. Grade: 0  
Condition: Tap Factory Made  
Remarks: N/A

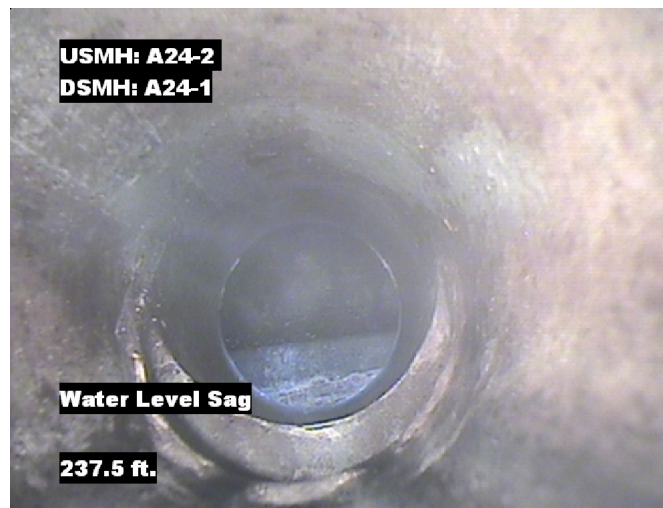
Distance: 237.4 ft. Grade: 2  
Condition: Water Level Sag  
Remarks: N/A

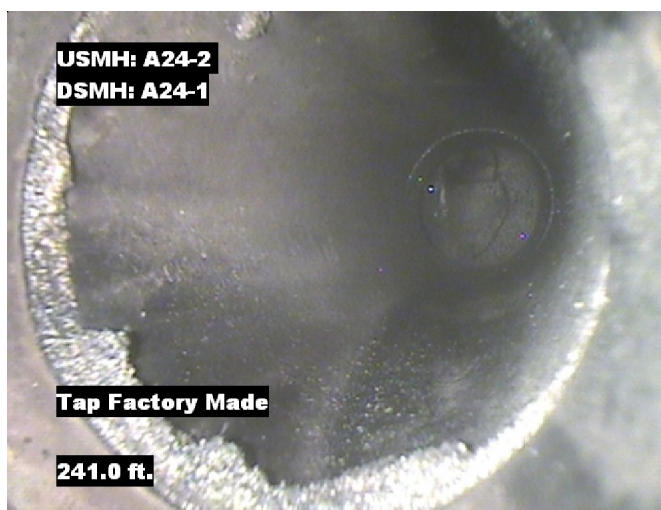
Distance: 241.0 ft. Grade: 0  
Condition: Tap Factory Made  
Remarks: N/A

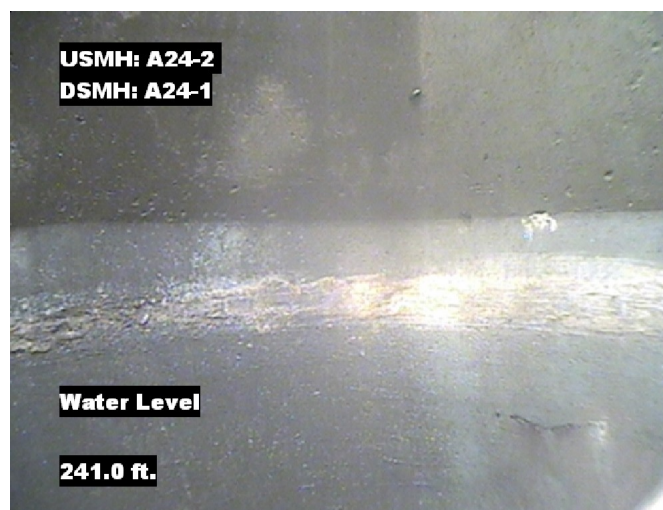
Distance: 241.0 ft. Grade: 0  
Condition: Water Level  
Remarks: N/A

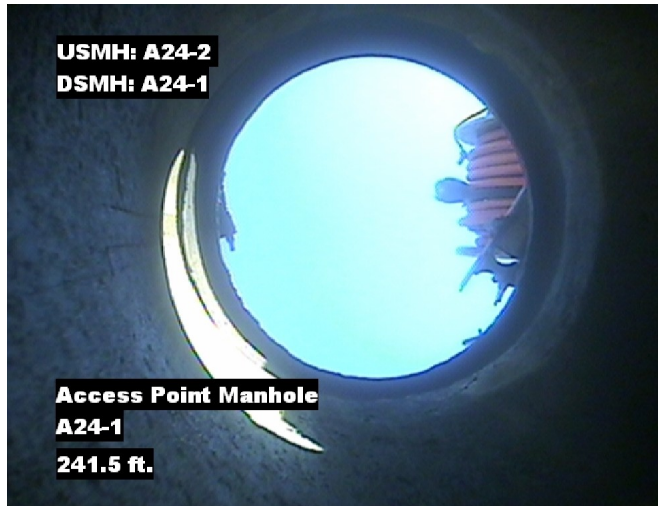
Distance: 241.5 ft. Grade: 0  
Condition: Access Point Manhole  
Remarks: A24-1A
