Defect Listing

Pipe Segment Refere... A24-3_A24-2	City Oliver Springs	Street Morgen St	Material Fibreglass Reinforc...	Location C... Light High...	Sewer Use Sanitary
Upstream MH A24-3	Total Length 263.4	Year Laid	Shape Circular	Location Details	
DS Manhole A24-2	Length surveyed 263.4	Year Renewed	Height 8	Width 8	Pipe Joint... N/A

SPR N/A	MPR N/A	PO Number 4397-03	Customer GRW
SPRI N/A	MPRI N/A	Work Order 4397-02	Purpose Pre-Rehabilitation Survey
QSR N/A	QMR N/A		
OPR N/A	Surveyed By Barry Rogers	Direction Downstream	Date 20150803
OPRI N/A	Certificate Number U-1012-16405	Pre-Cleaning Jetting	Time 07:34
	Date Cleaned 20150803	End Time 07:48	Weather Damp
			Media label
			Additional Info

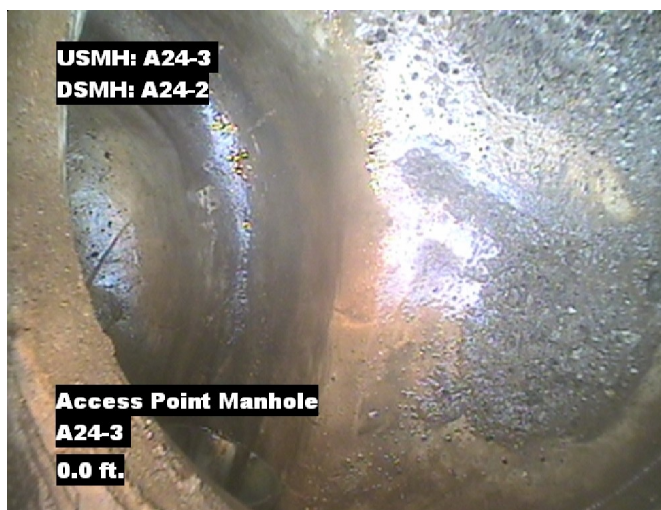
Distance: 0.0 ft. Grade: 0
Condition: Access Point Manhole
Remarks: A24-3

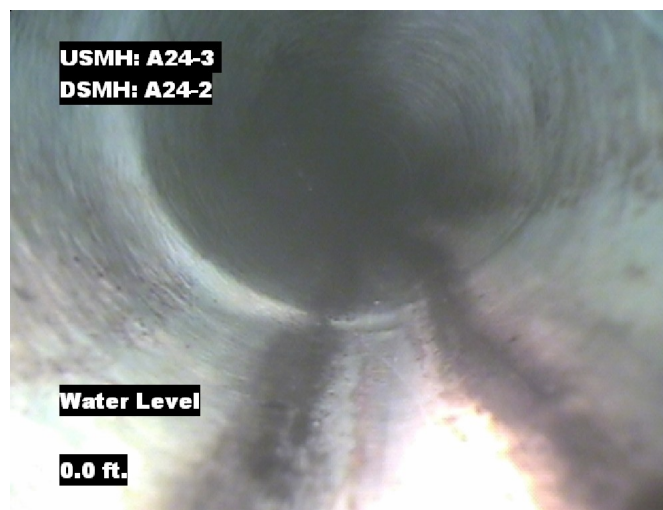
Distance: 0.0 ft. Grade: 0
Condition: Water Level
Remarks: N/A

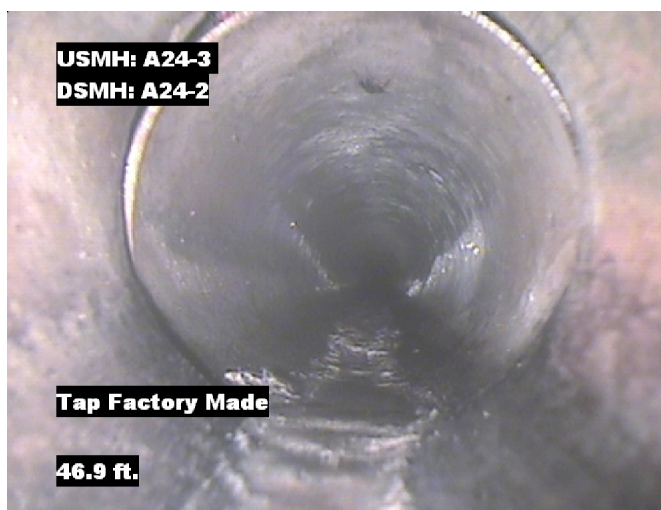
Distance: 46.9 ft. Grade: 0
Condition: Tap Factory Made
Remarks: N/A

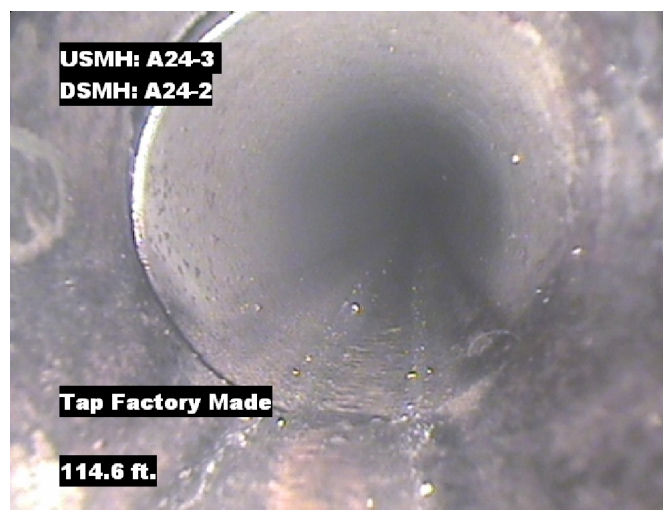
Distance: 114.6 ft. Grade: 0
Condition: Tap Factory Made
Remarks: N/A

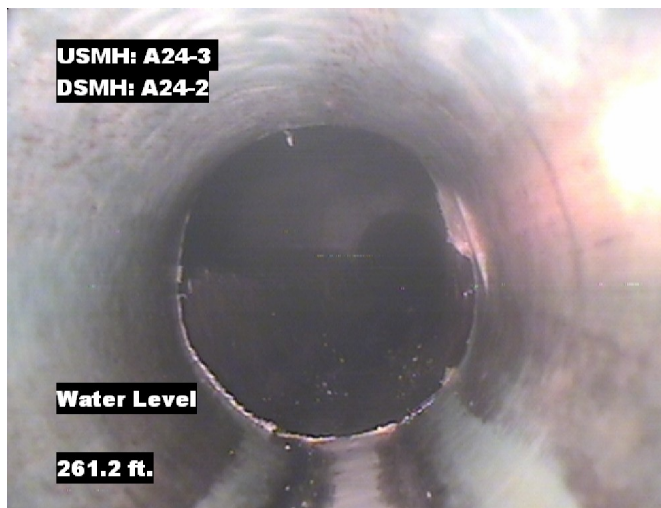
Distance: 261.2 ft. Grade: 0
Condition: Water Level
Remarks: N/A

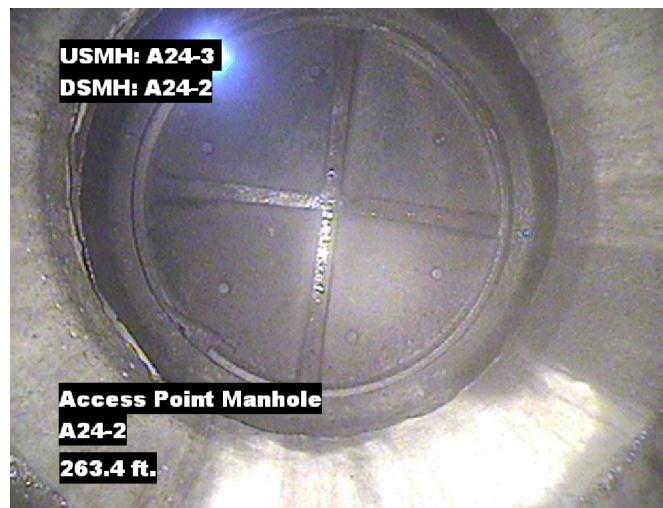
Distance: 263.4 ft. Grade: 0
Condition: Access Point Manhole
Remarks: A24-2
