Defect Listing

Image Report 4/Page

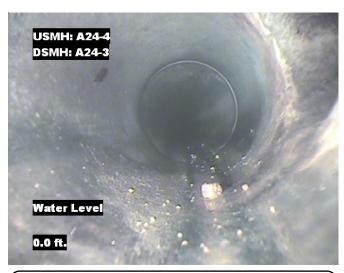
Distance: 0.0 ft. Grade: 0

Condition: Water Level

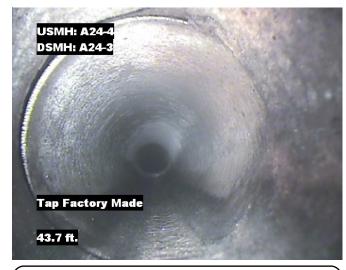
Distance: 43.7 ft. Grade: 0

Condition: Tap Factory Made

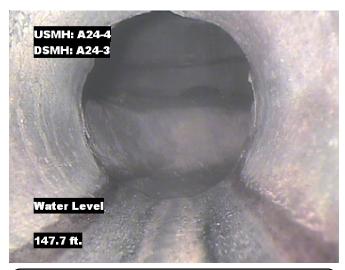
Distance: 147.7 ft. Grade: 0

Condition: Water Level

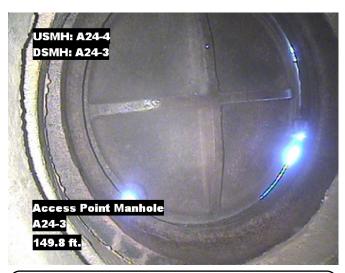
Distance: 149.8 ft. Grade: 0

Condition: Access Point Manhole

Remarks: A24-3
