Defect Listing

| Pipe Segment Refere | | City | | Street | Mat | Material | | Sewer Use | |
|---|---|---|---|---|---|---|---|---|--|
| A25-1_A19-1 | | Oliver Springs | | Roane St | Concrete F | Concrete Pipe (non | | Sanitary | |

Image Report 4/Page

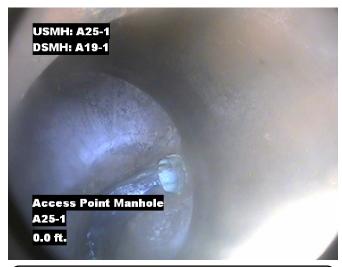
Distance: 0.0 ft. Grade: 0

Condition: Access Point Manhole

Remarks: A25-1

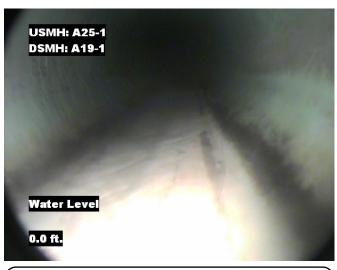
Distance: 0.0 ft. Grade: 0

Condition: Water Level

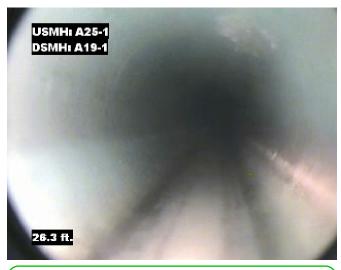
| Distance | Condition | Cont. Dfct. | Values | | | Joint | Clock Position | | 0 |
|---|---|---|---|---|---|---|---|---|---|
| 26.6 ft. | Deposits Attached Grease | | | | 5 | | 1 | | 2 |

Distance: 26.6 ft. Grade:
Condition: Deposits Attached Grease

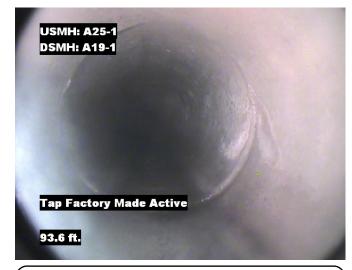
Distance: 93.6 ft. Grade: 0

Condition: Tap Factory Made Active

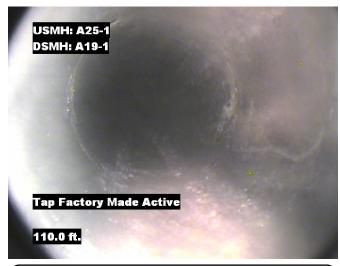
Distance: 110.0 ft. **Grade**: 0 **Condition**: Tap Factory Made Active

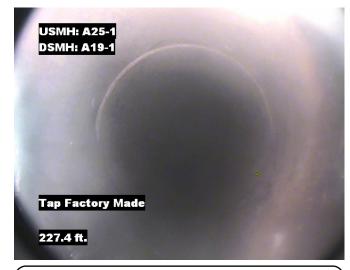
Distance: 227.4 ft. Grade: 0

Condition: Tap Factory Made

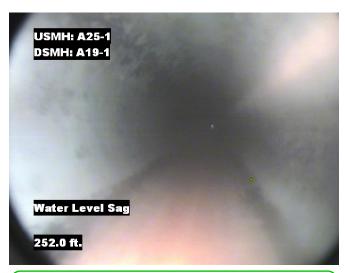
| Distance | Condition | Cont. Dfct. | Values | | | Joint | Clock Position | | 0 |
|---|---|---|---|---|---|---|---|---|---|
| 251.9 ft. | Water Level Sag | | | | 10 | | | | 2 |

Distance: 251.9 ft. Grade: 2

Condition: Water Level Sag

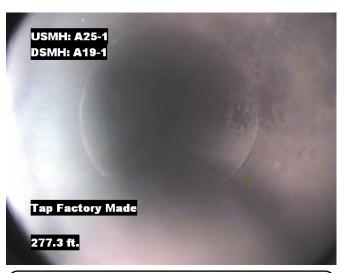
Distance: 277.3 ft. Grade: (

Condition: Tap Factory Made

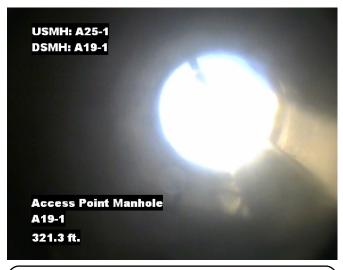
Distance: 321.3 ft. Grade: 0

Condition: Access Point Manhole

Remarks: A19-1
