Defect Listing

Pipe Segment Refere... A25-2_A25-1	City Oliver Springs	Street Spring St	Material Fibreglass Reinforc...	Location C... Light High...	Sewer Use Sanitary
Upstream MH A25-2	Total Length 239.5	Year Laid	Shape Circular	Location Details	
DS Manhole A25-1	Length surveyed 239.5	Year Renewed	Height 8	Width 8	Pipe Joint... N/A

SPR N/A	MPR 2	PO Number 4397-03	Customer GRW
SPRI N/A	MPRI 2	Work Order 4397-02	Purpose Pre-Rehabilitation Survey
QSR N/A	QMR 2100		
OPR 2	Surveyed By Barry Rogers	Direction Downstream	Date 20150803
OPRI 2	Certificate Number U-1012-16405	Pre-Cleaning Jetting	Time 14:22
	Date Cleaned 20150803	End Time 14:36	Weather Dry
			Additional Info

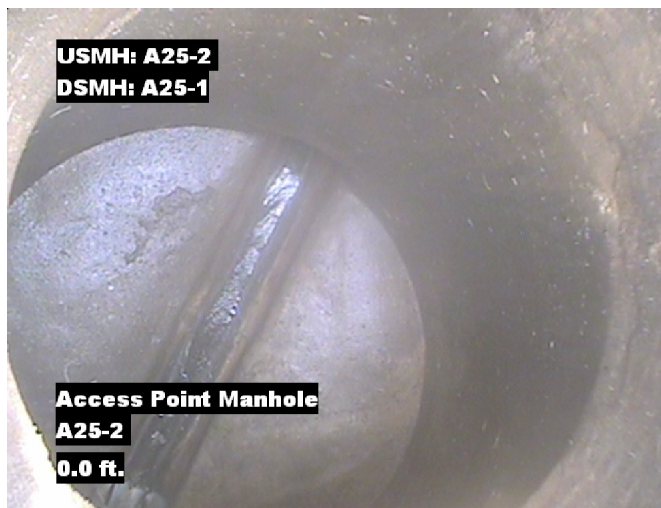
Distance: 0.0 ft. Grade: 0
Condition: Access Point Manhole
Remarks: A25-2

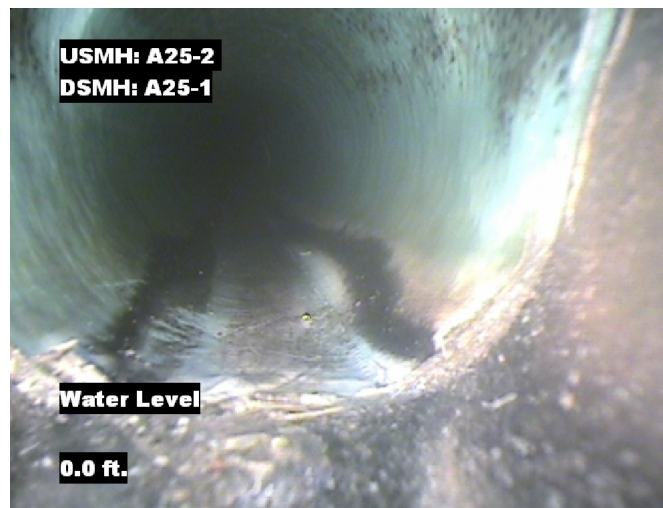
Distance: 0.0 ft. Grade: 0
Condition: Water Level
Remarks: N/A

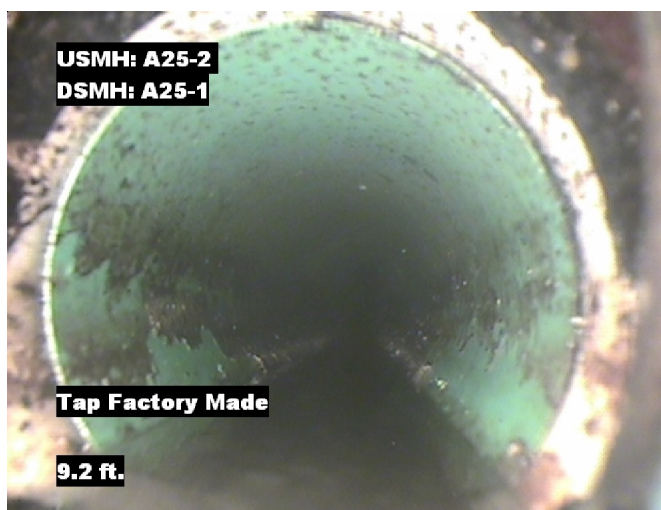
Distance: 9.2 ft. Grade: 0
Condition: Tap Factory Made
Remarks: N/A

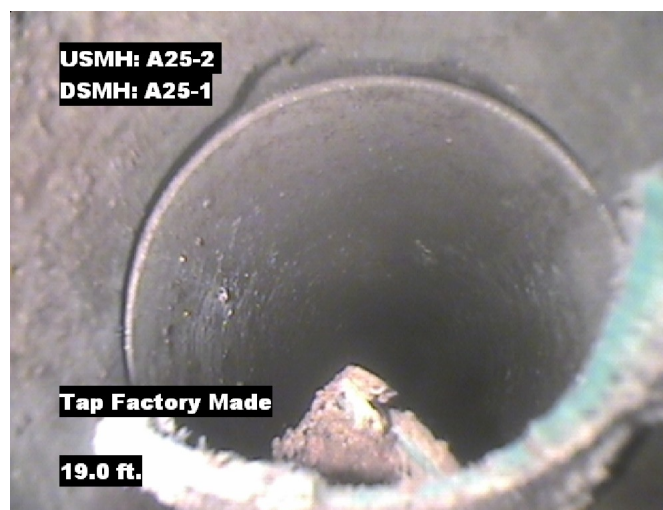
Distance: 19.0 ft. Grade: 0
Condition: Tap Factory Made
Remarks: N/A

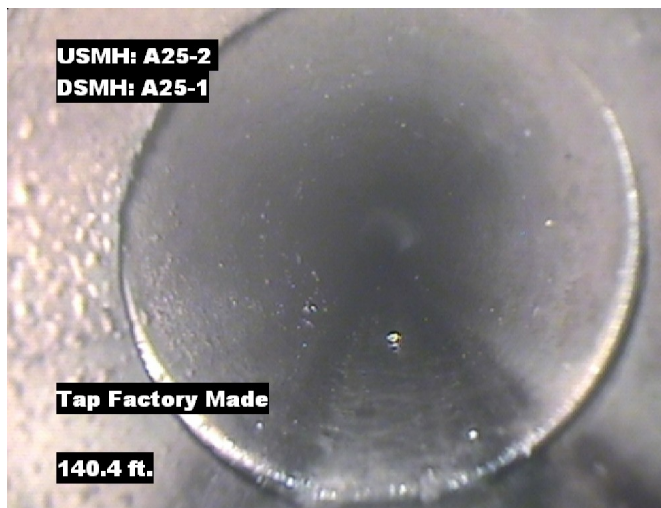
Distance: 140.4 ft. Grade: 0
Condition: Tap Factory Made
Remarks: N/A

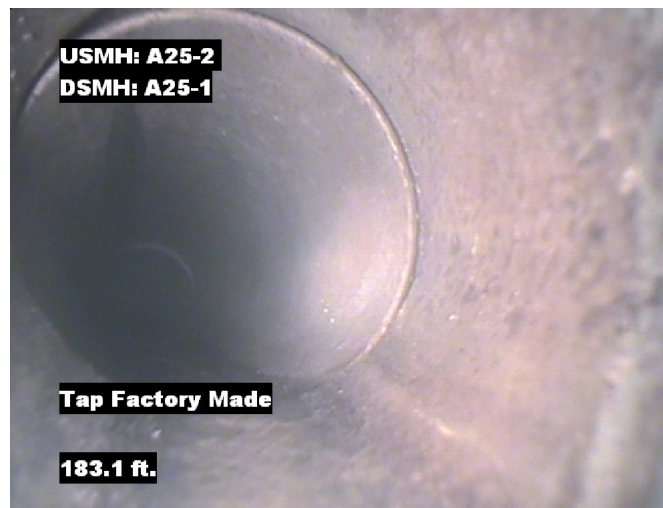
Distance: 183.1 ft. Grade: 0
Condition: Tap Factory Made
Remarks: N/A

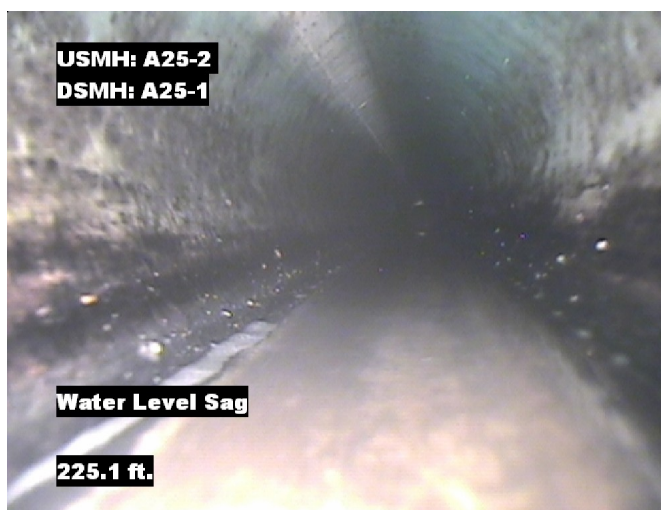
Distance: 225.1 ft. Grade: 2
Condition: Water Level Sag
Remarks: N/A

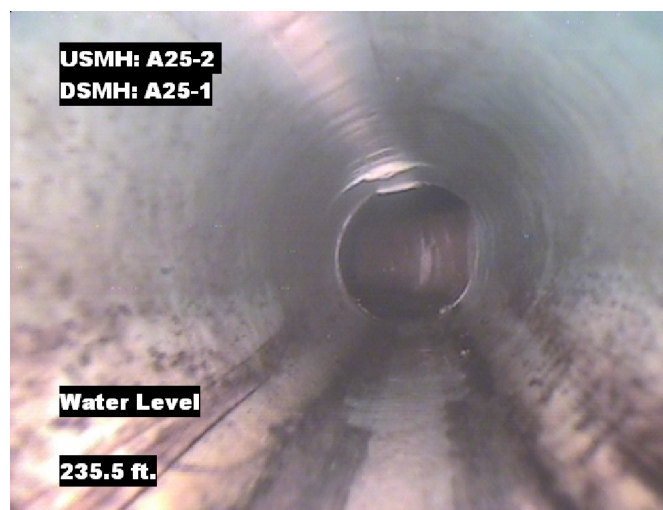
Distance: 235.5 ft. Grade: 0
Condition: Water Level
Remarks: N/A

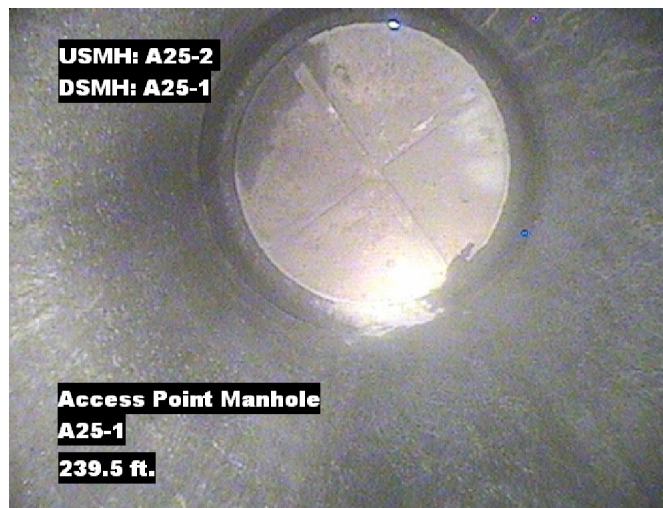
Distance: 239.5 ft. Grade: 0
Condition: Access Point Manhole
Remarks: A25-1
