Defect Listing

Pipe Segment Refere... A25-3_A25-2	City Oliver Springs	Street Spring St	Material Concrete Pipe (non-...	Location C... Light High...	Sewer Use Sanitary
Upstream MH A25-3	Total Length 281.8	Year Laid	Shape Circular	Location Details	
DS Manhole A25-2	Length surveyed 281.8	Year Renewed	Height 8	Width 8	Pipe Joint... 4

SPR 3	MPR N/A	PO Number 4397-03	Customer GRW
SPRI 3	MPRI N/A	Work Order 4397-02	Purpose Pre-Rehabilitation Survey
QSR 3100	QMR N/A		
OPR 3	Surveyed By Barry Rogers	Direction Downstream	Date 20150803
OPRI 3	Certificate Number U-1012-16405	Pre-Cleaning Jetting	Time 13:54
	Date Cleaned 20150803	End Time 14:10	Weather Dry
			Media label
			Additional Info

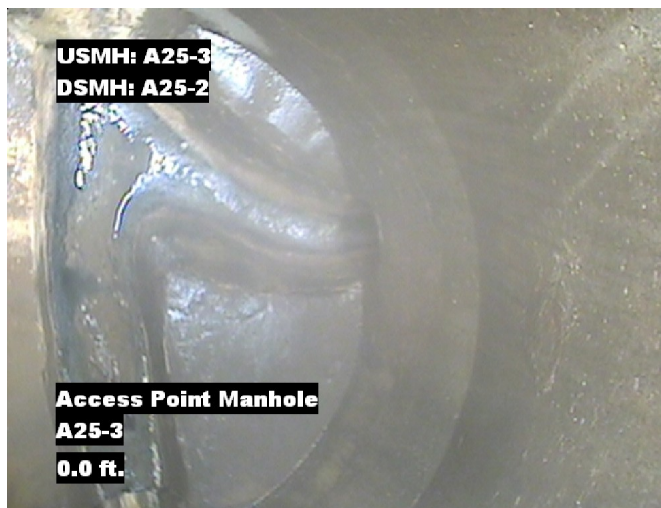
Distance: 0.0 ft. Grade: 0
Condition: Access Point Manhole
Remarks: A25-3

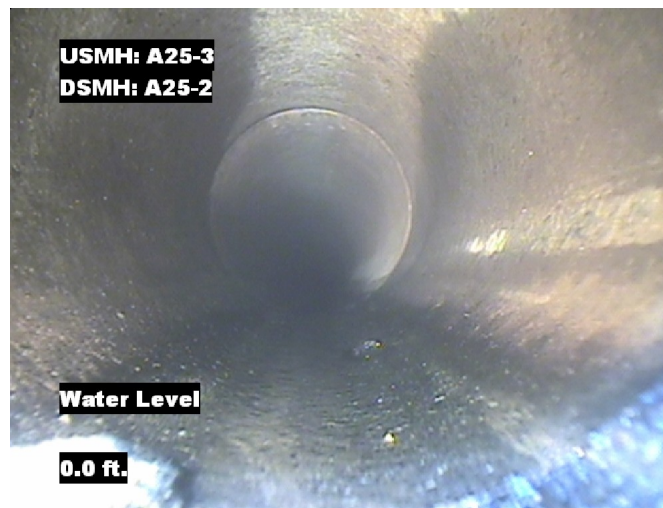
Distance: 0.0 ft. Grade: 0
Condition: Water Level
Remarks: N/A

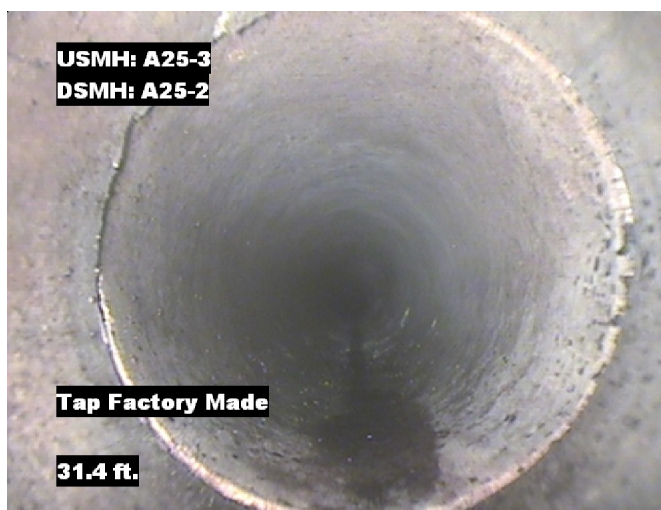
Distance: 31.4 ft. Grade: 0
Condition: Tap Factory Made
Remarks: N/A

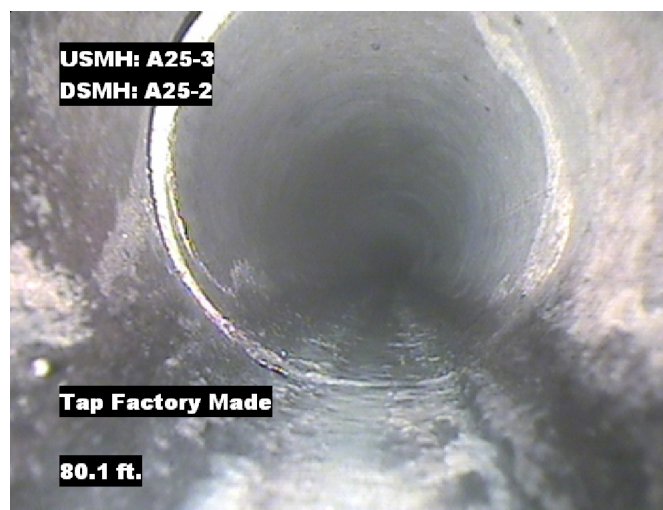
Distance: 80.1 ft. Grade: 0
Condition: Tap Factory Made
Remarks: N/A

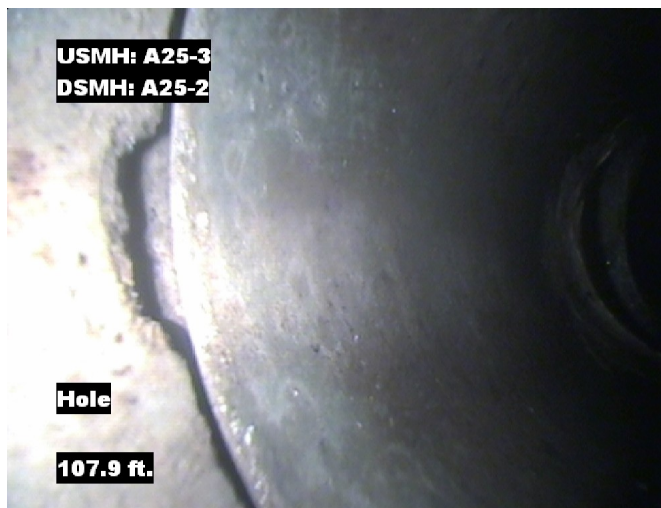
Distance: 107.9 ft. Grade: 3
Condition: Hole
Remarks: N/A

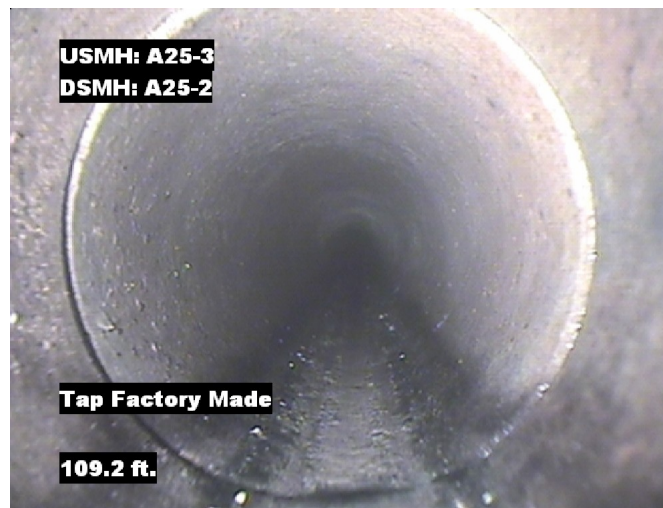
Distance: 109.2 ft. Grade: 0
Condition: Tap Factory Made
Remarks: N/A

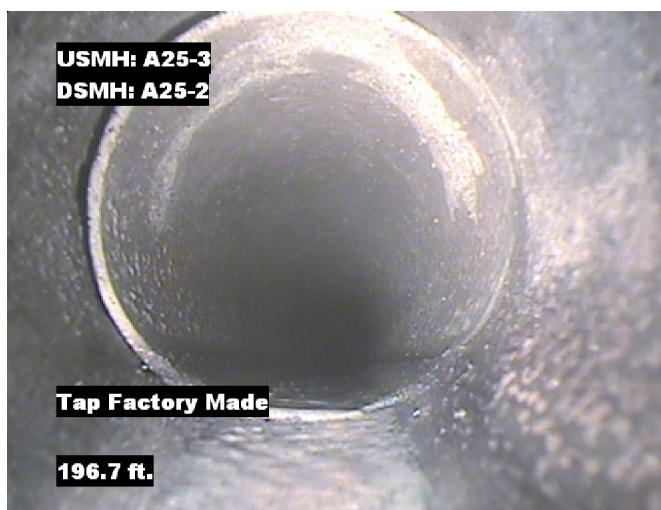
Distance: 196.7 ft. Grade: 0
Condition: Tap Factory Made
Remarks: N/A

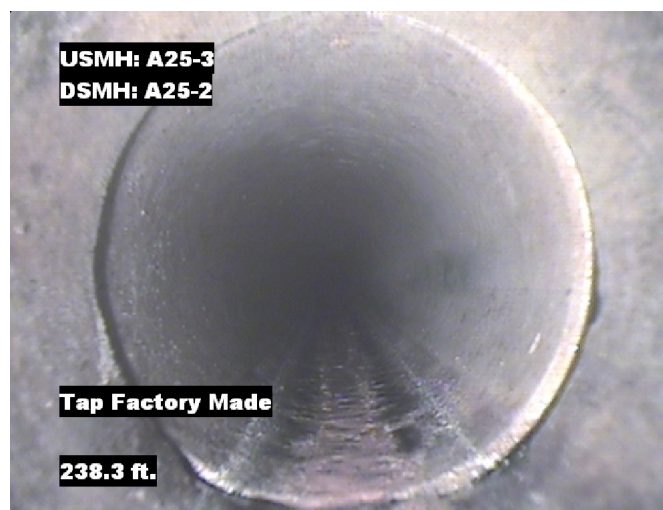
Distance: 238.3 ft. Grade: 0
Condition: Tap Factory Made
Remarks: N/A

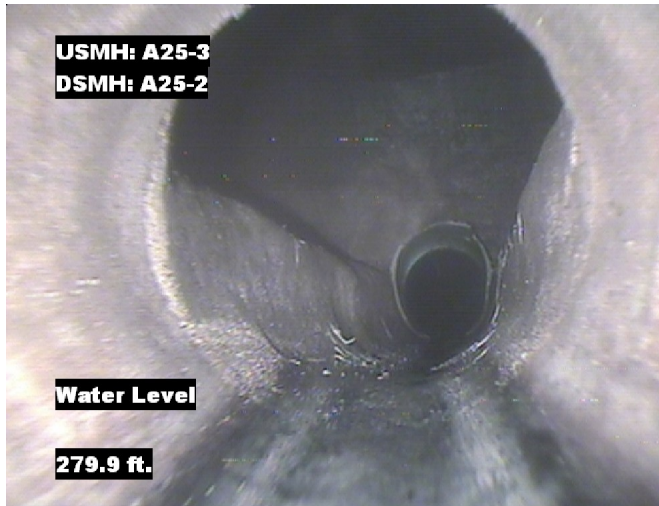
Distance: 279.5 ft. Grade: 0
Condition: Water Level
Remarks: N/A

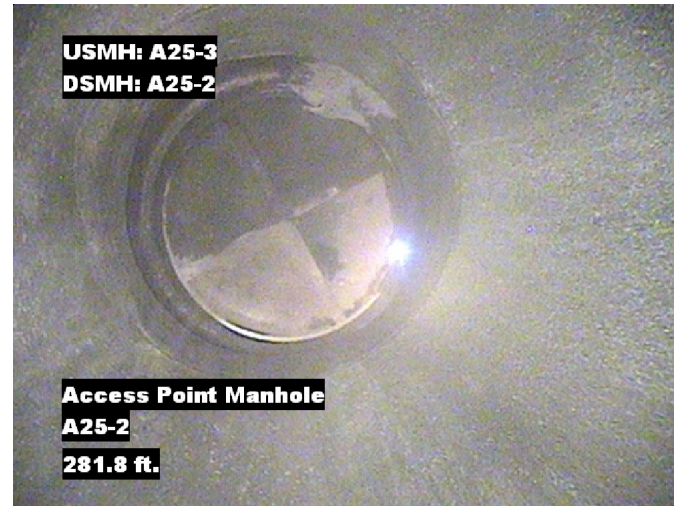
Distance: 281.8 ft. Grade: 0
Condition: Access Point Manhole
Remarks: A25-2
