## Defect Listing

Pipe Segment Refere... <b>A25-4_A25-3</b>	City <b>Oliver Springs</b>	Street <b>Spring St</b>	Material <b>Fibreglass Reinforc...</b>	Location C... <b>Light High...</b>	Sewer Use <b>Sanitary</b>
Upstream MH <b>A25-4</b>	Total Length <b>199.9</b>	Year Laid	Shape <b>Circular</b>	Location Details	
DS Manhole <b>A25-3</b>	Length surveyed <b>199.9</b>	Year Renewed	Height <b>8</b>	Width <b>8</b>	Pipe Joint... <b>N/A</b>

## Image Report 4/Page

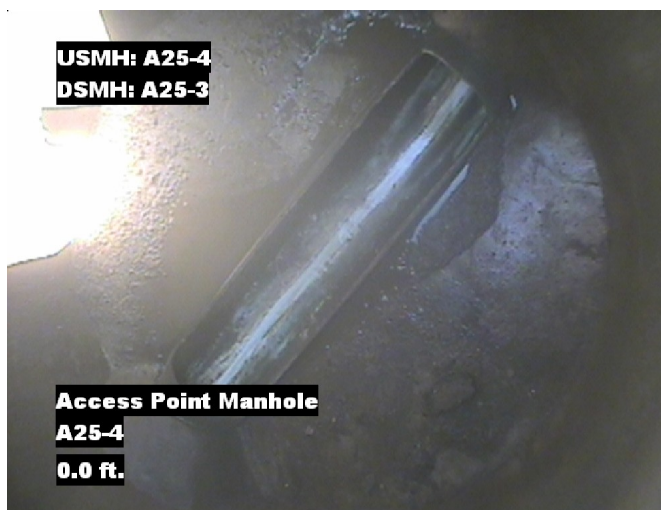
Distance: 0.0 ft. Grade: 0  
Condition: Access Point Manhole  
Remarks: A25-4

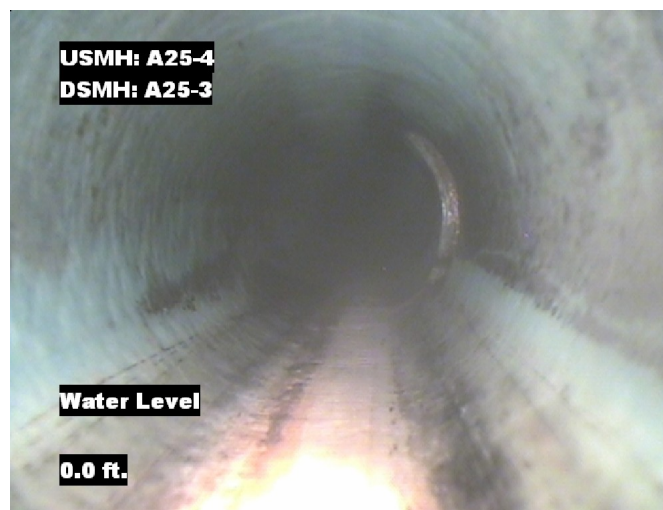
Distance: 0.0 ft. Grade: 0  
Condition: Water Level  
Remarks: N/A

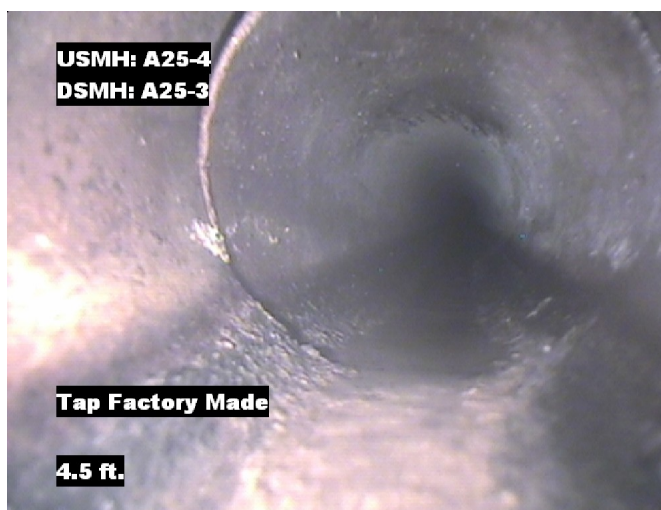
Distance: 4.5 ft. Grade: 0  
Condition: Tap Factory Made  
Remarks: N/A

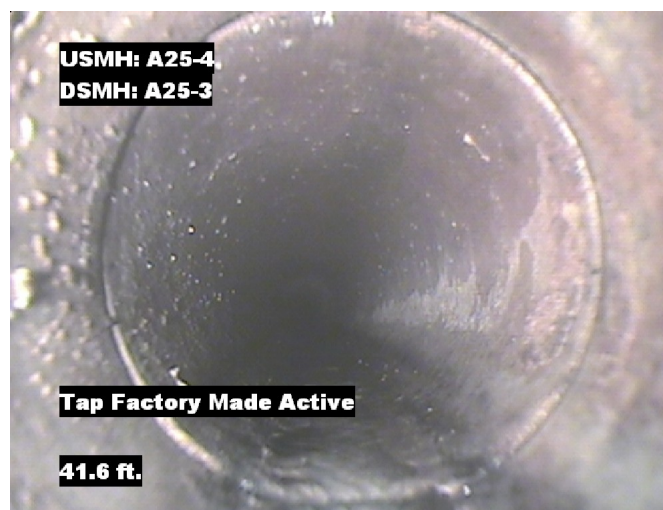
Distance: 41.6 ft. Grade: 0  
Condition: Tap Factory Made Active  
Remarks: N/A

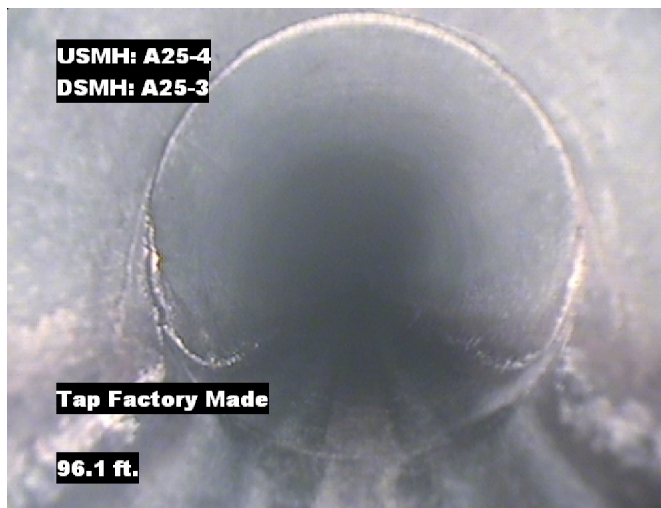
Distance: 96.1 ft. Grade: 0  
Condition: Tap Factory Made  
Remarks: N/A

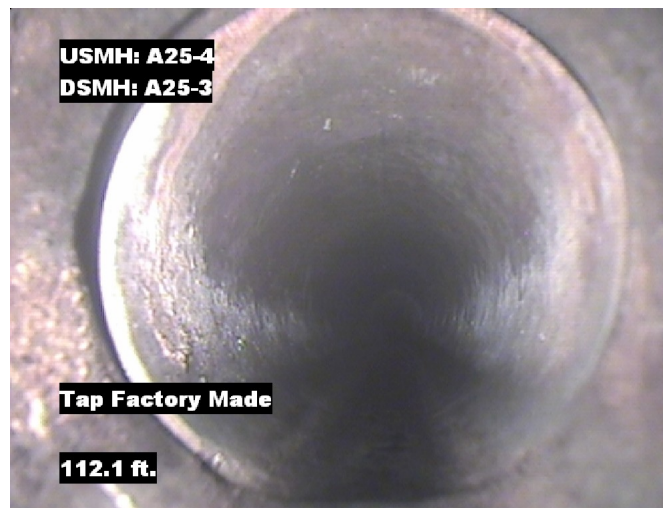
Distance: 112.1 ft. Grade: 0  
Condition: Tap Factory Made  
Remarks: N/A

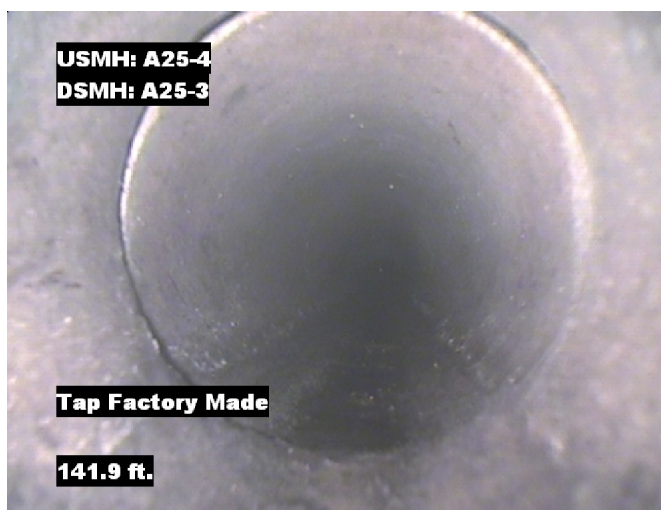
Distance: 141.9 ft. Grade: 0  
Condition: Tap Factory Made  
Remarks: N/A

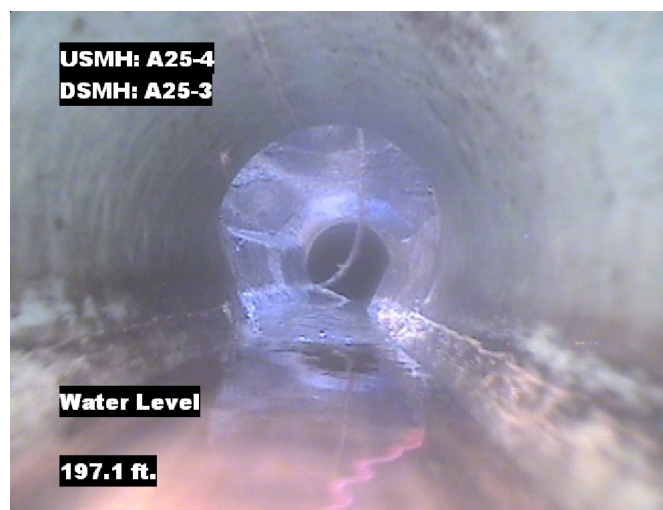
Distance: 197.1 ft. Grade: 0  
Condition: Water Level  
Remarks: N/A

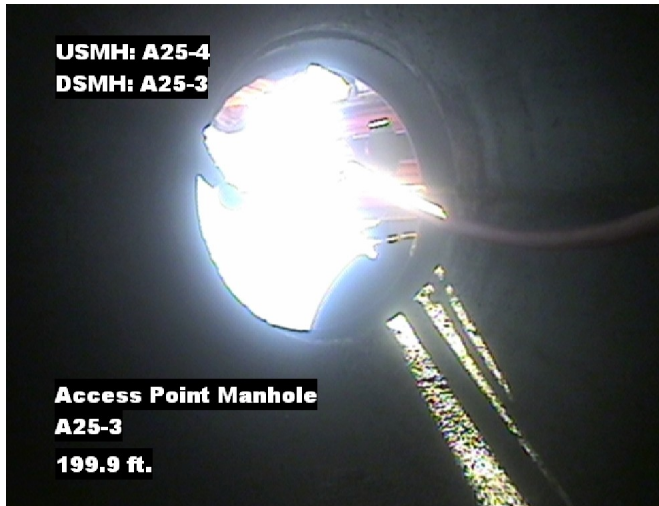
Distance: 199.9 ft. Grade: 0  
Condition: Access Point Manhole  
Remarks: A25-3
