## **Defect Listing**

Pipe Segment Refere		City		Street	Mat	erial	Location C	Sewer Use	
A25-5_A25-4		Oliver Springs		Spring St	Fibreglass Reinforc		Light High	Sanitary	
Upstream MH A25-5		Total Length 201.7		Year Laid	Shape Circular		Location Details		
DS Ma	DS Manhole A25-4		surveyed	Year Renewed	Height	Width	Pipe Joint <b>N/A</b>		
A2			1.7		8	8			
SPR	N/A	MPR	N/A	PO Number			Customer GRW Purpose		
2001				4397-03					
SPRI	N/A	MPRI	N/A	Work Order					
QSR	N/A	QMR	N/A	4397-02			urvey		
O	PR	Surveyed By		Direction	Date		Media label		
N	/A	Barry_Rogers		Downstream	20150803				
OF	PRI	Certificate Number		Pre-Cleaning	Time		Weather		
N	N/A		2-16405	Jetting	10:02		Dry		
		Date C	leaned	End Time		Additional Info			
		2015	0803	10:14

## Image Report 4/Page

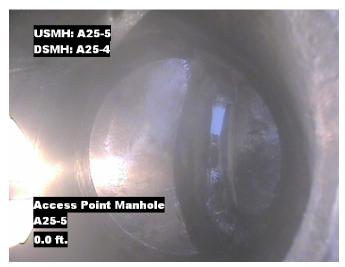
Distance: 0.0 ft. Grade: 0

Condition: Access Point Manhole

Remarks: A25-5

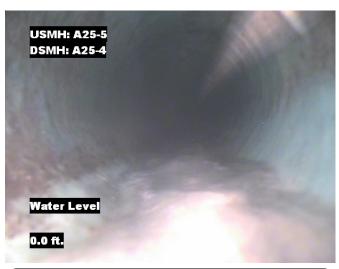
Distance: 0.0 ft. Grade: 0

Condition: Water Level

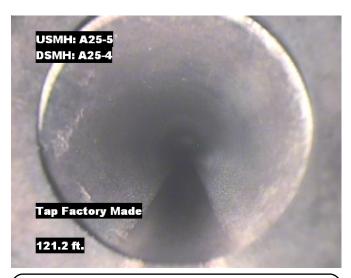
Distance: 121.2 ft. Grade: 0

Condition: Tap Factory Made

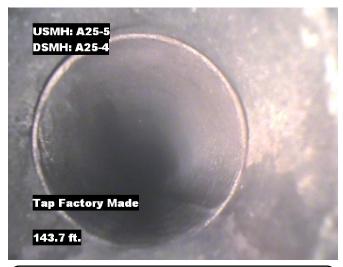
Distance: 143.7 ft. Grade: 0

Condition: Tap Factory Made

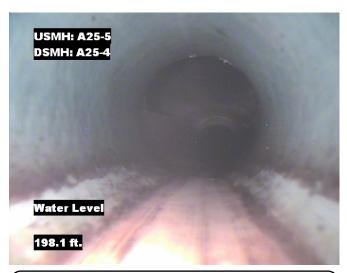
Distance: 197.9 ft. Grade: 0

Condition: Water Level

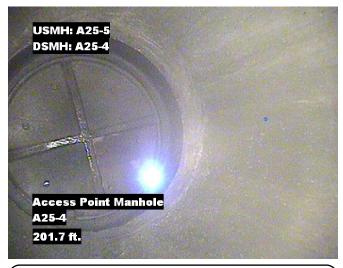
Distance: 201.7 ft. Grade: 0
Condition: Access Point Manhole

Remarks: A25-4
