## Defect Listing

Pipe Segment Refere... <b>A25-6_A25-5</b>	City <b>Oliver Springs</b>	Street <b>East St</b>	Material <b>Concrete Pipe (non-...</b>	Location C... <b>Light High...</b>	Sewer Use <b>Sanitary</b>
Upstream MH <b>A25-6</b>	Total Length <b>2</b>	Year Laid	Shape <b>Circular</b>	Location Details	
DS Manhole <b>A25-5</b>	Length surveyed <b>2</b>	Year Renewed	Height <b>8</b>	Width <b>8</b>	Pipe Joint... <b>4</b>

SPR <b>N/A</b>	MPR <b>N/A</b>	PO Number <b>4397-03</b>		Customer <b>GRW</b>	
SPRI <b>N/A</b>	MPRI <b>N/A</b>	Work Order <b>4397-02</b>		Purpose <b>Pre-Rehabilitation Survey</b>	
QSR <b>N/A</b>	QMR <b>N/A</b>				
OPR <b>N/A</b>	Surveyed By <b>Charlie Gordon</b>	Direction <b>Upstream</b>	Date <b>20150818</b>	Media label	
OPRI <b>N/A</b>	Certificate Number <b>U-615-07000491</b>	Pre-Cleaning <b>No Pre-Cleaning</b>	Time <b>12:57</b>	Weather <b>Damp</b>	
Date Cleaned			End Time <b>13:01</b>	Additional Info <b>UPSTREAM MANHOLE IS...</b>

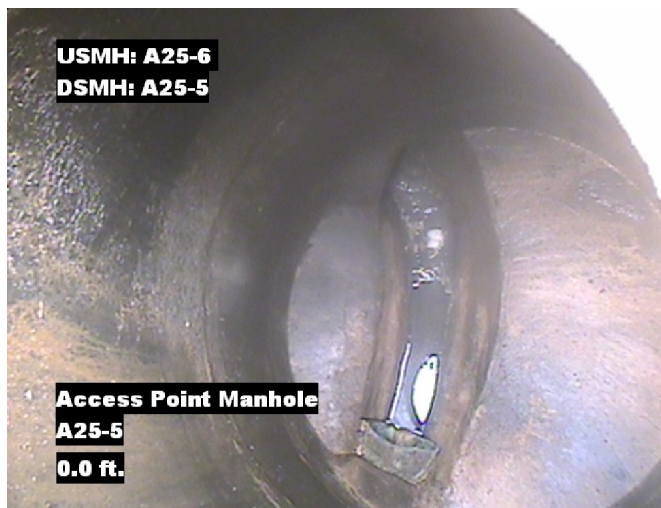
Distance: 0.0 ft. Grade: 0  
Condition: Access Point Manhole  
Remarks: A25-5

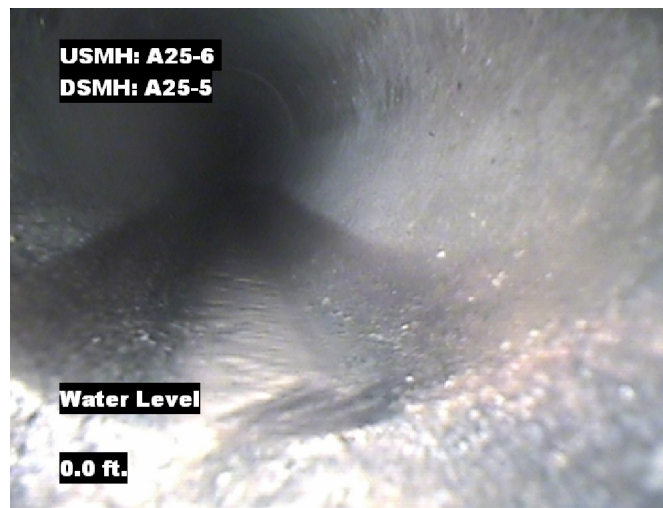
Distance: 0.0 ft. Grade: 0  
Condition: Water Level  
Remarks: N/A

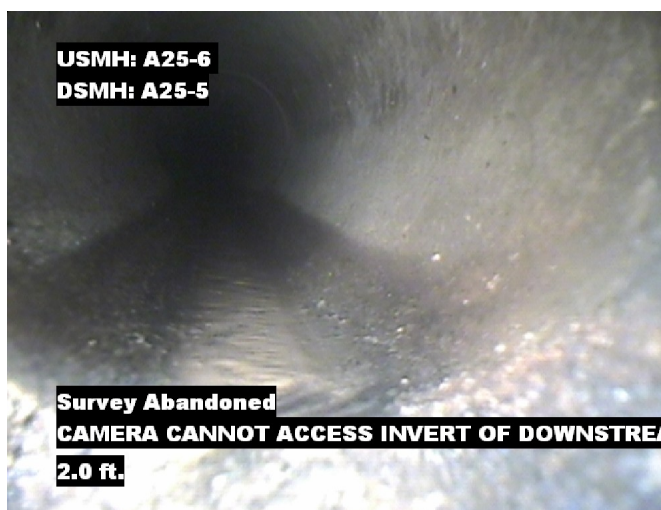
Distance: 2.0 ft. Grade: 0  
Condition: Survey Abandoned  
Remarks: CAMERA CANNOT ACCESS INVERT OF DOWNSTREAM MANHOLE
