## **Defect Listing**

Pipe Segment Refere		City		Street	Mat	Material		Sewer Use	
A26-1_	_A25-3	-3 Oliver Springs Pine st Concrete		Concrete F	Pipe (non	Light High	Sanitary		
Upstream MH		Total Length		Year Laid	Shape		Location Details		
A2	A26-1		4.1		Circ	ular			
DS Ma	anhole	Length s	surveyed	Year Renewed	Height	Width	Pipe Joint		
A2	A25-3		4.1		8	8	4		
SPR	N/A	MPR	N/A	PO Number	Number		Customer		
0001	NI/A	MDDI	NI/A	4397-03	GRW Purpose				
SPRI	N/A	MPRI	N/A	Work Order					
QSR	N/A	QMR	N/A	4397-02	Pre-Rehabilitation Survey				
OF	PR	Survey	ed By	Direction	Date		Media label		
N/	/A	Barry_Rogers		Downstream	20150803				
OF	PRI	Certificate Number		Pre-Cleaning	Time		Weather		
N/A U-1012-16405		Jetting	10:51		Dry				
		Date C	leaned		End Time		Additional Info		
		2015	0803		11:05

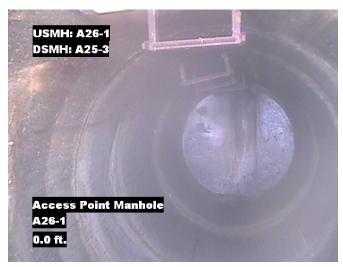
Distance: 0.0 ft. Grade: (

Condition: Access Point Manhole

Remarks: A26-1

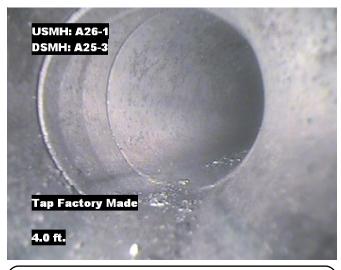
Distance: 4.0 ft. Grade: 0

Condition: Tap Factory Made

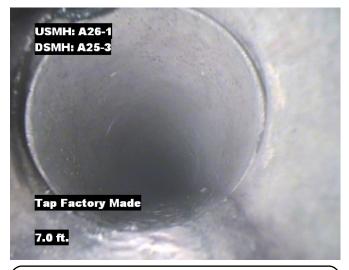
Distance: 7.0 ft. Grade: 0

Condition: Tap Factory Made

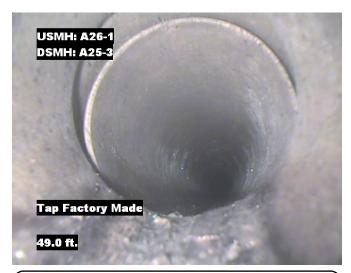
Distance: 49.0 ft. Grade: 0

Condition: Tap Factory Made

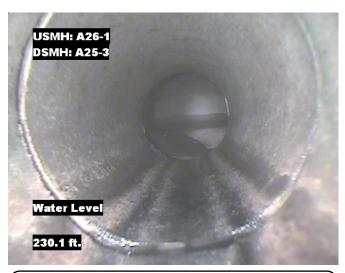
Distance: 230.1 ft. Grade: 0

Condition: Water Level

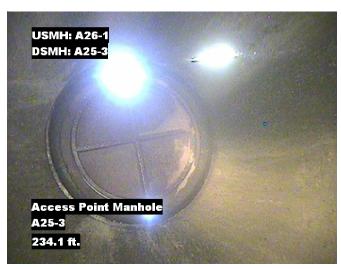
Distance: 234.1 ft. Grade: 0 Condition:

Access Point Manhole

Remarks: A25-3
